Spring Lake Rehabilitation & Naturalization – A Case Study in Aurora, IL

Spring Lake Naturalization

Spring Lake - Aurora, IL

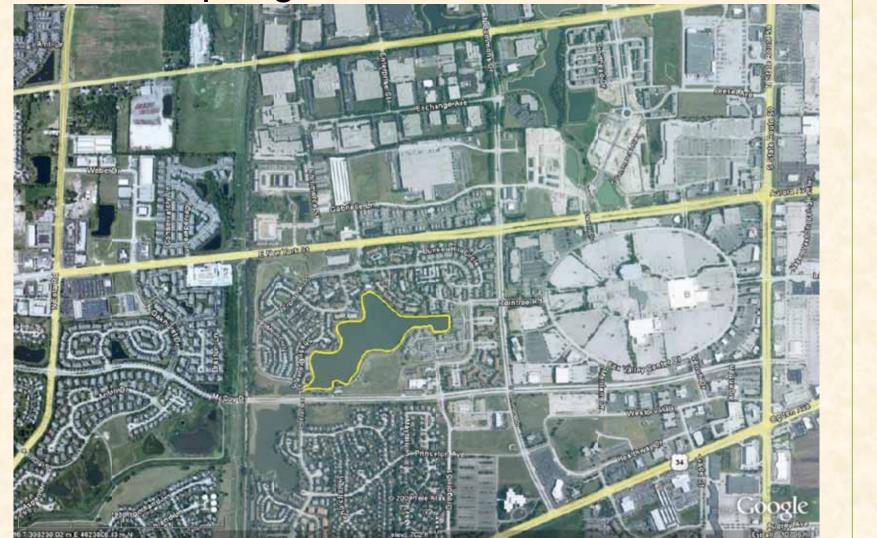
Spring Lake Bathymetric Survey

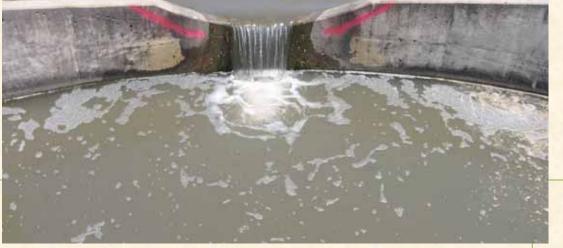
• Existing Weir Structure

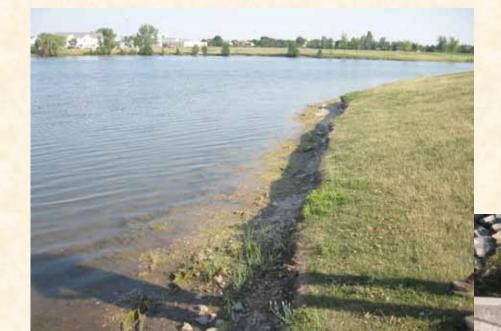
Mid June 2007

- Weir Saw Cut and Modificiation
- Drop invert of weir

From 678.10 to 677.35

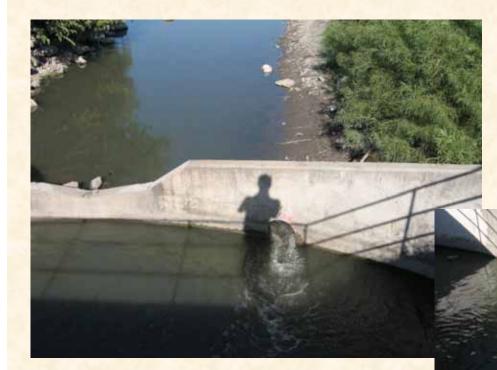
September 2007

Water Control Structure
 – 12" Diameter hole with inv. 18" below weir crest

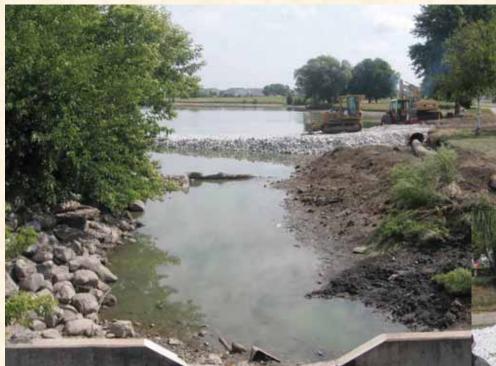
August 19, 2008

- Temporary Crossing
 - Crest above HWL
 - Low Point in Center
- Bypass Pumping

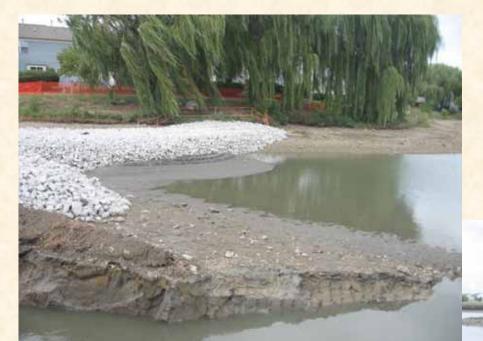
August 22, 2008

- Temporary Lake Level Draw Down
 - 2.5 Feet Below NWL
- Grading of Side Slopes

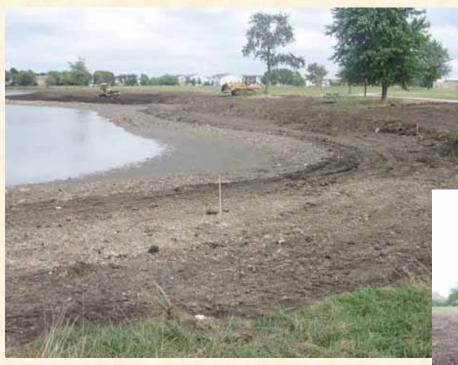
August 22, 2008

- Temporary Lake Level
 Draw Down
 - 2.5 Feet Below NWL
- Grading of Side Slopes

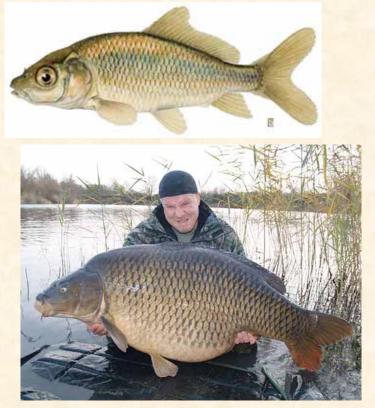
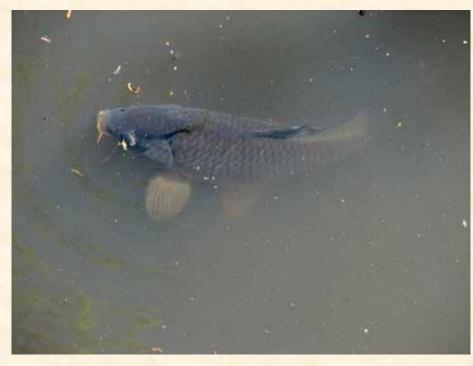
Spring Lake Shoreline Repair A New Concern Arises

Common Carp (especially large ones) and newly planted shorelines with wetland species do not mix well

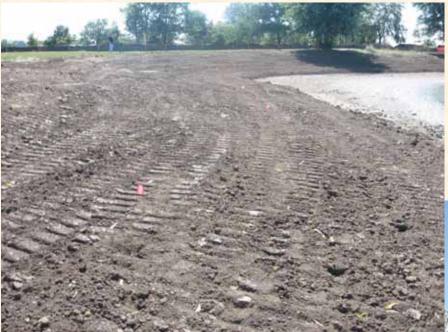
August 25, 2008

- Temporary Lake Level
 Draw Down
 - 2.5 Feet Below NWL
- Grading of Side Slopes

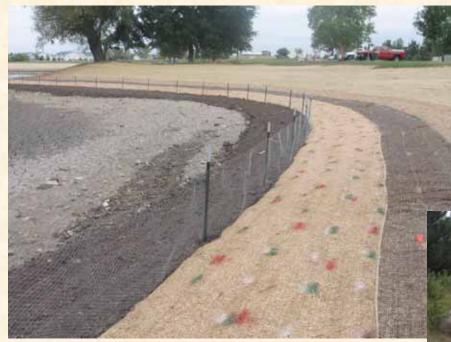
Installation Completed September 3, 2008

Observed Normal Water Level Surveyed and Flagged to Mark Centerline of TRM

Carp Exclusion Fence installed in anchor trench of matting

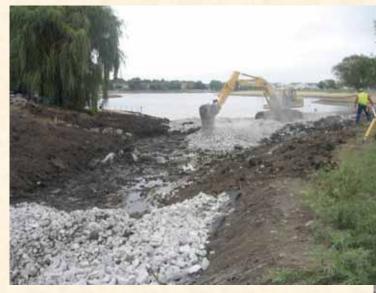
- Temporary Crossing Removed
- Gate Valve and Water Control Structure Installed at Weir

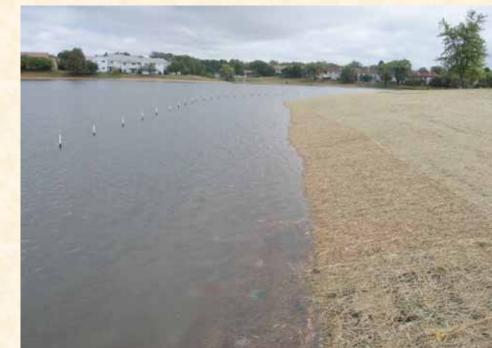
September 5, 2008

- Flooding in Region Extensive
- High Water Mark After September 15th
 - Approximately 4 feet above NWL

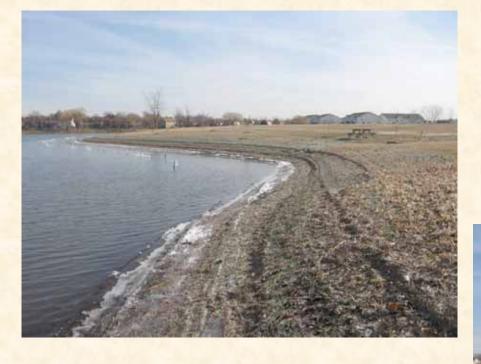
Photos February, 2008

- Additional Flooding in December and February
- Erosion More Extensive than September 2008 Flooding
 - 2.3 Inches of Heavy Rain on 8 inches of Snow and Frozen Ground on December 27

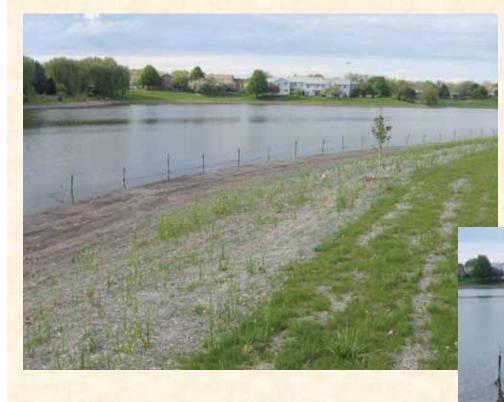
May 2, 2009

- Spring Evaluation
- Loss of cover crop in wet zones due to flooding
- Water levels lowered to promote germination of wet zones throughout growing season of 2009
- Wetland Plug Installation Mid-Summer 2009

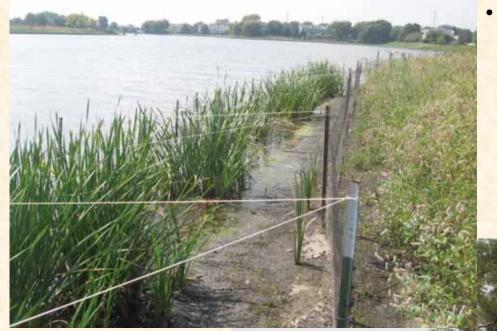
2009 Management & Monitoring

- Extensive Wet Mesic Zone Establishment
- Plugging was more successful in upper portions of emergent zone
- HOA issues with protection fencing and scalping buffer areas
- Prolonged high water levels and drastic fluctuation in lake levels
