Understanding and Controlling Shoreline Erosion on Reservoirs with fine grain, cohesive shoreline soils

Presented by: Shoreline Metrics, LLC
Hank Sutton, Senior Engineering Technician

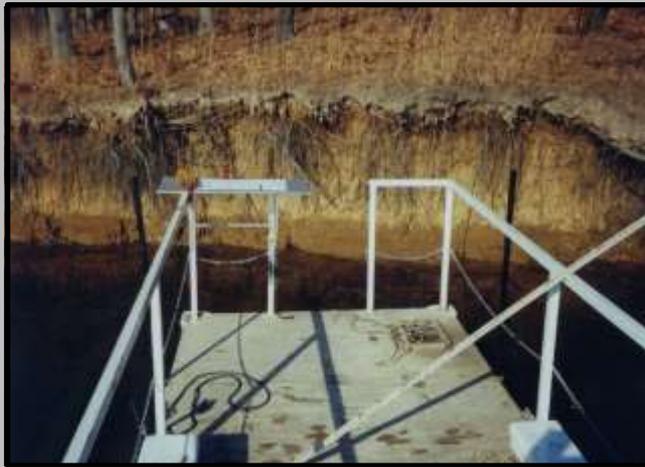
Determine appropriate cross section spacing. Estimate approximate bank heights using a range pole or leveling rod. Use the water level for the bench mark adjusted to full pool elevation. Record water depth at the bank, 10 feet out and 20 feet out to determine littoral slope gradient. Measure the reach length at the proposed center line of the breakwater. Record information and photograph the bank along the selected reaches.

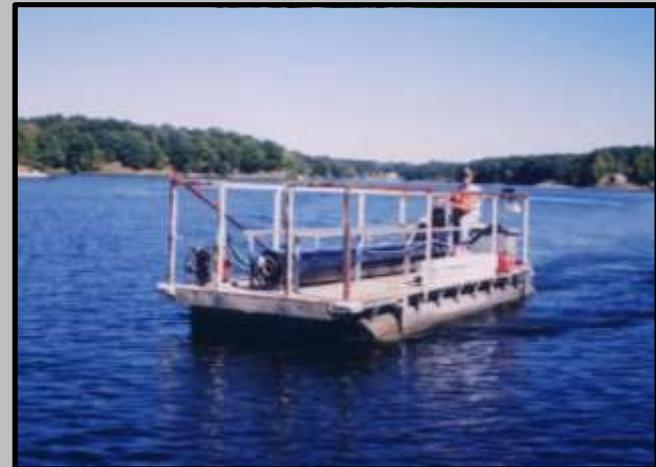
A technician experienced in shoreline erosion control must be on site to ensure proper fabric placement and proposed lines and grade.

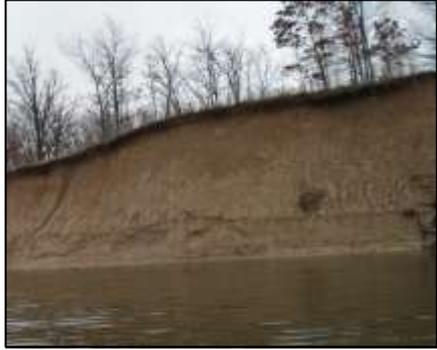
Full pool at Shelbyville

Carlyle Lake has longer fetches and therefore more wind driven wave energy, but the bank height will never reach that of Shelbyville, where the surrounding terrain is much higher.

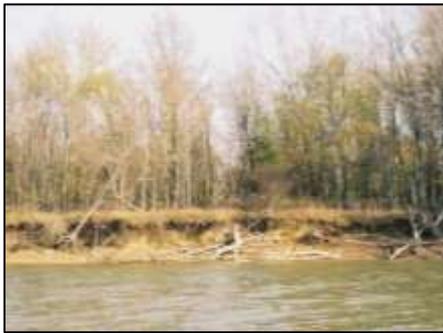
Full pool at Carlyle

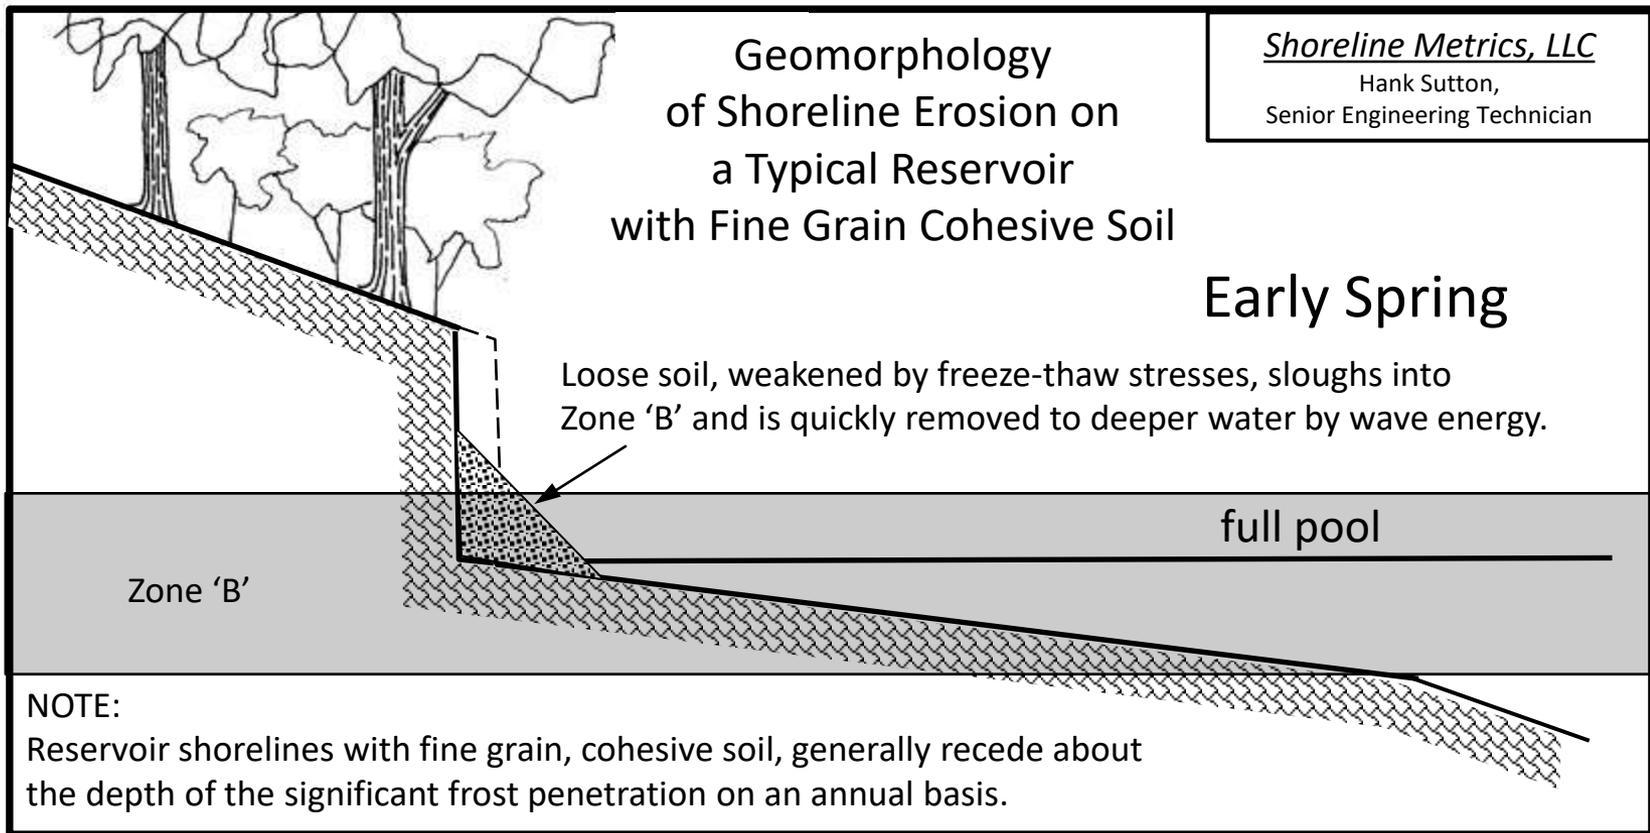
This weakened fine grain cohesive soil commonly has a consistency similar to loose sand.

It is also very common for sloughing to occur intermittently during the winter between freeze-thaw cycles. In those cases, the sloughing and bank recession is not as noticeable.

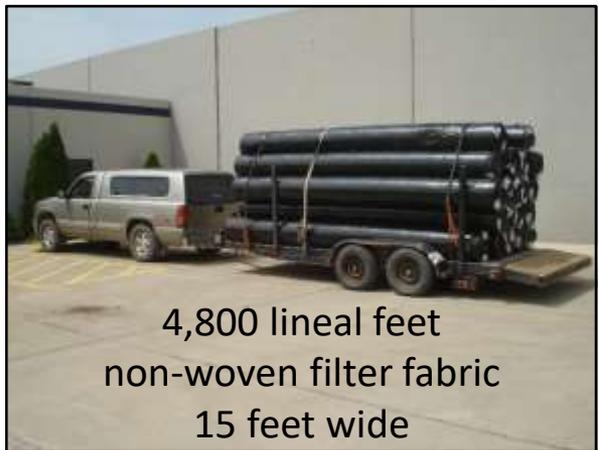
4,800 lineal feet
non-woven filter fabric
15 feet wide

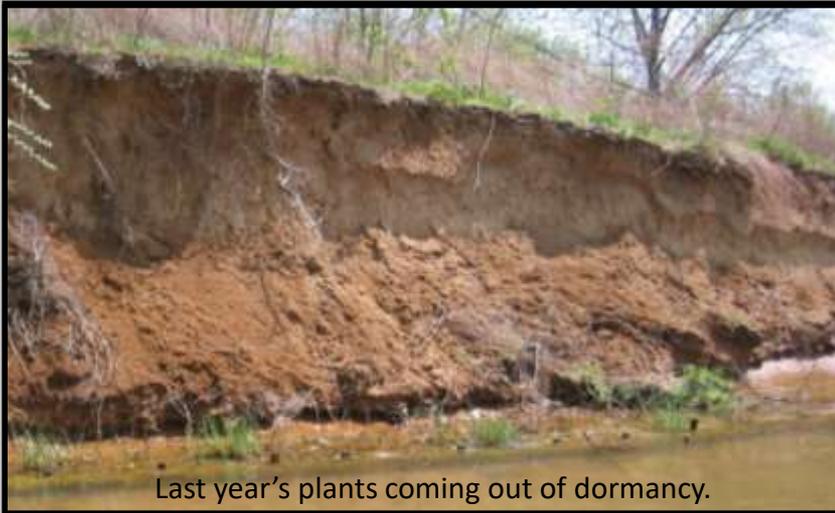
Last year's plants coming out of dormancy.

In Spring and Summer a small number of plants sprout along the eroding shoreline, put down roots, become dormant in Fall and survive through the Winter. In late Winter and early Spring the frost weakened soil is removed to deeper water, including the emerging plants, roots and all. If the shoreline is not isolated from wave energy, this process is an ongoing annual event, resulting in continuous shoreline recession, excessive sedimentation and nutrient loading.

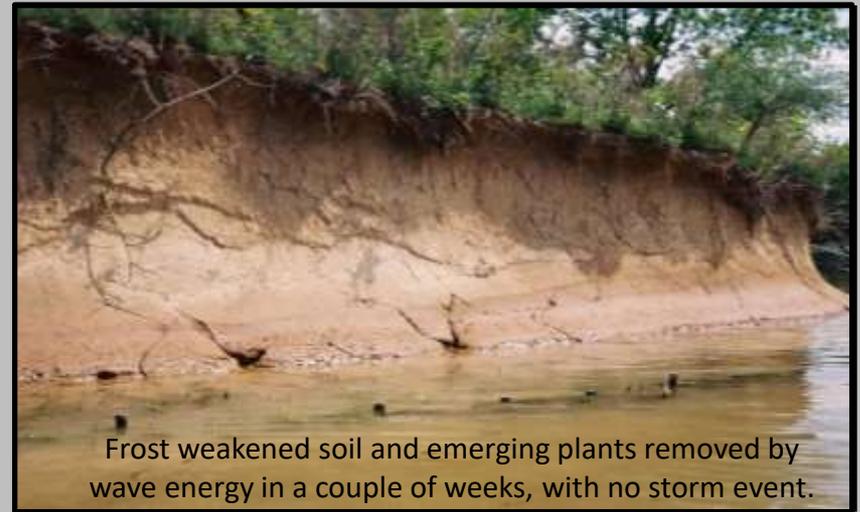
Frost weakened soil and emerging plants removed by wave energy in a couple of weeks, with no storm event.

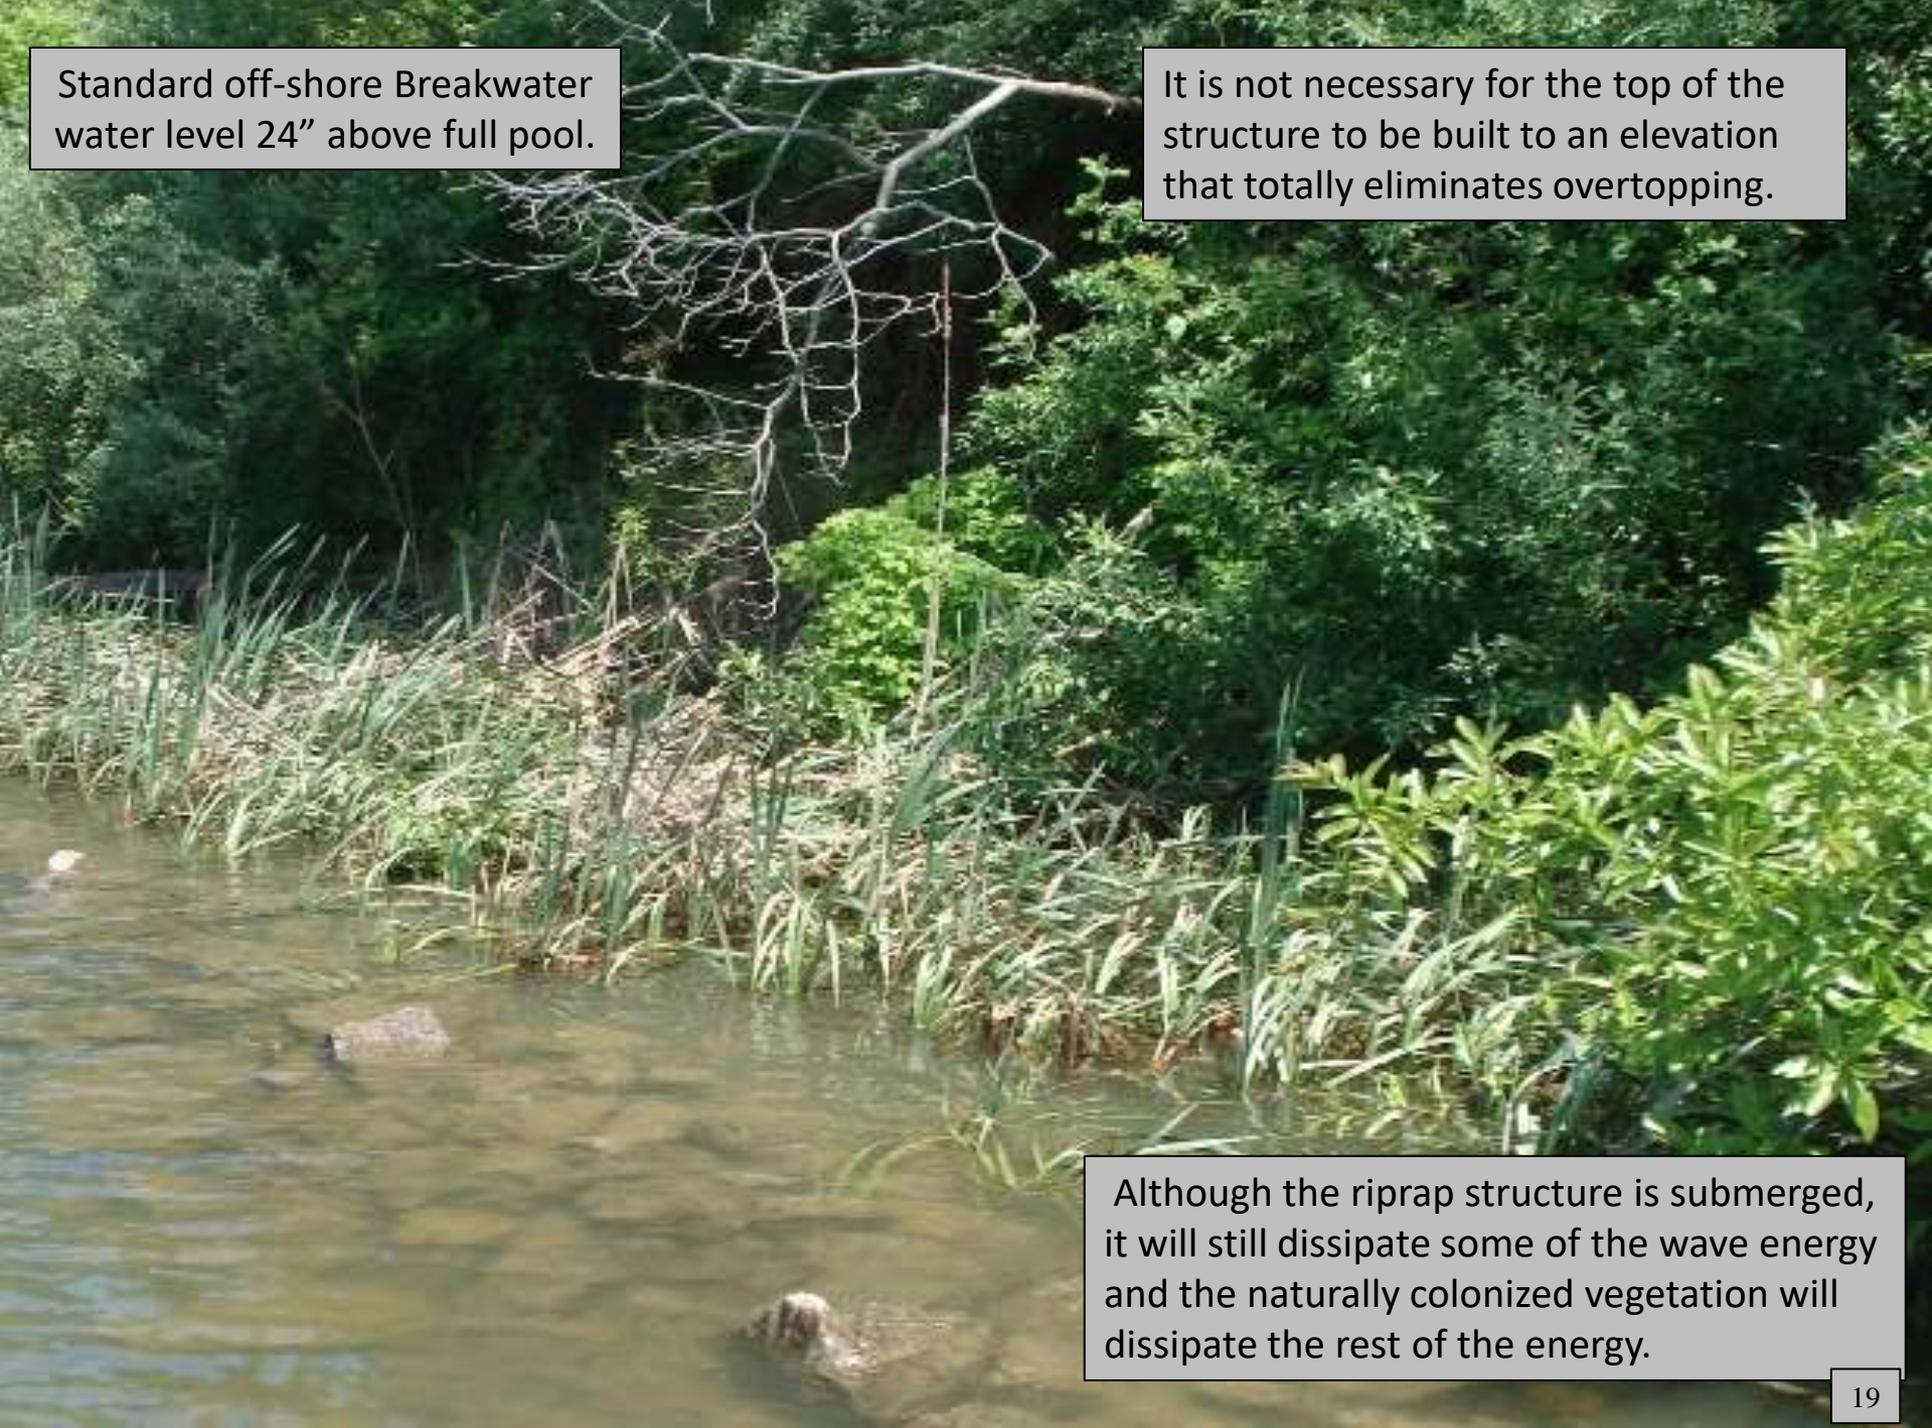
A photograph showing a riprap structure submerged in a body of water. The structure is partially obscured by dense vegetation, including tall grasses and shrubs. A large, bare tree branch hangs over the water from the background. The water is calm, and the overall scene is lush and green.

Standard off-shore Breakwater
water level 24" above full pool.

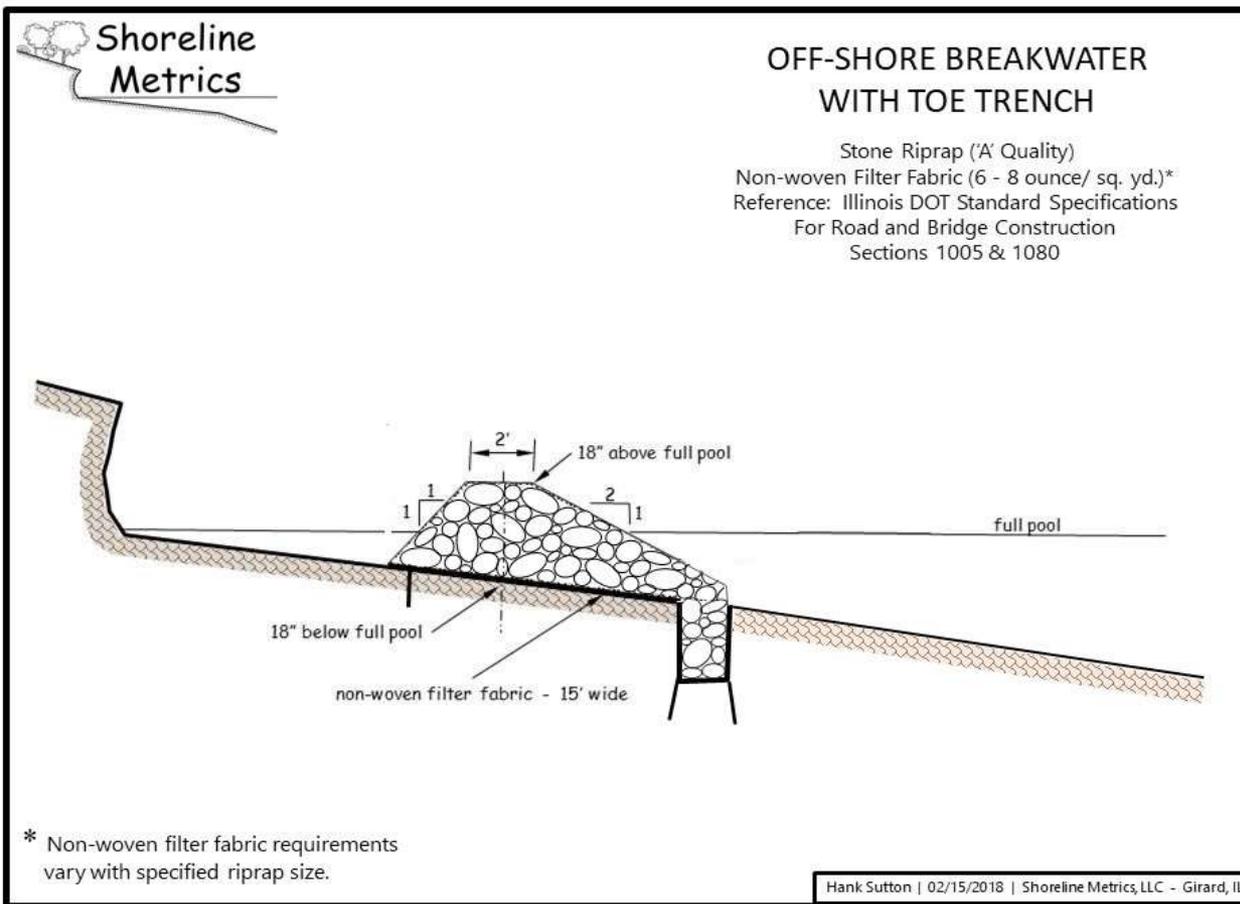
The apron is an improved design that replaces the toe trench.

The problem with the toe trench is that it was difficult to accurately excavate the trench under water and added significant cost to the work. Before non-woven filter fabric was developed, stone bedding was used under riprap. Stone Bedding remains in IDOT Specifications, under Section 1005, RR-1 and RR-2.

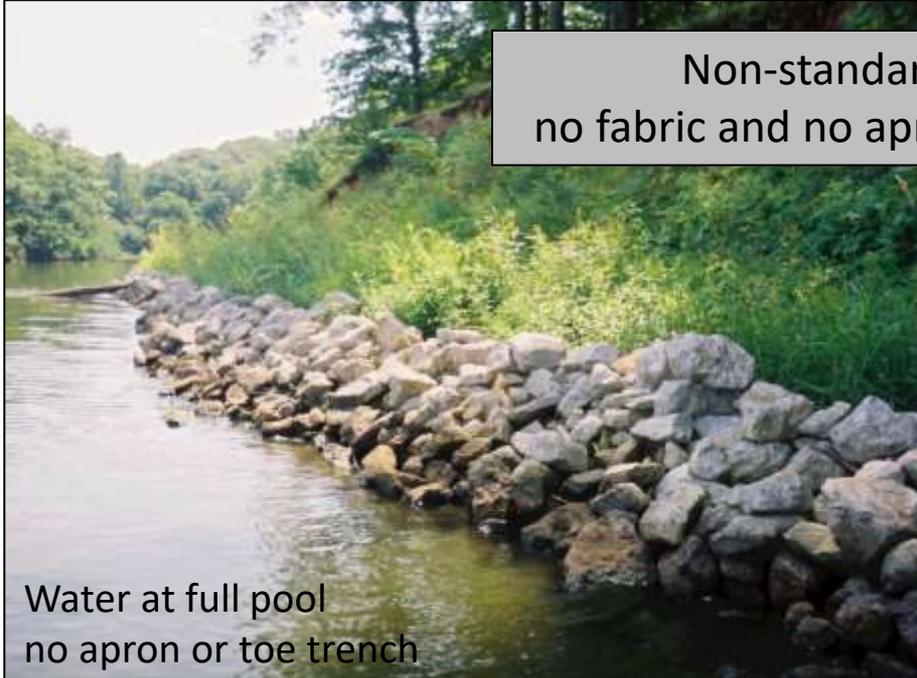
Non-standard Design with
no fabric and no apron to protect the toe

Water at full pool
no apron or toe trench

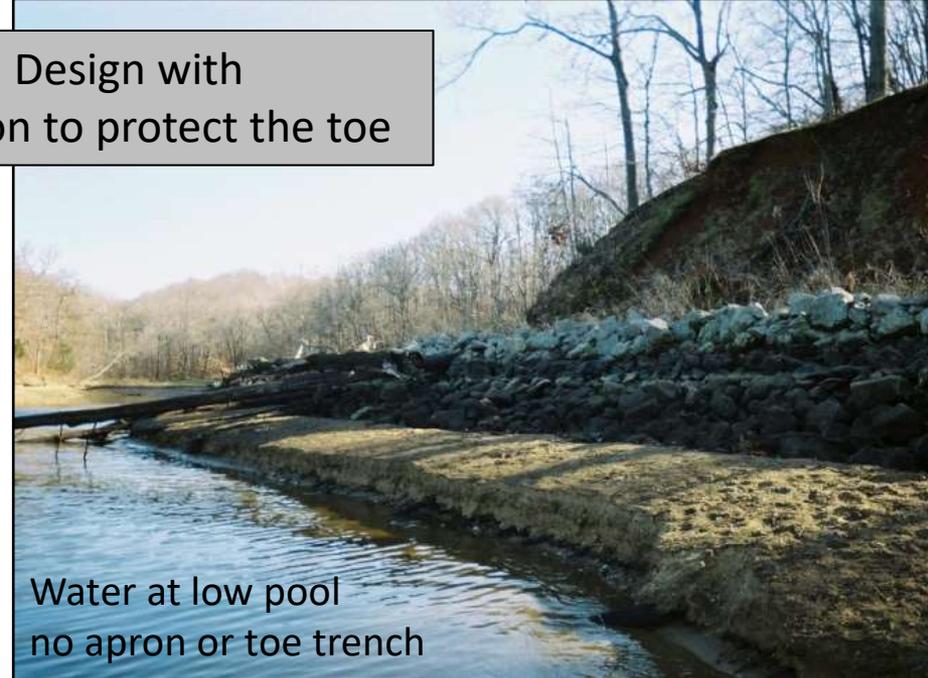
Water at low pool
no apron or toe trench

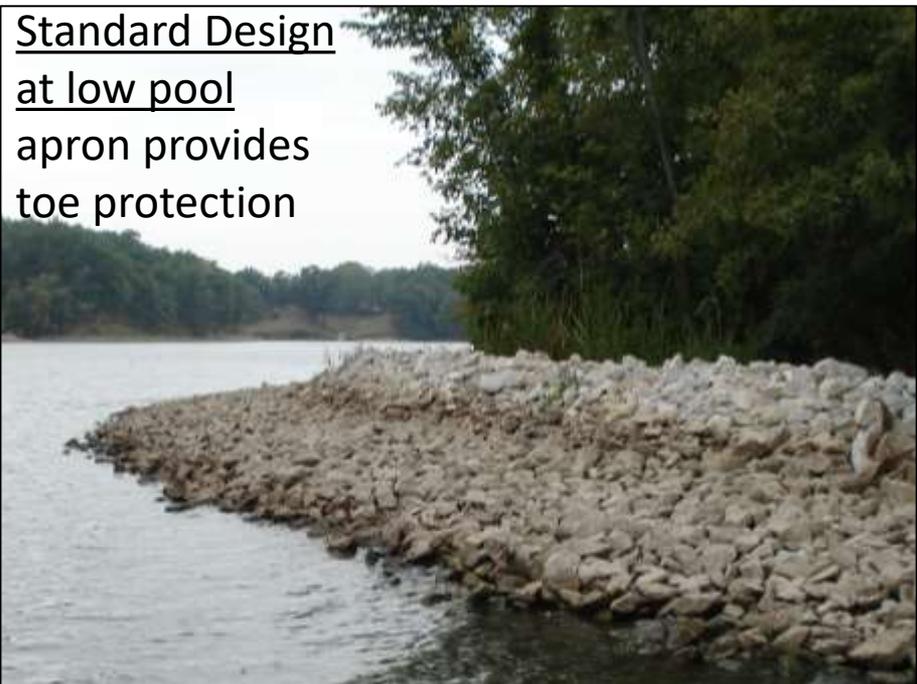
Standard Design
at low pool
apron provides
toe protection

Illinois Standard
Off-shore Breakwater
on non-woven filter fabric

NOTE: This design is deliberately lean to optimize cost-effectiveness. The intent is to effectively dissipate wave energy without over designing. This lean design has been in use for over 20 years with no significant failures. If, by chance, the structure needs maintenance, small additional quantities of riprap can simply be applied to restore the original lines and grade of the localized failures. High quality riprap (IDOT quality designation 'A') is virtually impervious to weathering.

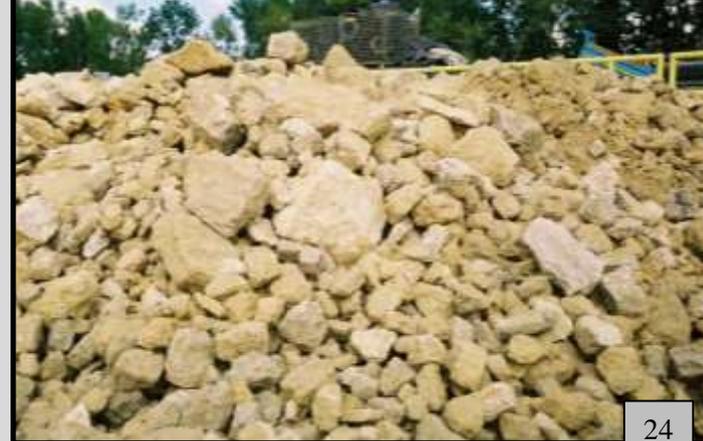
RR-5

Material rejected & removed from site segregated and not well graded.

All gradations produced shall be well graded (not skip graded) from the specified top-size particles to the smallest particles. Shoreline Metrics, LLC recommends 2 additional key-stones per RR size, of intermediate weights to ensure that the material is well graded. Example of additional key-stones for RR-4: specified key-stones : 150 lbs, 40 lbs, 1 lb - intermediate key-stones: 90 lbs & 20 lbs.

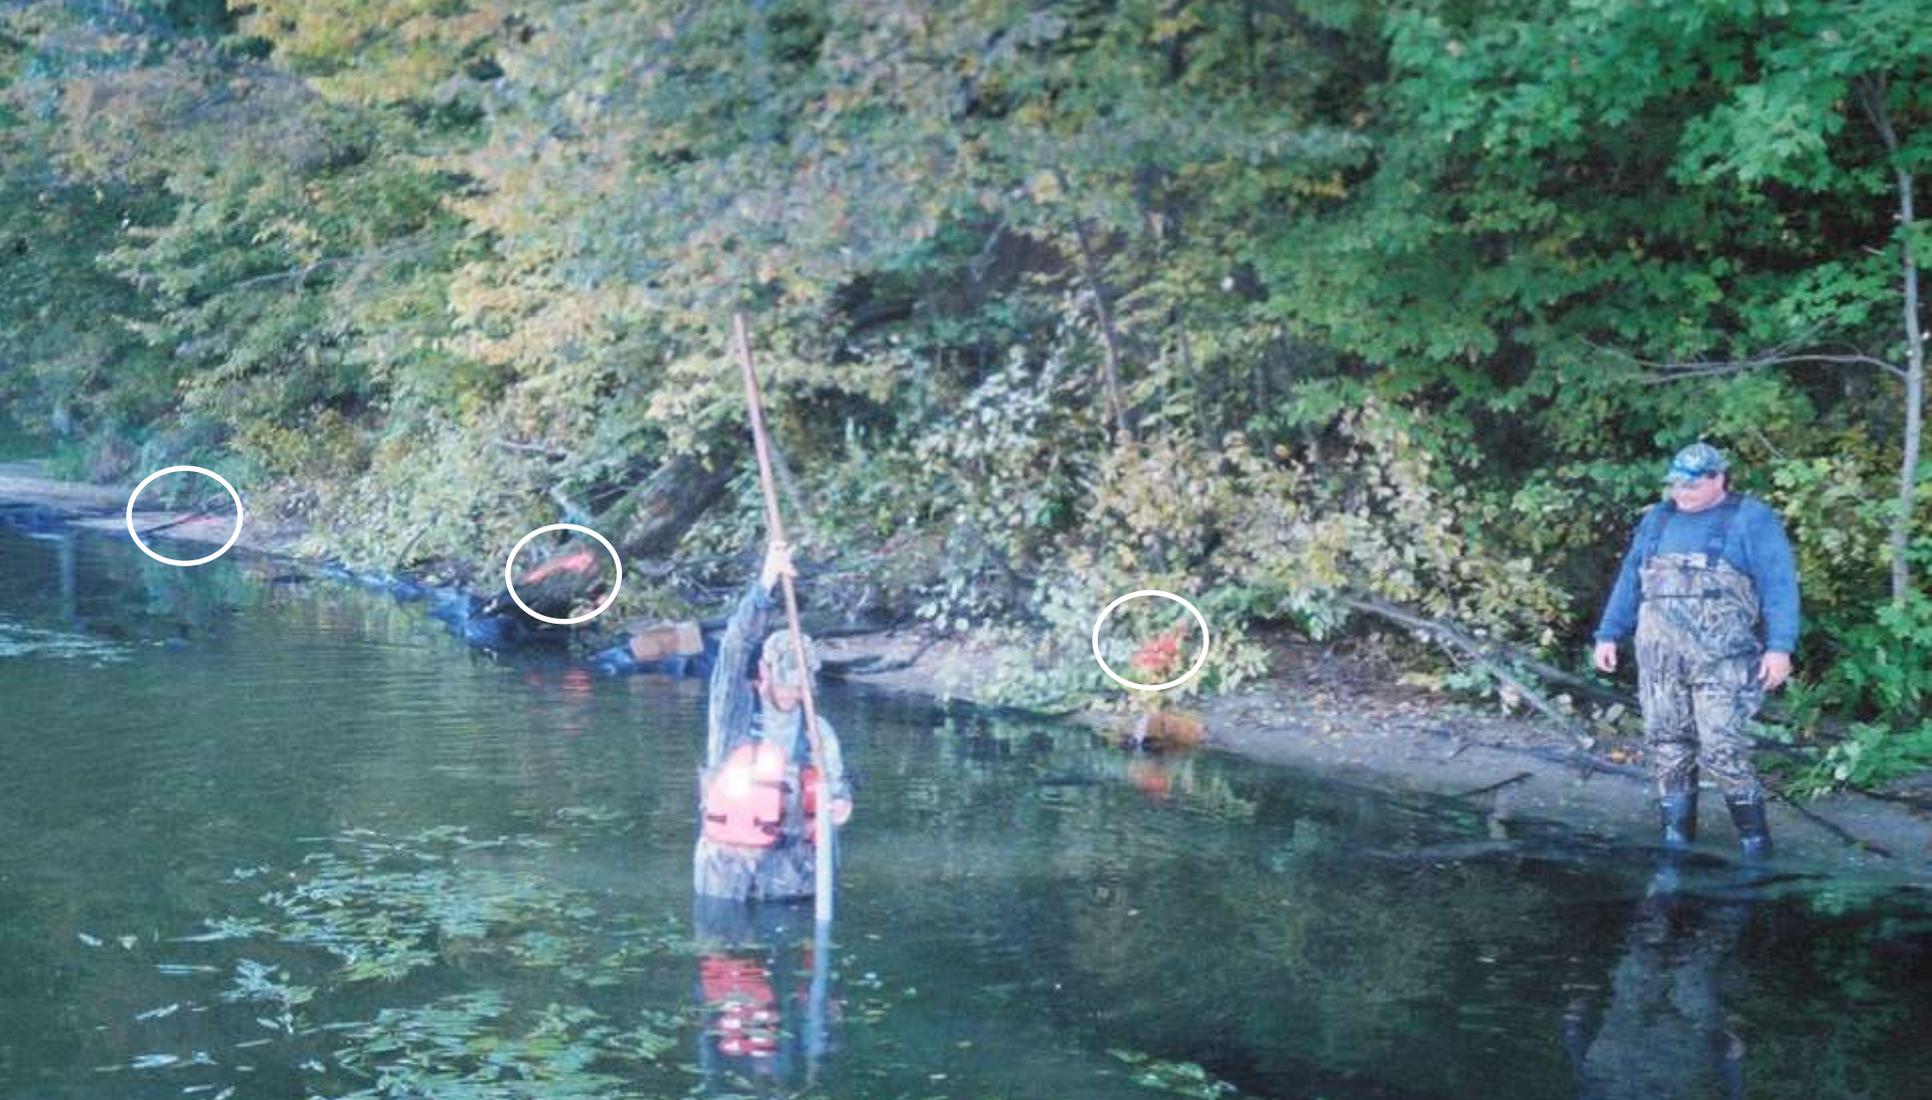
The filter fabric must be anchored on both sides with 12" steel landscape pins to ensure the proper location before the riprap is placed. Once the riprap is placed, the fabric will not move. Maximum riprap freefall on fabric: 12".

Paint marks indicate load spacing for material budgeting.

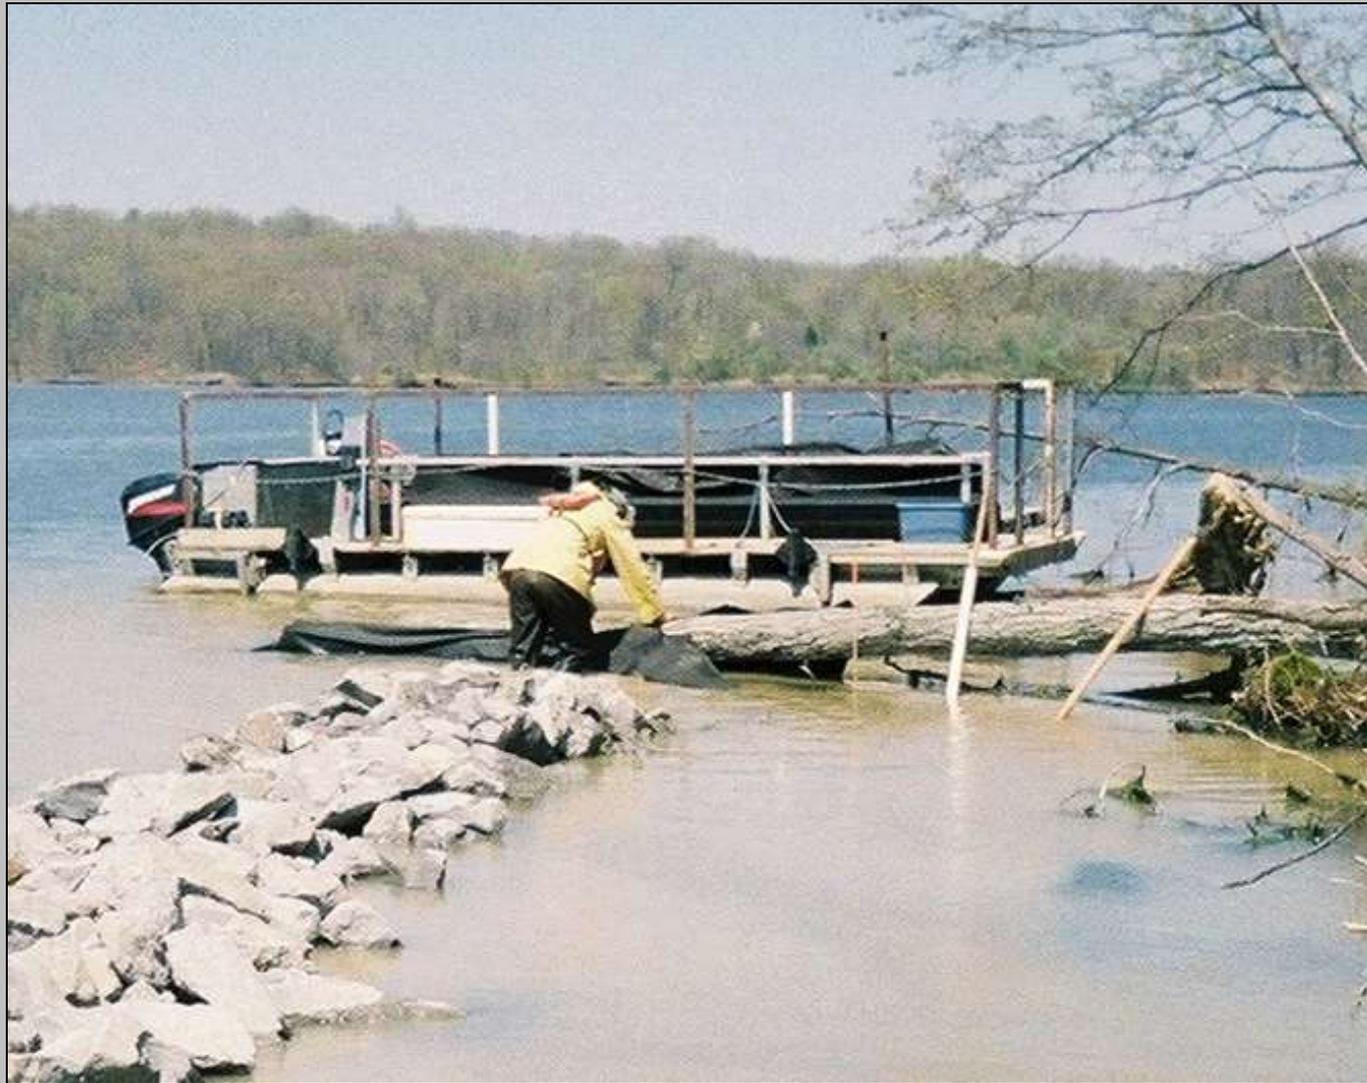
Drape fabric loosely over the log, then cut the fabric along the top of the log.

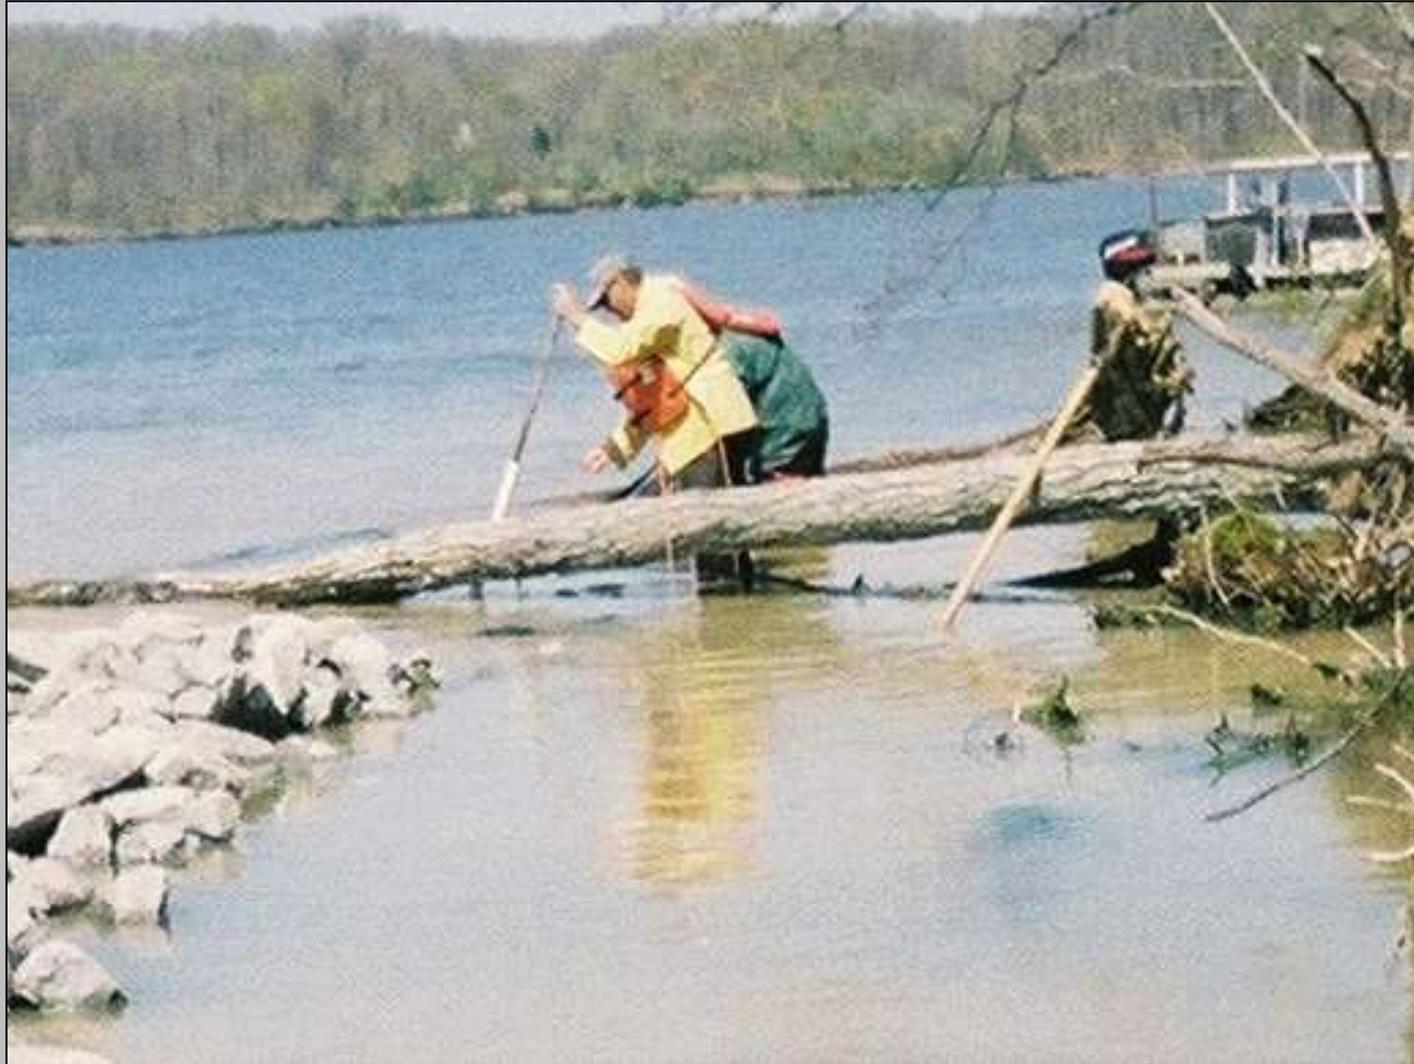
Lap and pin the fabric under the log from both sides.

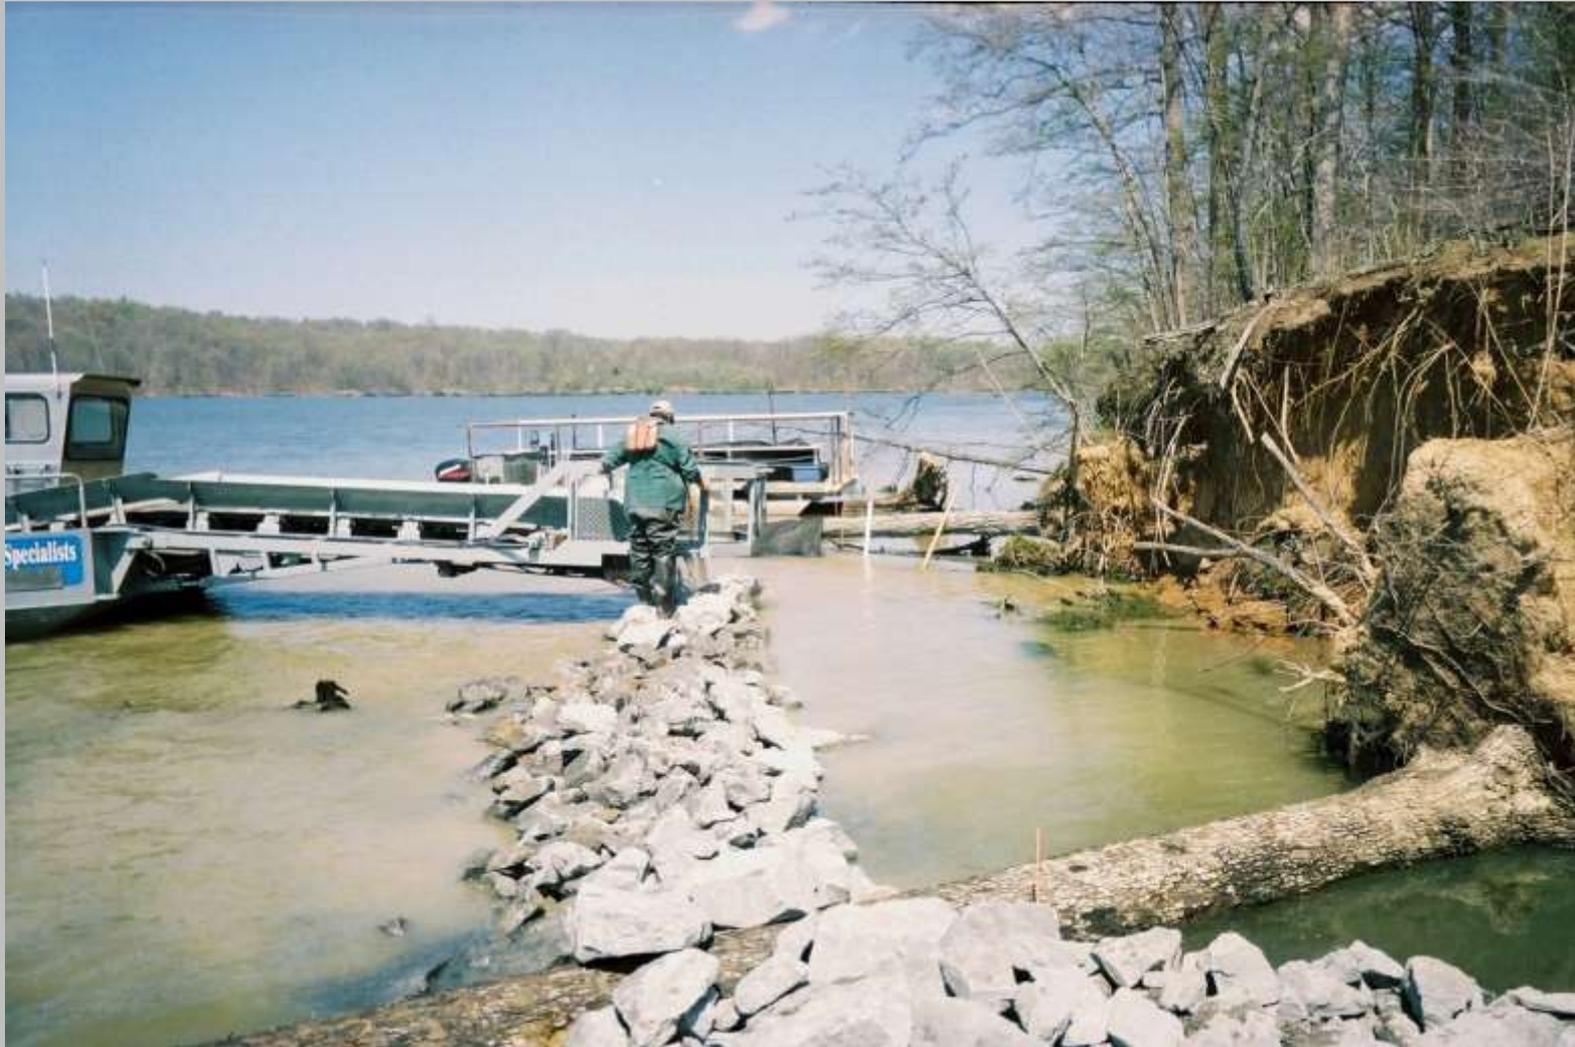
Place riprap over the log. Although the log will last a long time, we have started placing additional riprap on top of logs to replace the volume of the log as it decays.

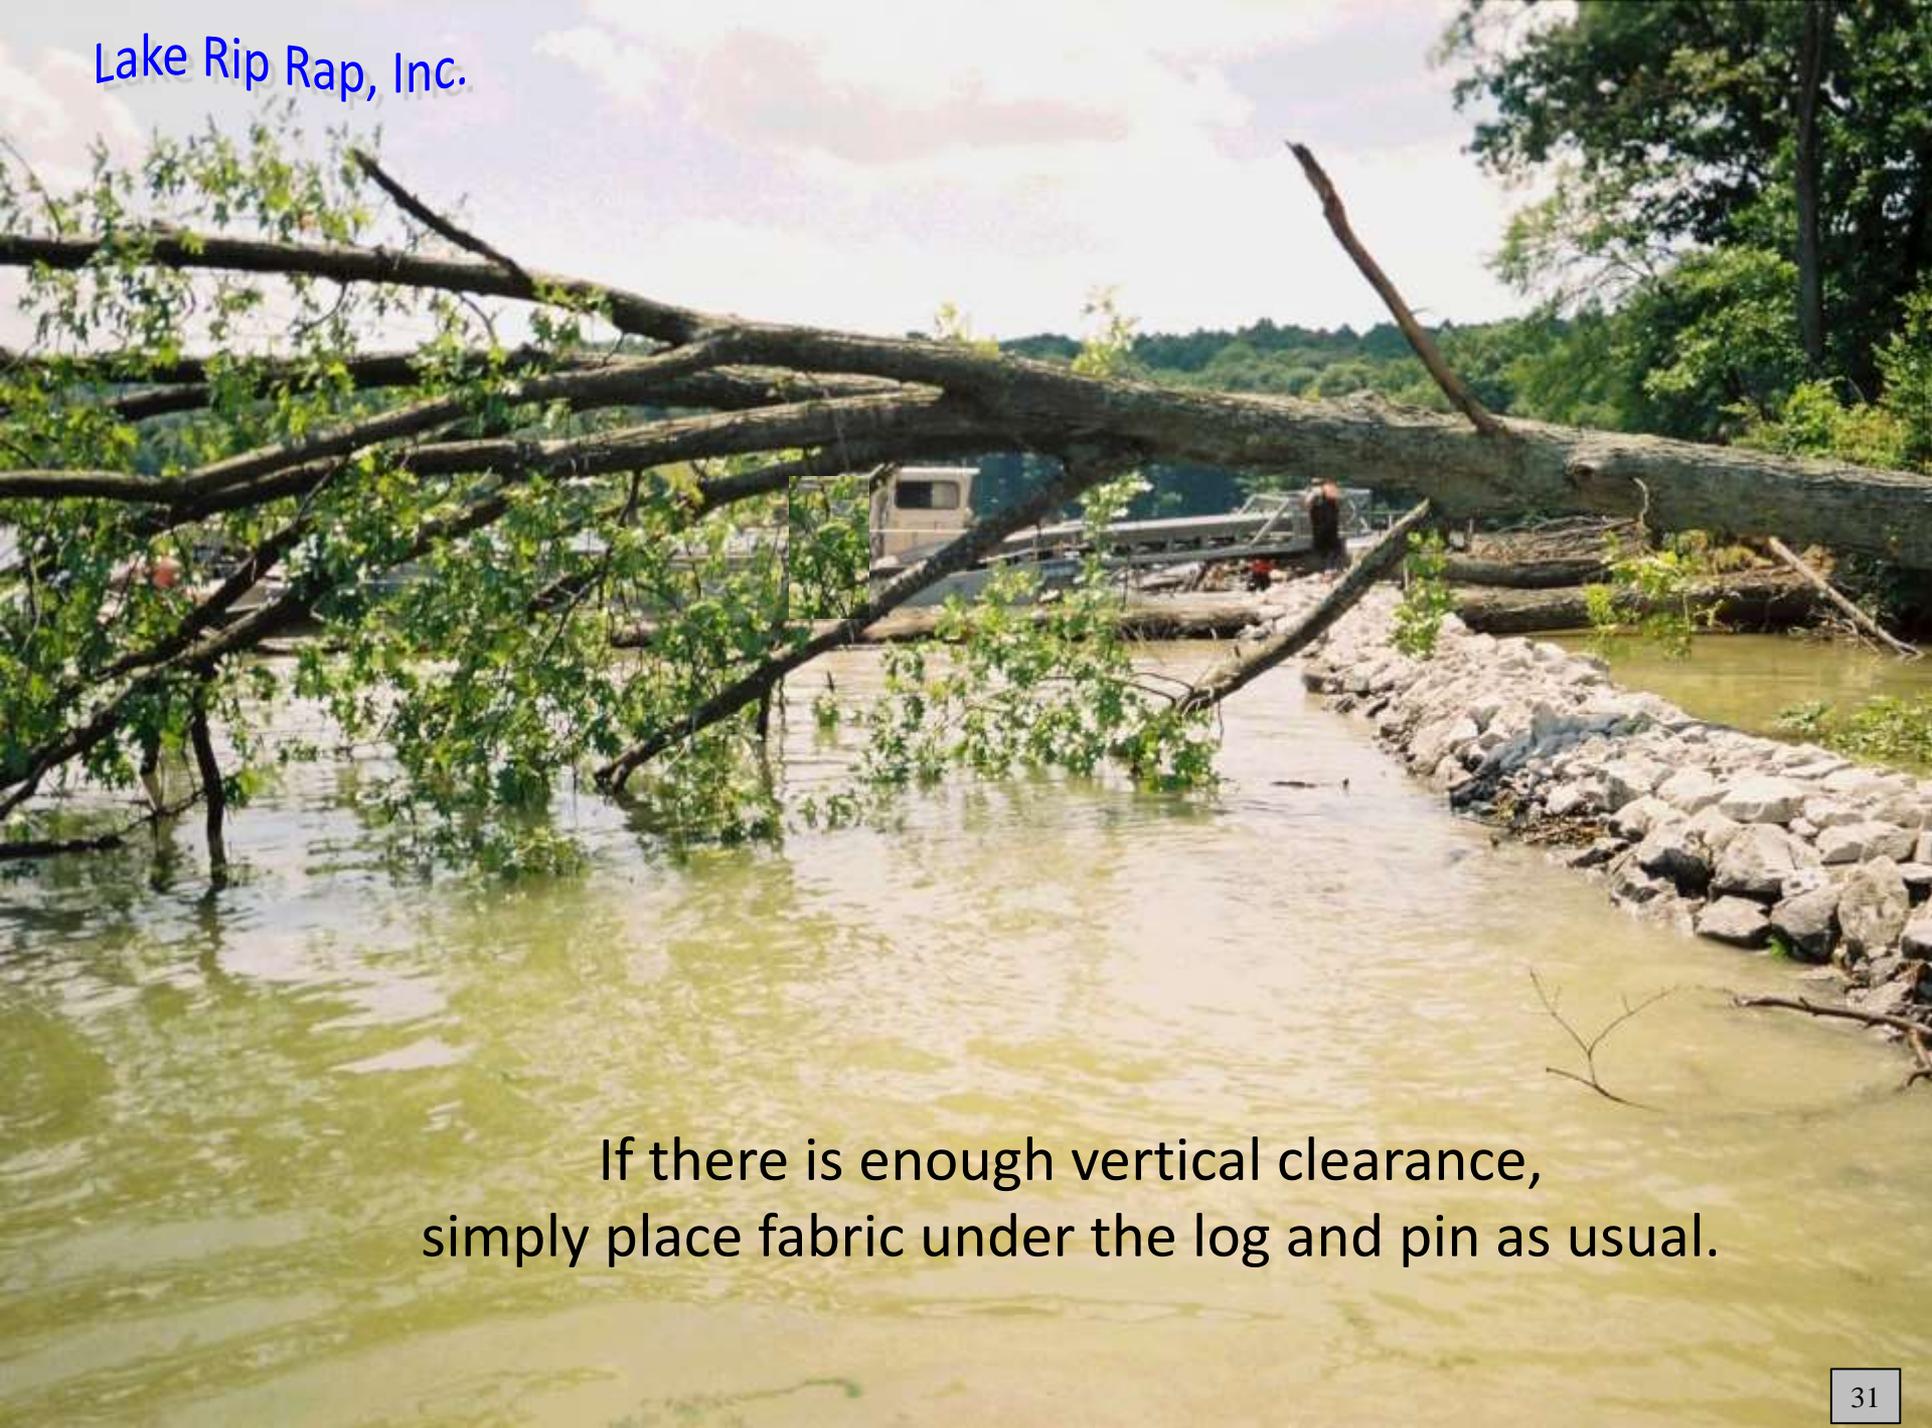
If there is enough vertical clearance,
simply place fabric under the log and pin as usual.

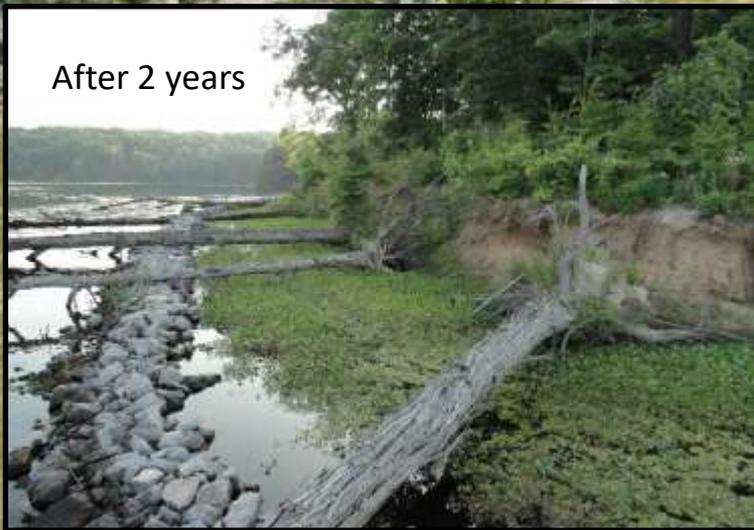
Working around down trees can be a challenge, but, biologists agree that down trees provide a desirable element to the developing shoreline habitat and the cost of removing them can be avoided.

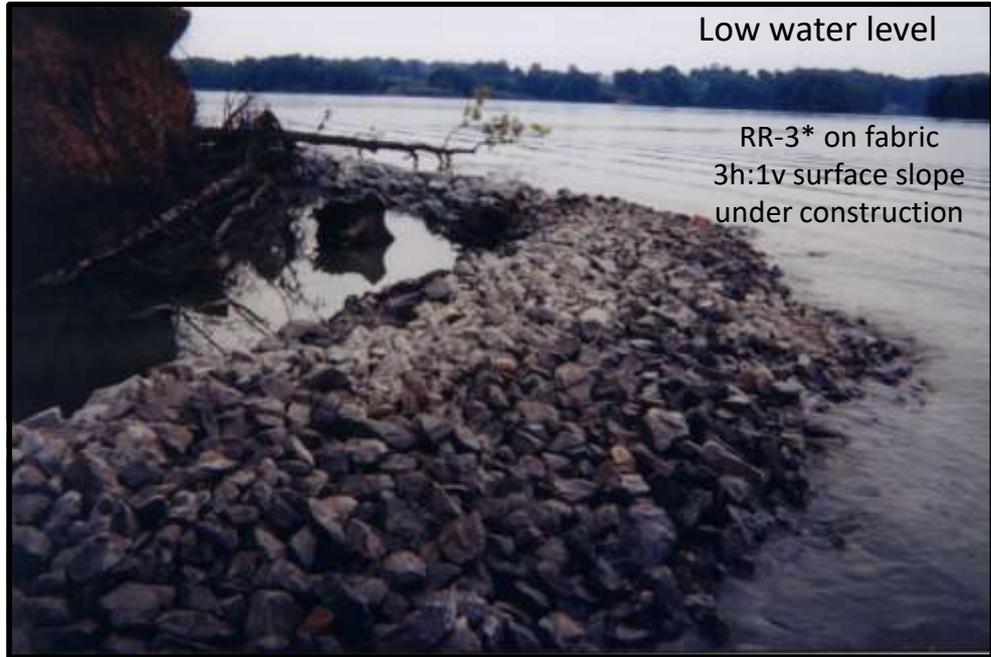
Low water level

RR-3* on fabric
3h:1v surface slope
under construction

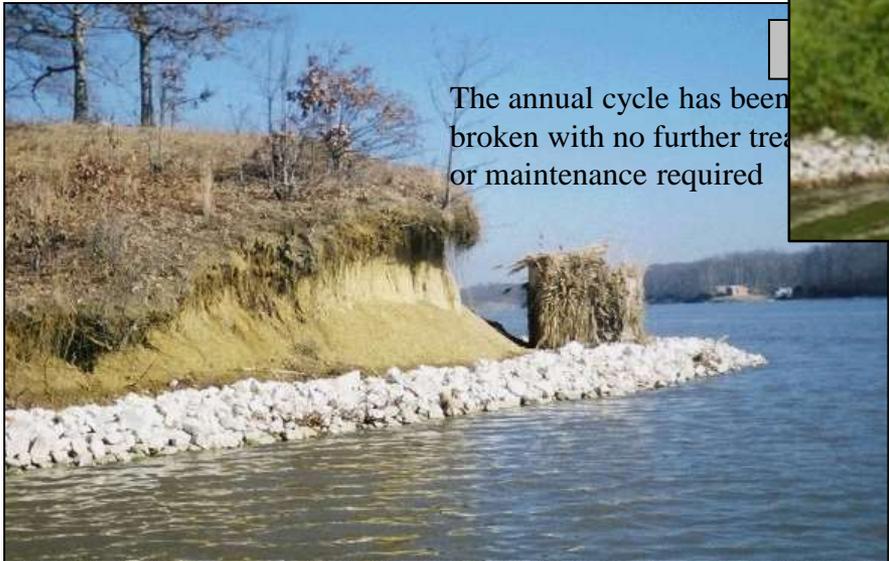
2005

This shoreline is now a complete, naturally colonized, living shoreline

The annual cycle has been broken with no further treatment or maintenance required

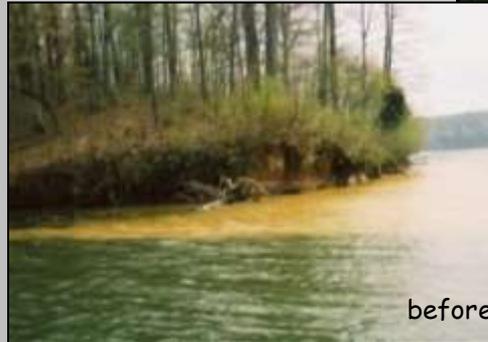
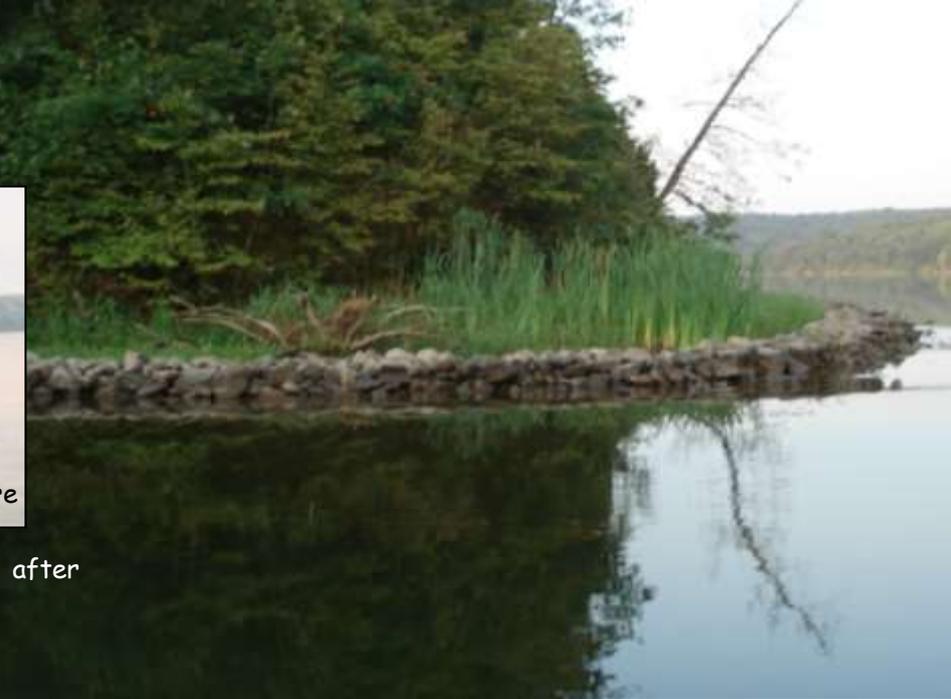
Notice sediment plume with relatively calm water, before stabilization.

Natural Plant Colonization

No excavation, no equipment on the bank and no seeding or planting required.
