Understanding and Controlling Shoreline Erosion on Reservoirs with fine grain, cohesive shoreline soils

Presented by: Shoreline Metrics, LLC
Hank Sutton, Senior Engineering Technician

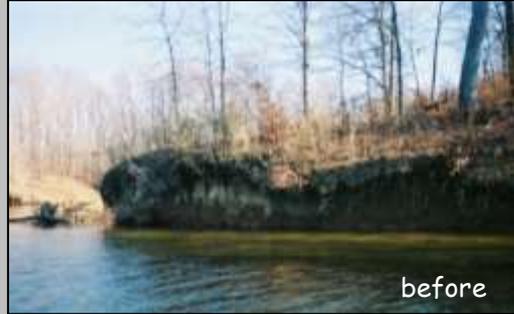
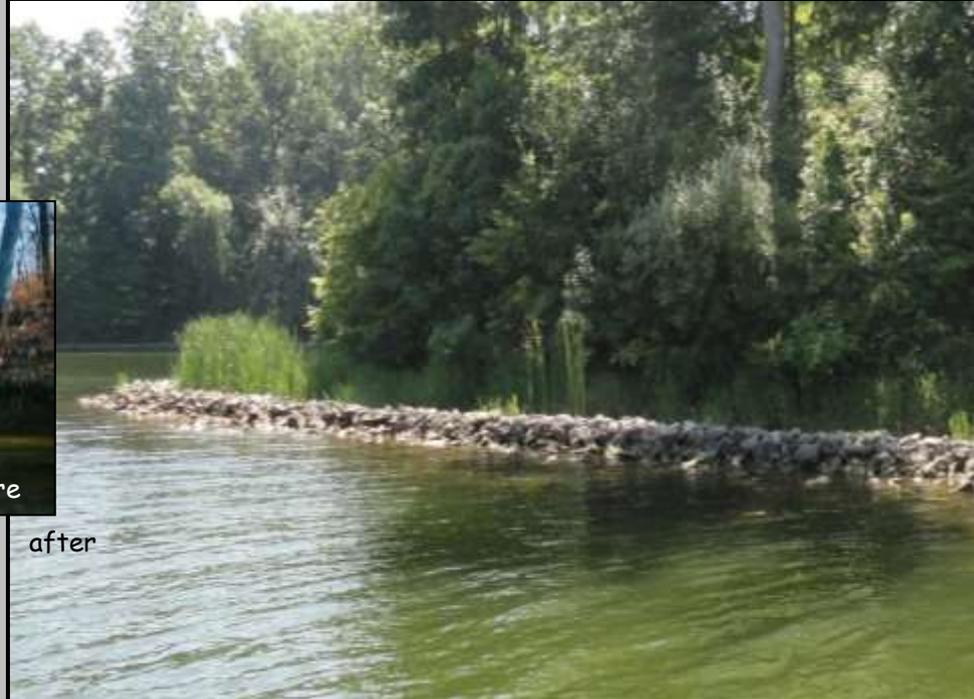
before

after

Natural Plant Colonization

No excavation, no equipment on the bank and no seeding or planting required.

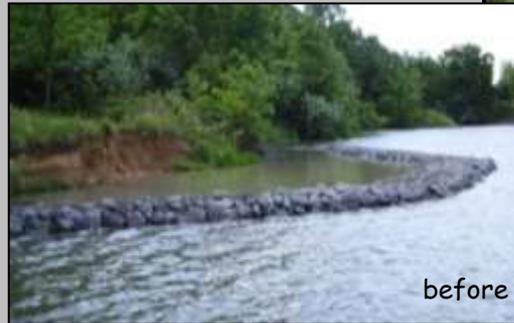
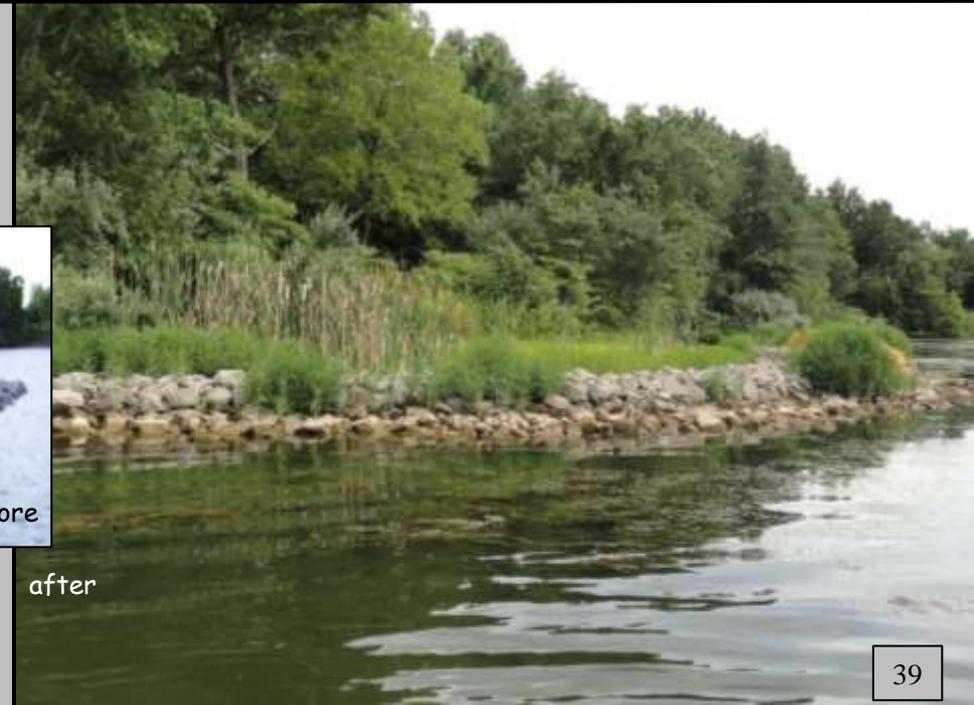
before

after

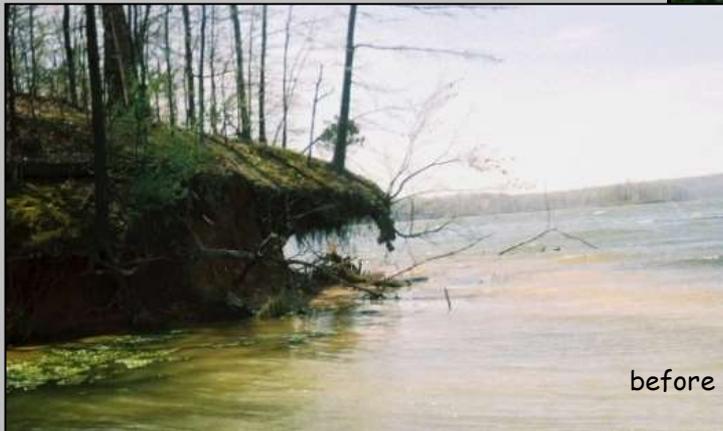
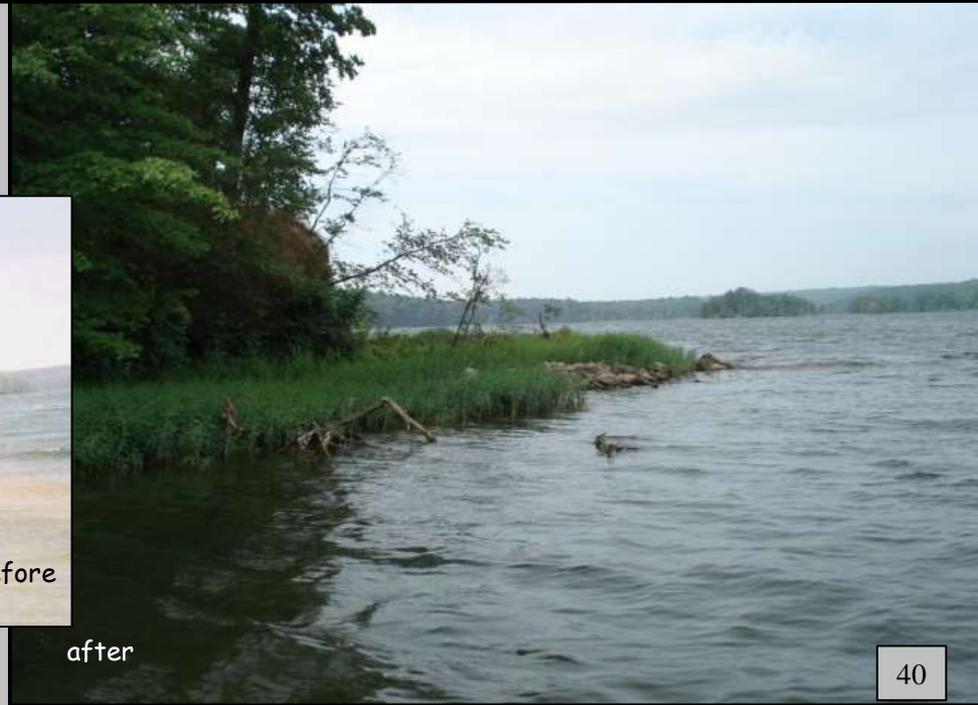
Natural Plant Colonization

No excavation, no equipment on the bank and no seeding or planting required.

before

after

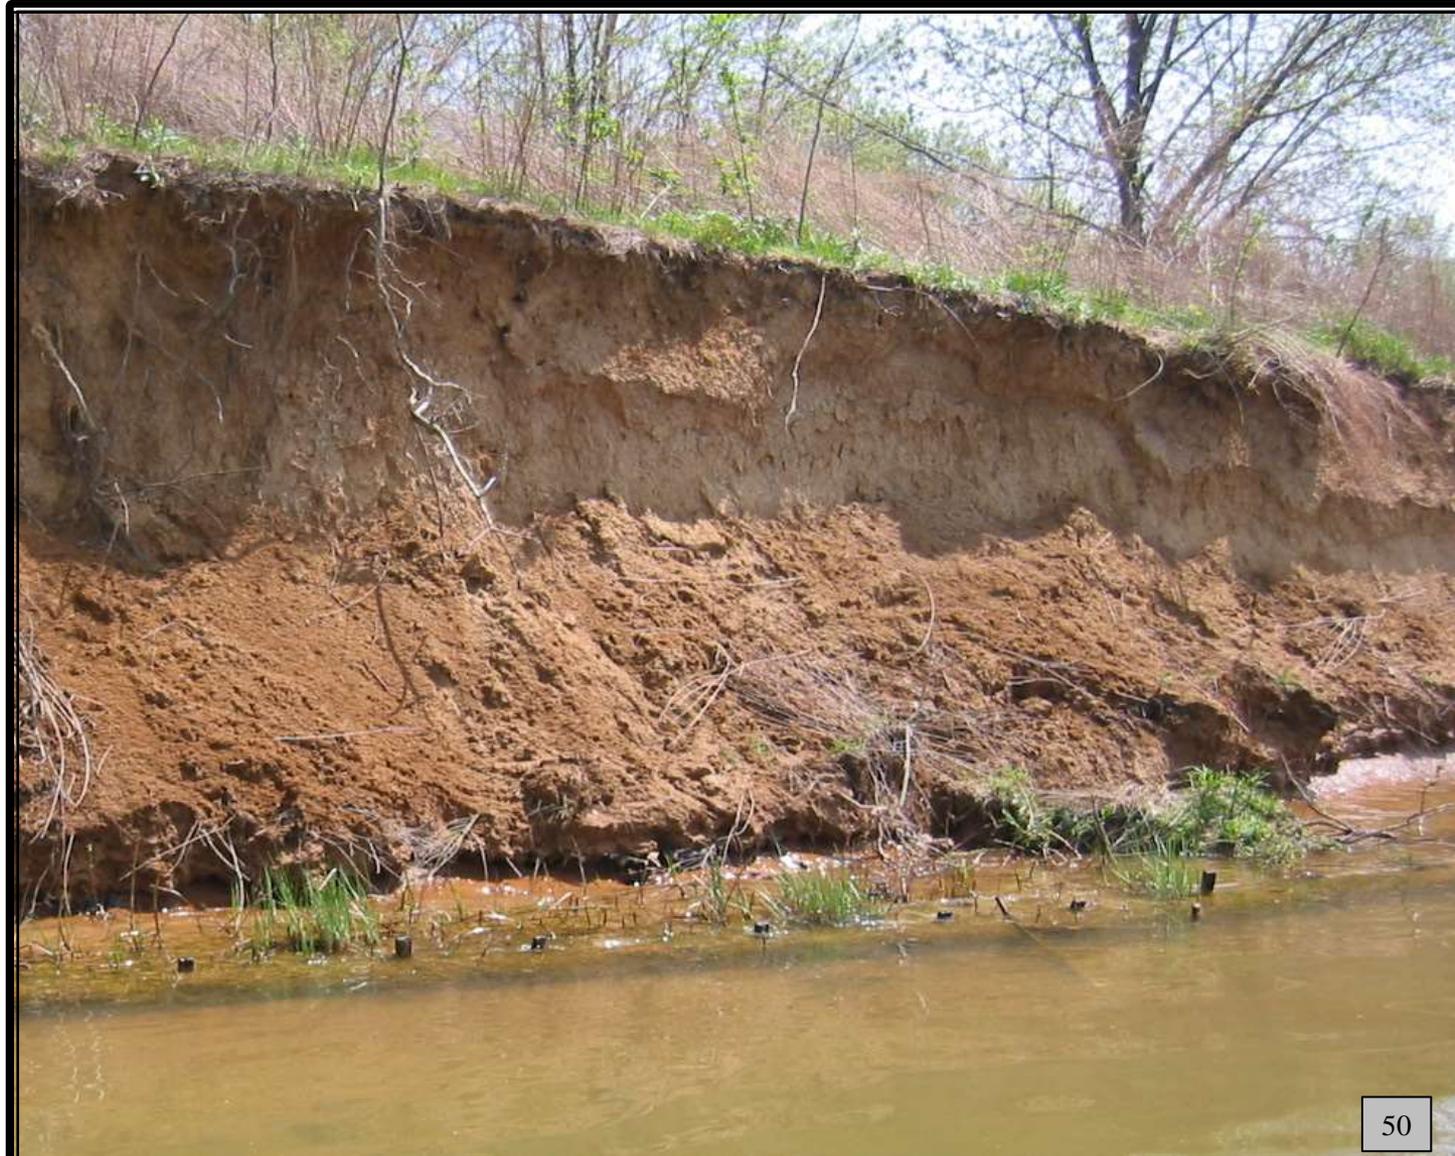
The destructive power of freeze-thaw stresses

Early Spring
actual erosion event

Kinkaid Lake, Murphysboro, Illinois

As we have observed, soil weakened by freeze thaw stresses, sloughs off the bank in early Spring and is quickly removed to deeper water by wind driven wave energy, where it remains indefinitely as unconsolidated sediment.

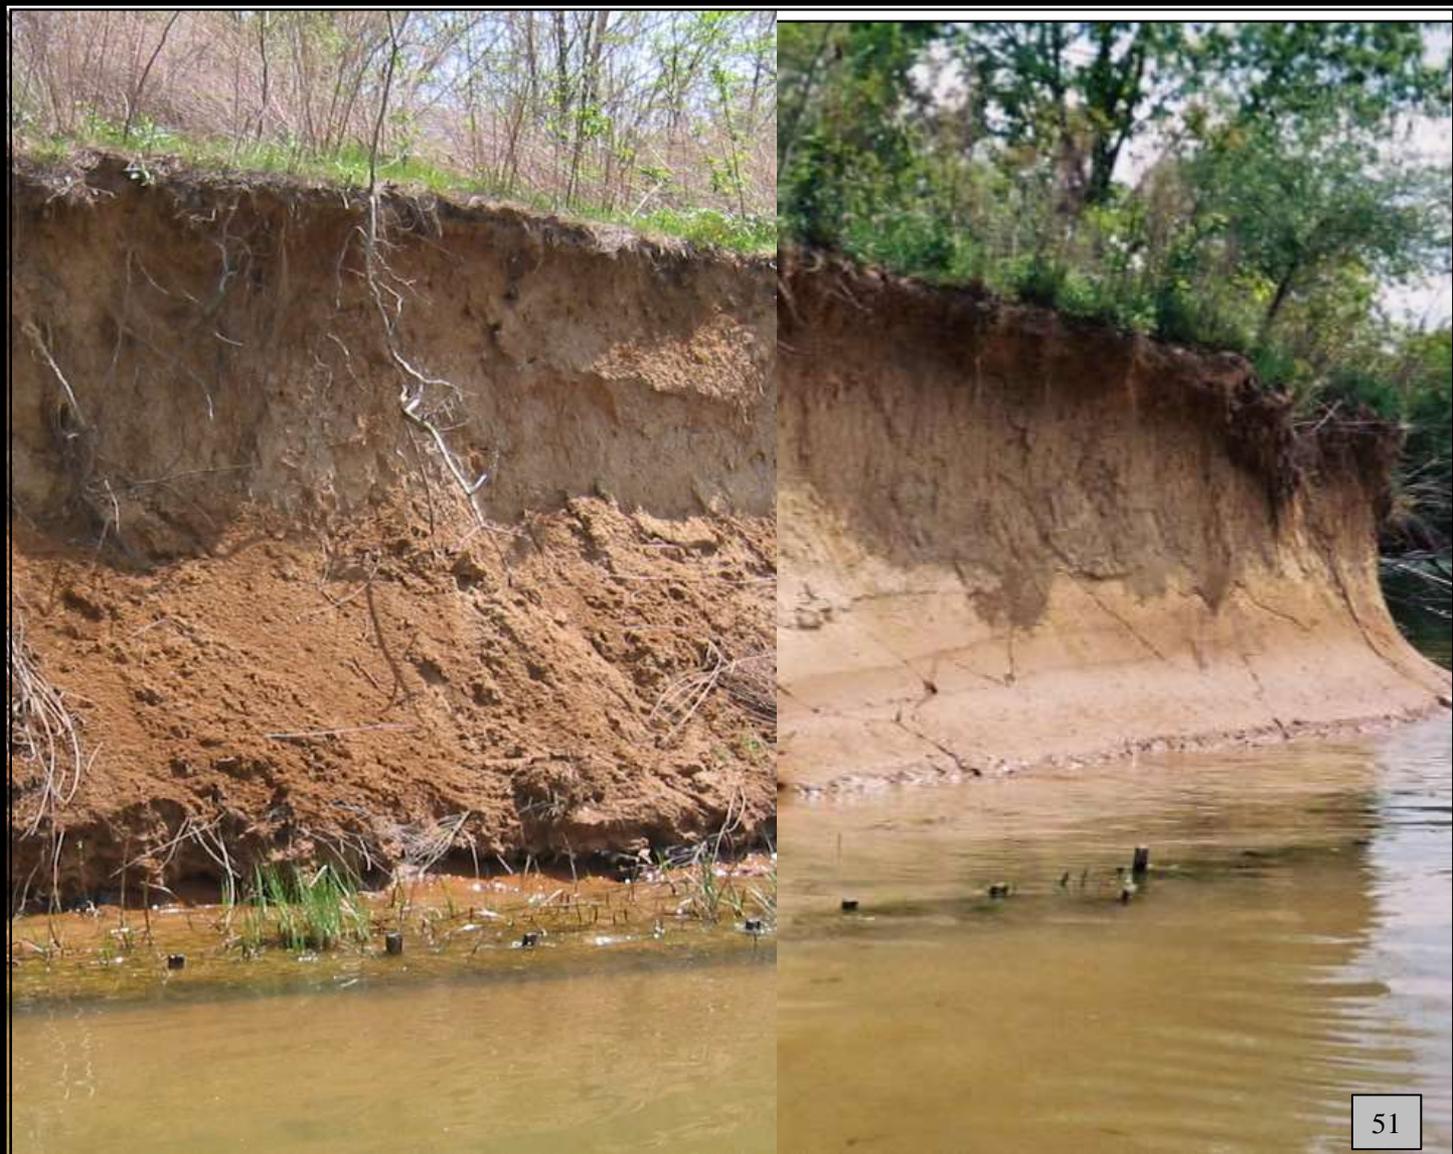
The destructive power of freeze-thaw stresses

Kinkaid Lake, Murphysboro, Illinois

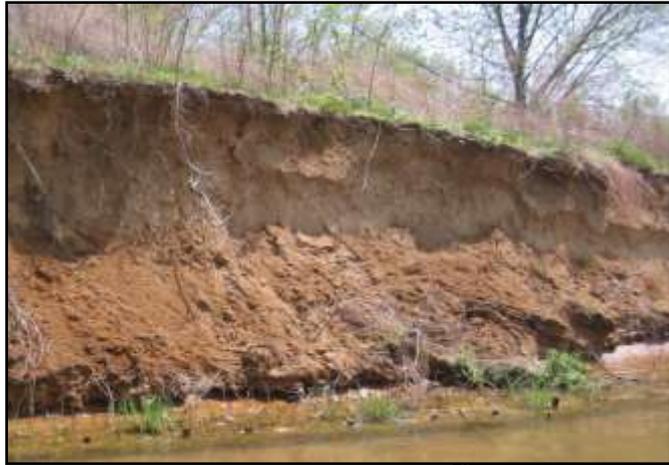
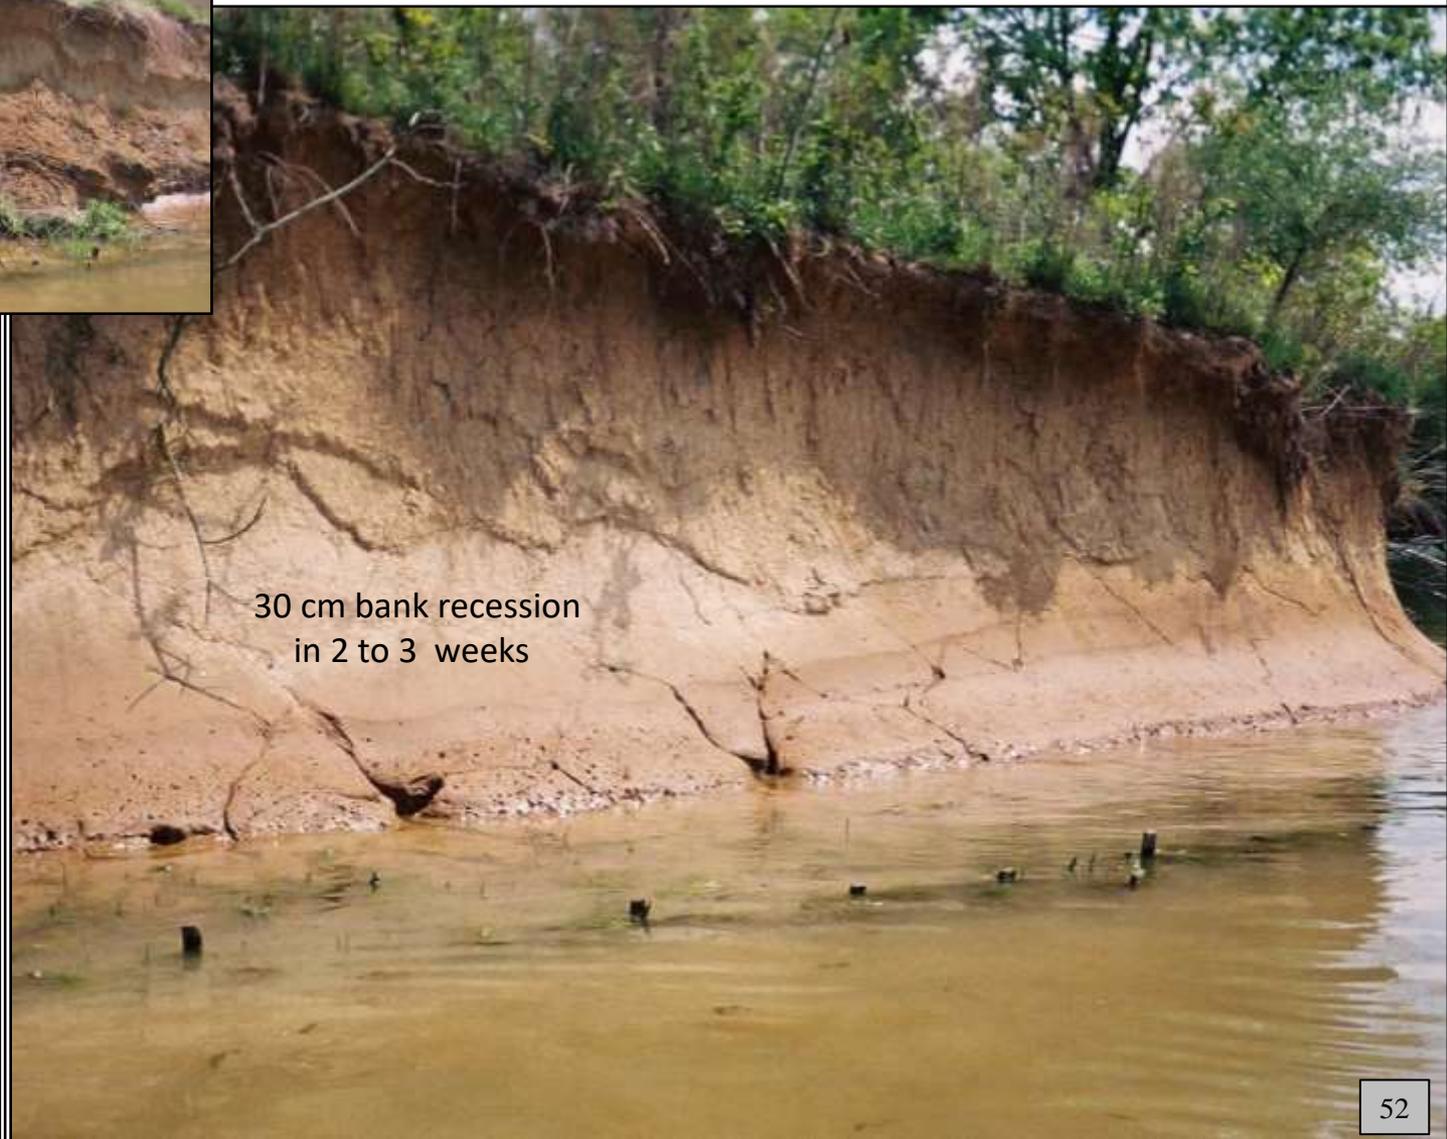
30 cm bank recession
in 2 to 3 weeks

You have just witnessed 95% of the annual shoreline erosion at this location.

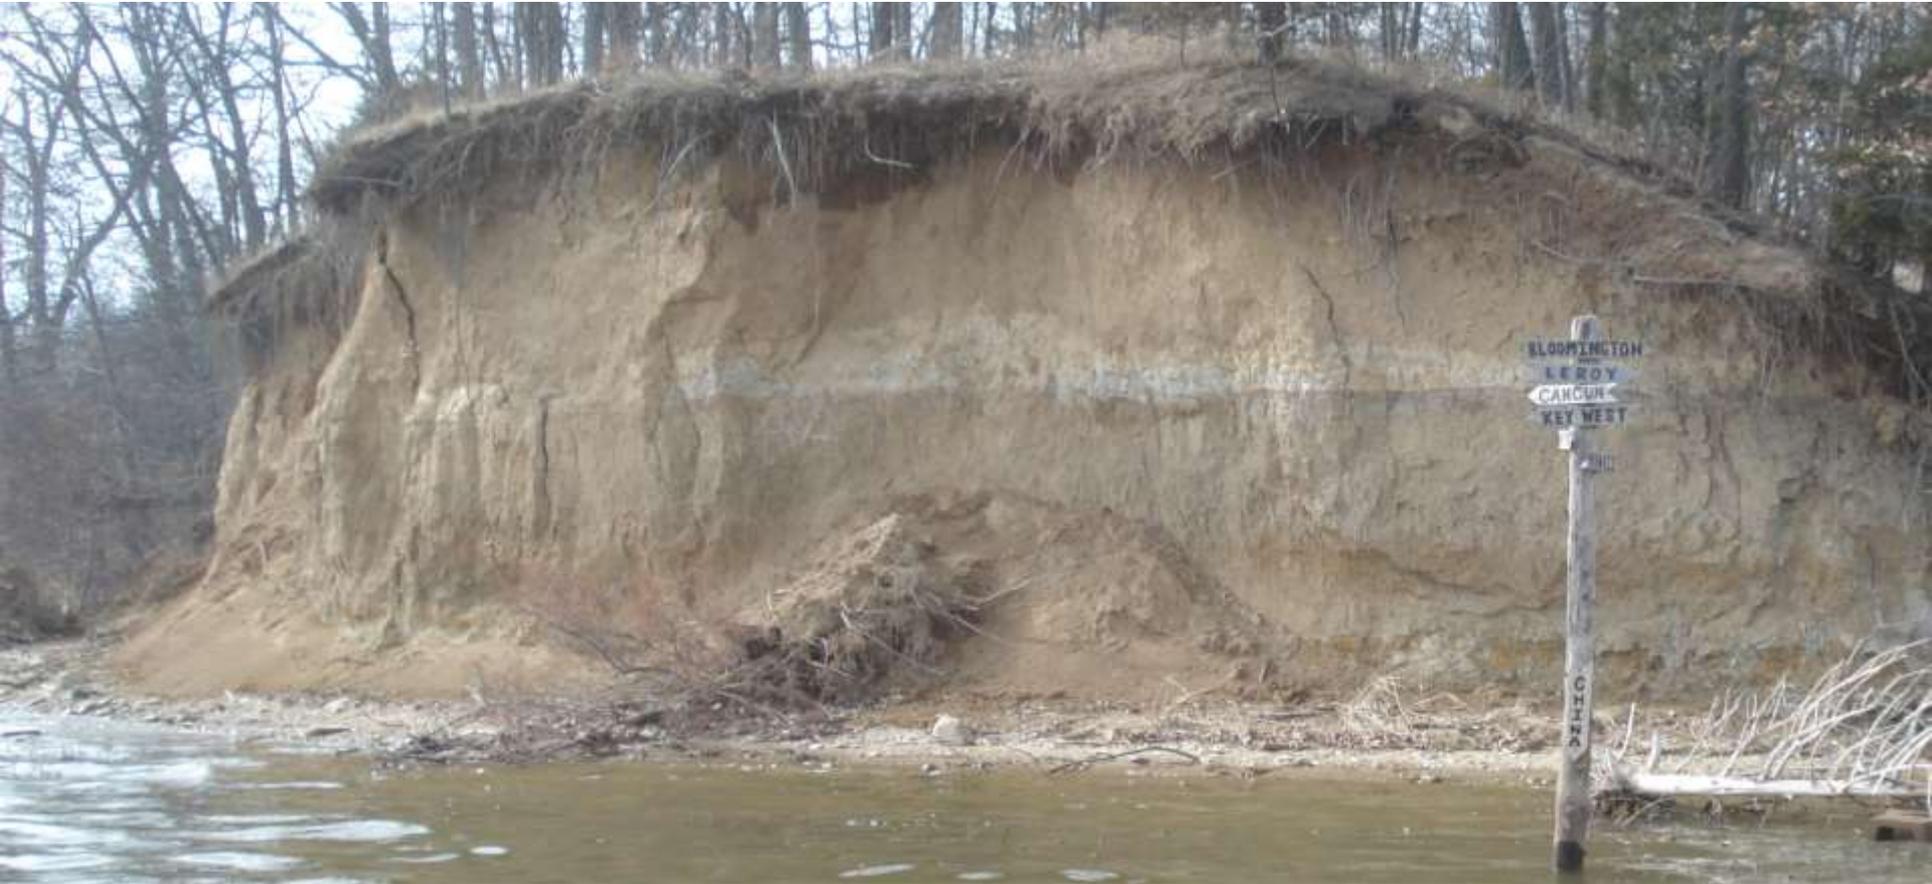
Bank slough - March 11, 2014 - Clinton Lake - Clinton, Illinois

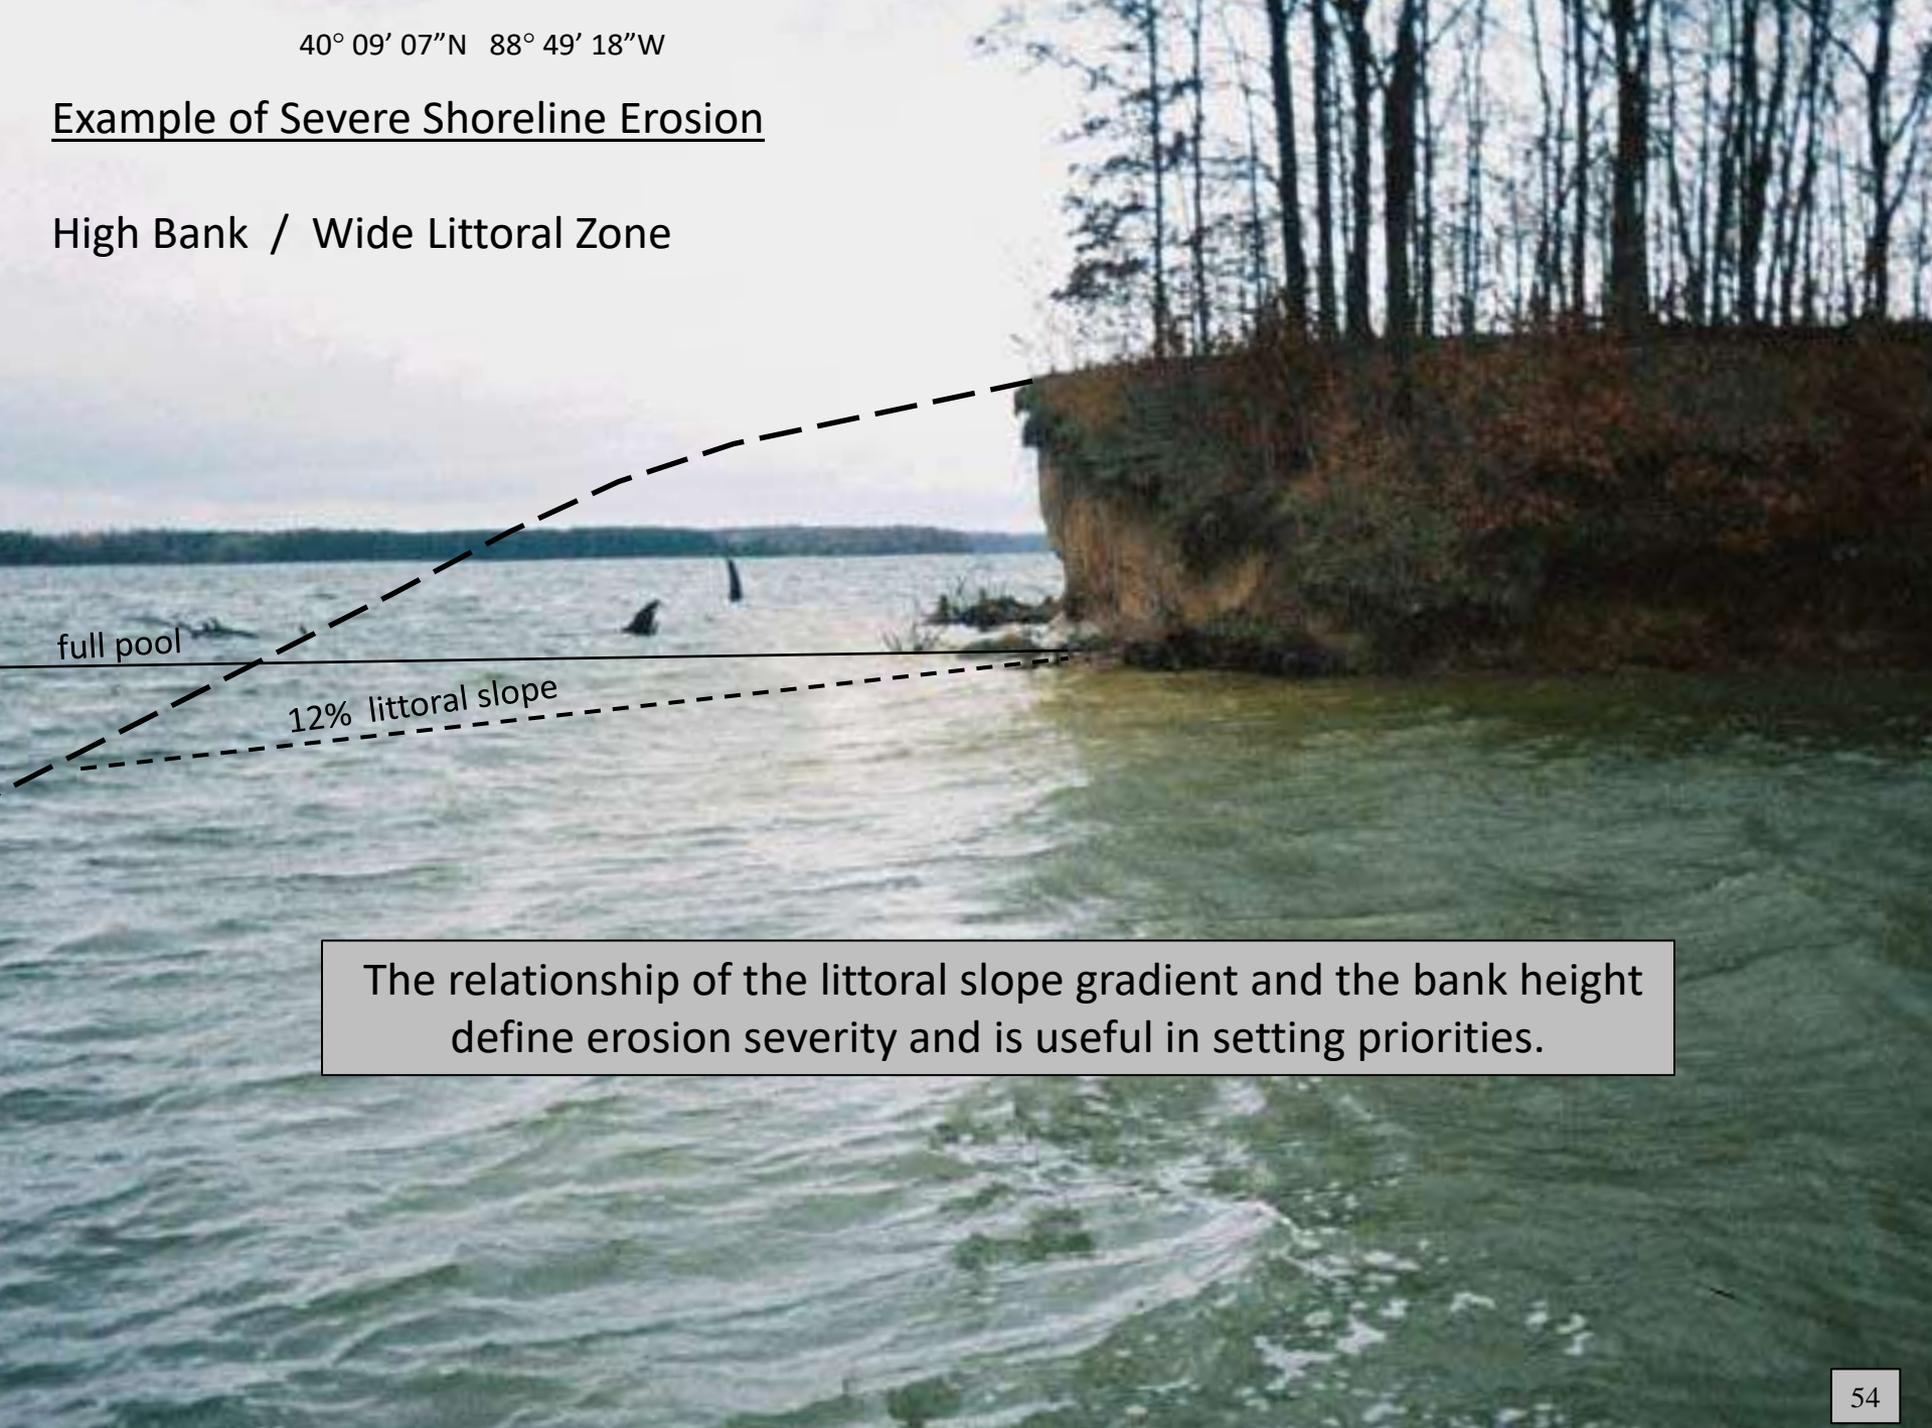
full pool

12% littoral slope

A wide littoral zone generally indicates rapid shoreline recession.

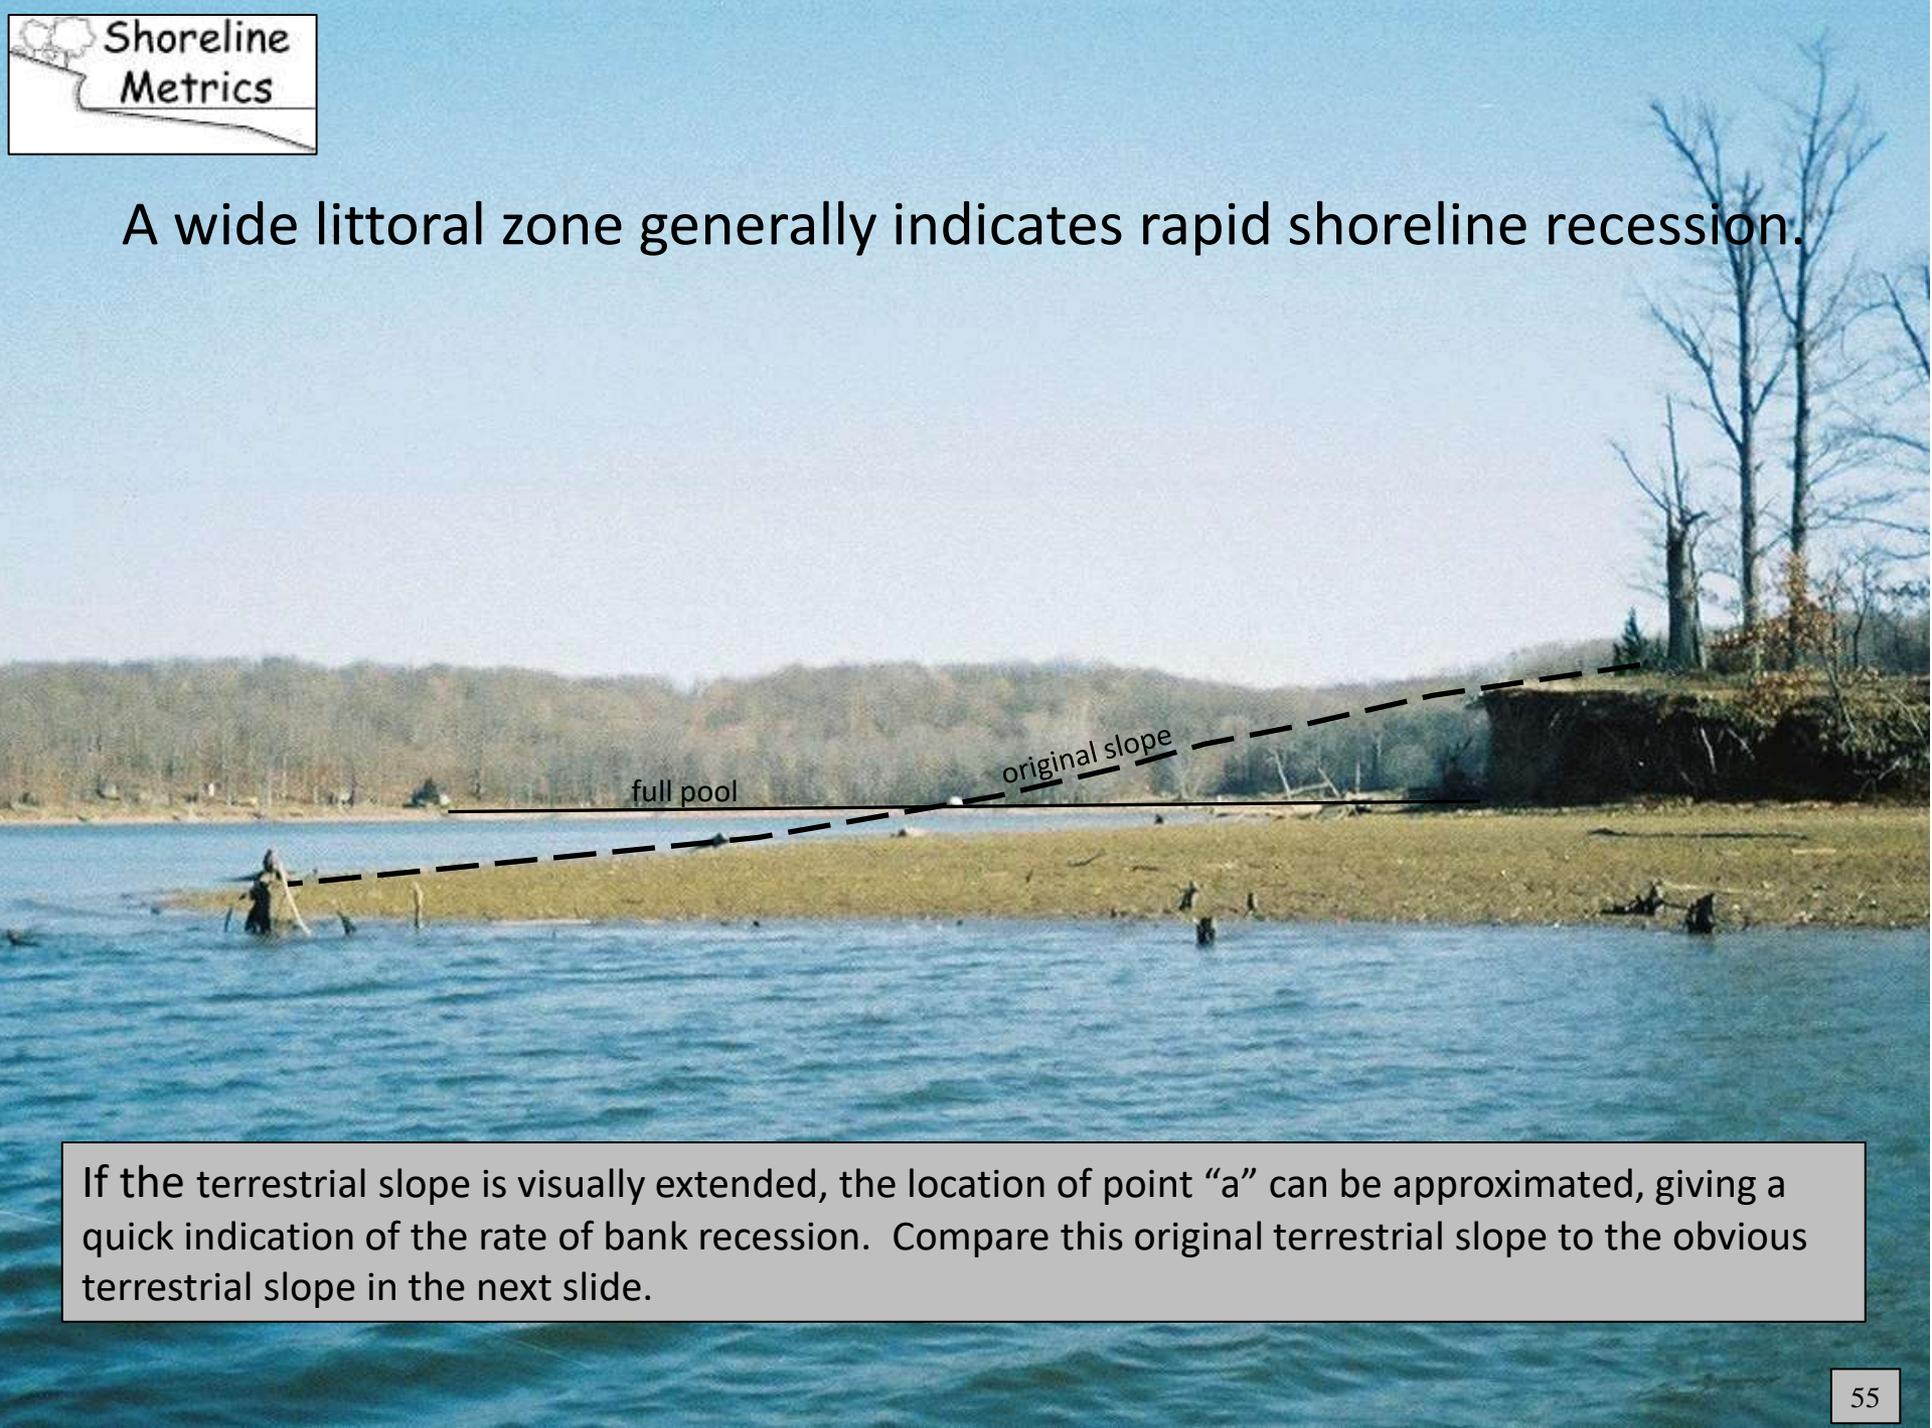
If the terrestrial slope is visually extended, the location of point “a” can be approximated, giving a quick indication of the rate of bank recession. Compare this original terrestrial slope to the obvious terrestrial slope in the next slide.

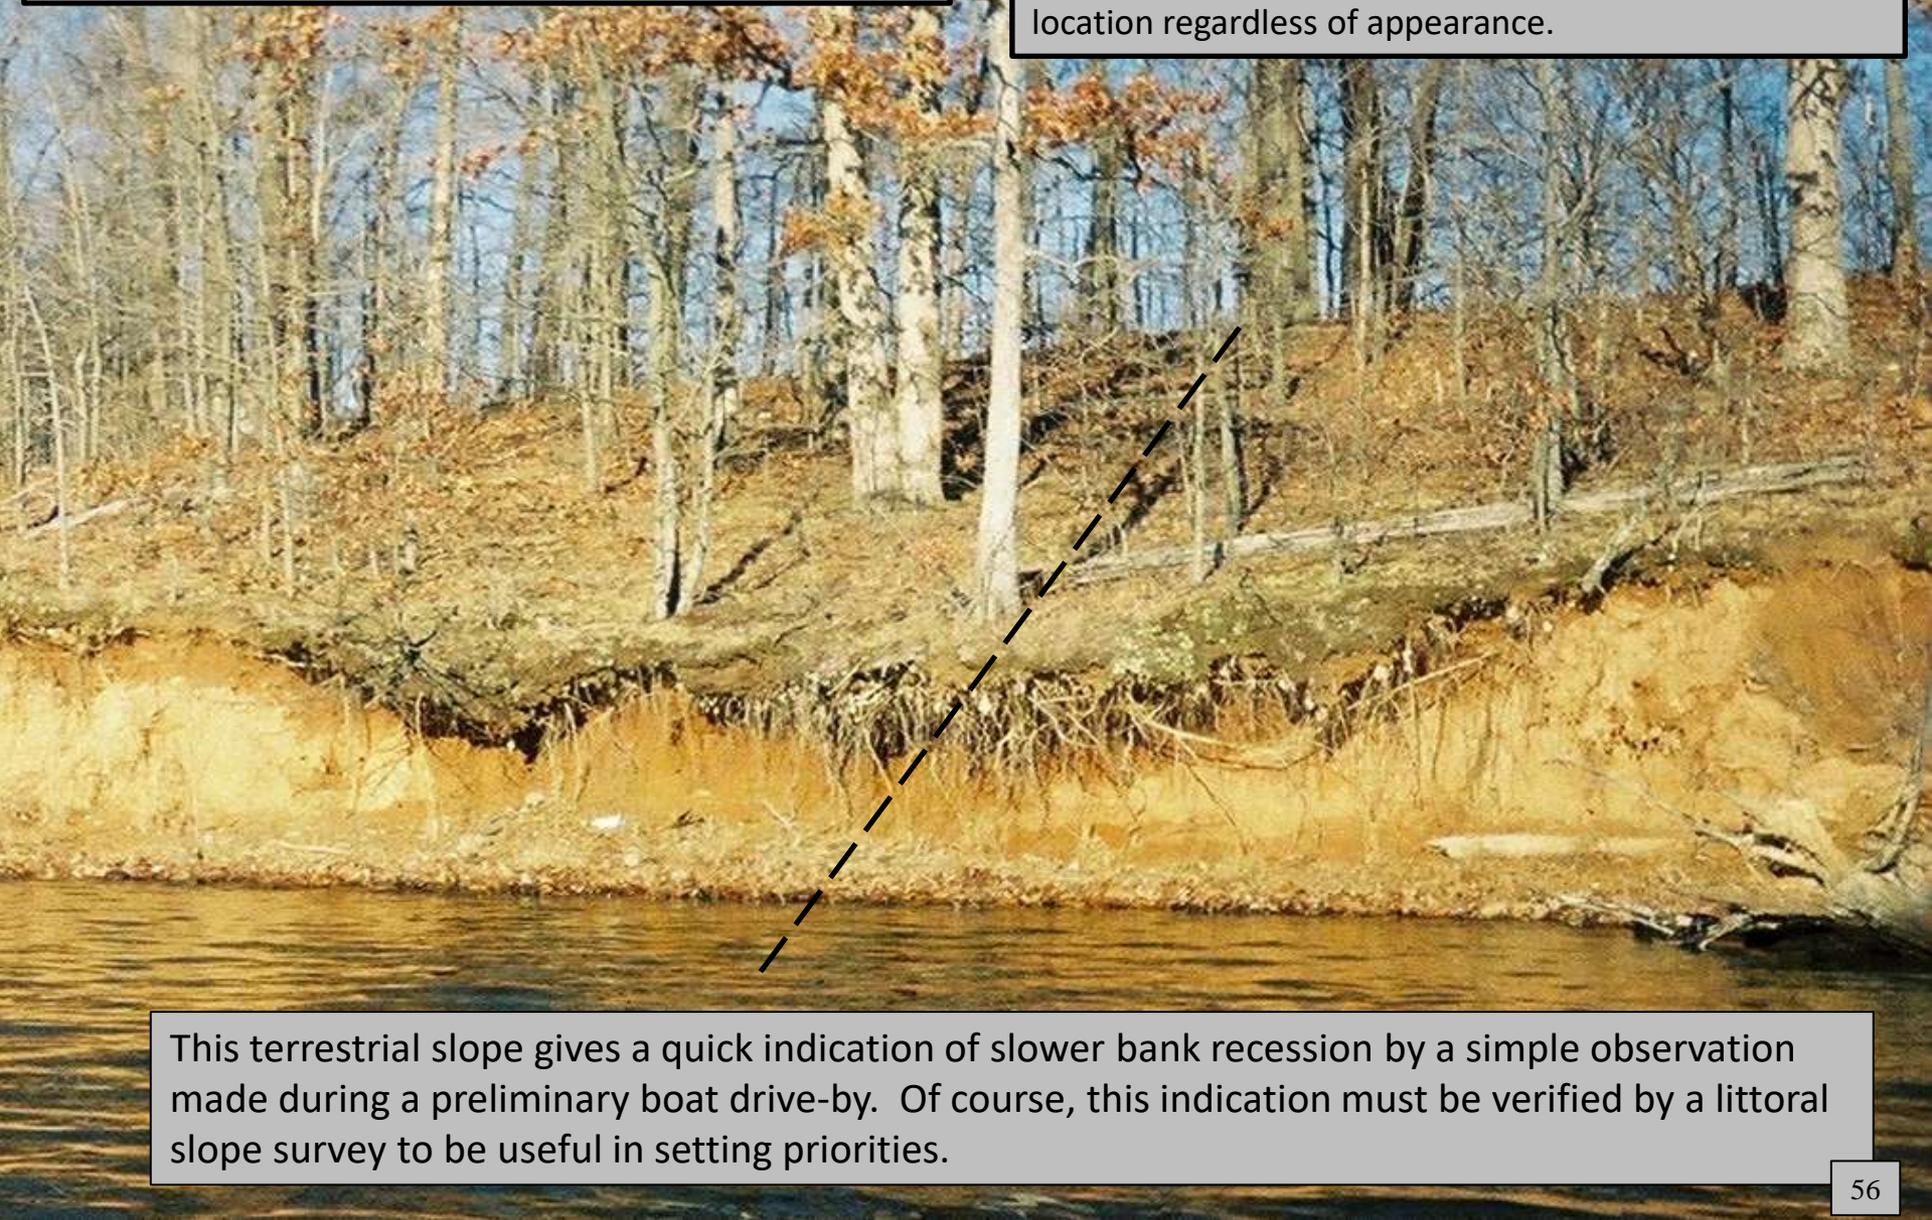
This terrestrial slope gives a quick indication of slower bank recession by a simple observation made during a preliminary boat drive-by. Of course, this indication must be verified by a littoral slope survey to be useful in setting priorities.

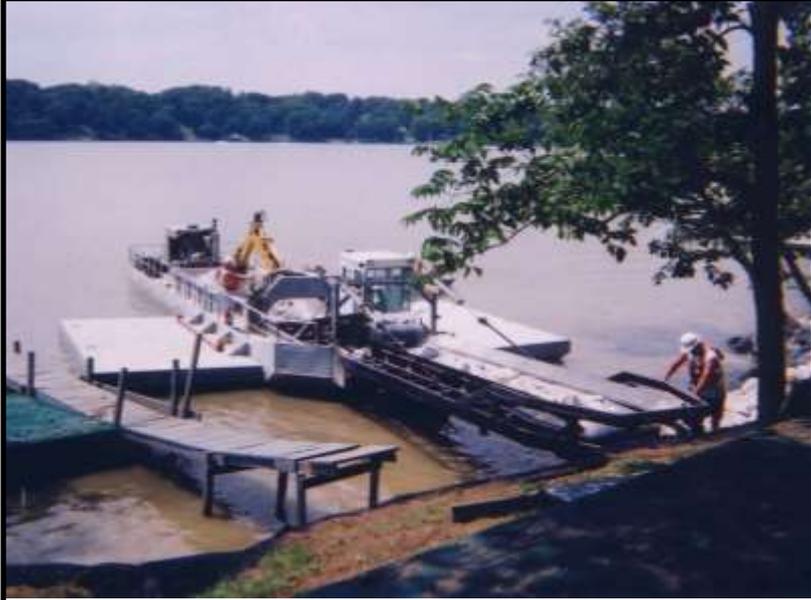
Macoupin 415 was rigged for shallow bow draft to gain access to the bank on this 1 ½% littoral slope.

Height of Bank: 6 feet
bank recession: > 200 feet
Littoral slope: 1 ½ %

Total soil lost to erosion: > 600 cubic feet
(per lineal foot of shoreline)

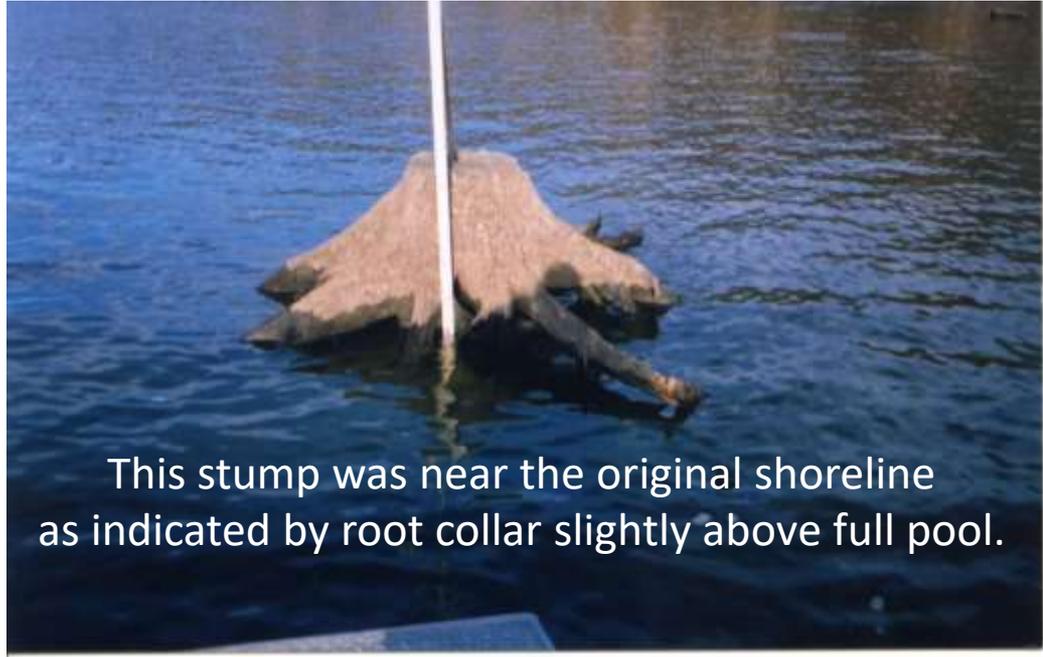
This stump was near the original shoreline as indicated by root collar slightly above full pool.

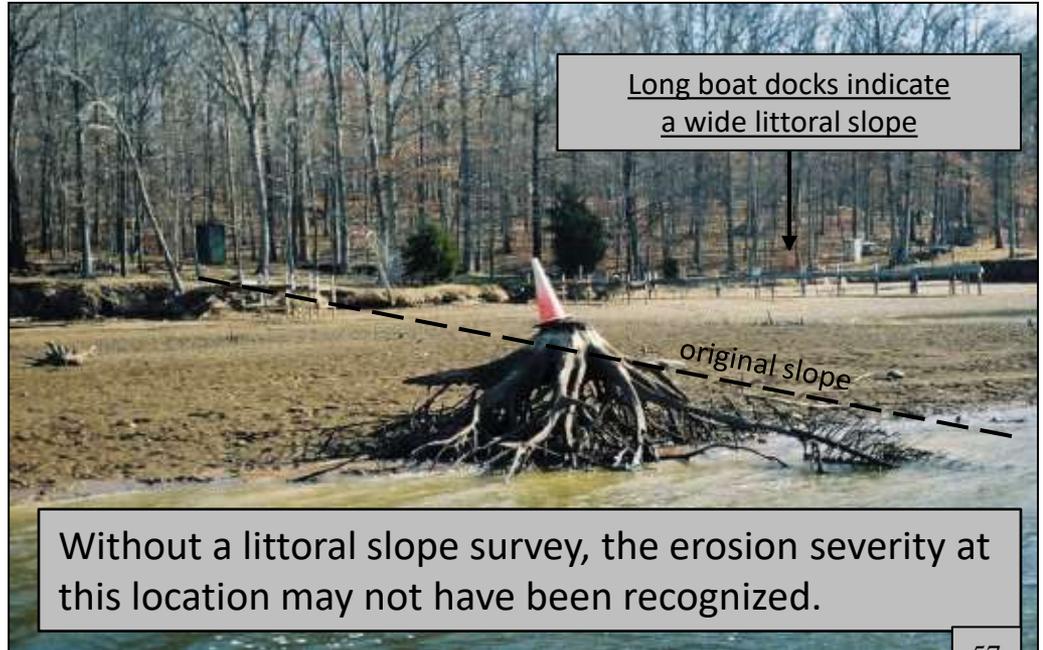
Long boat docks indicate a wide littoral slope

Without a littoral slope survey, the erosion severity at this location may not have been recognized.

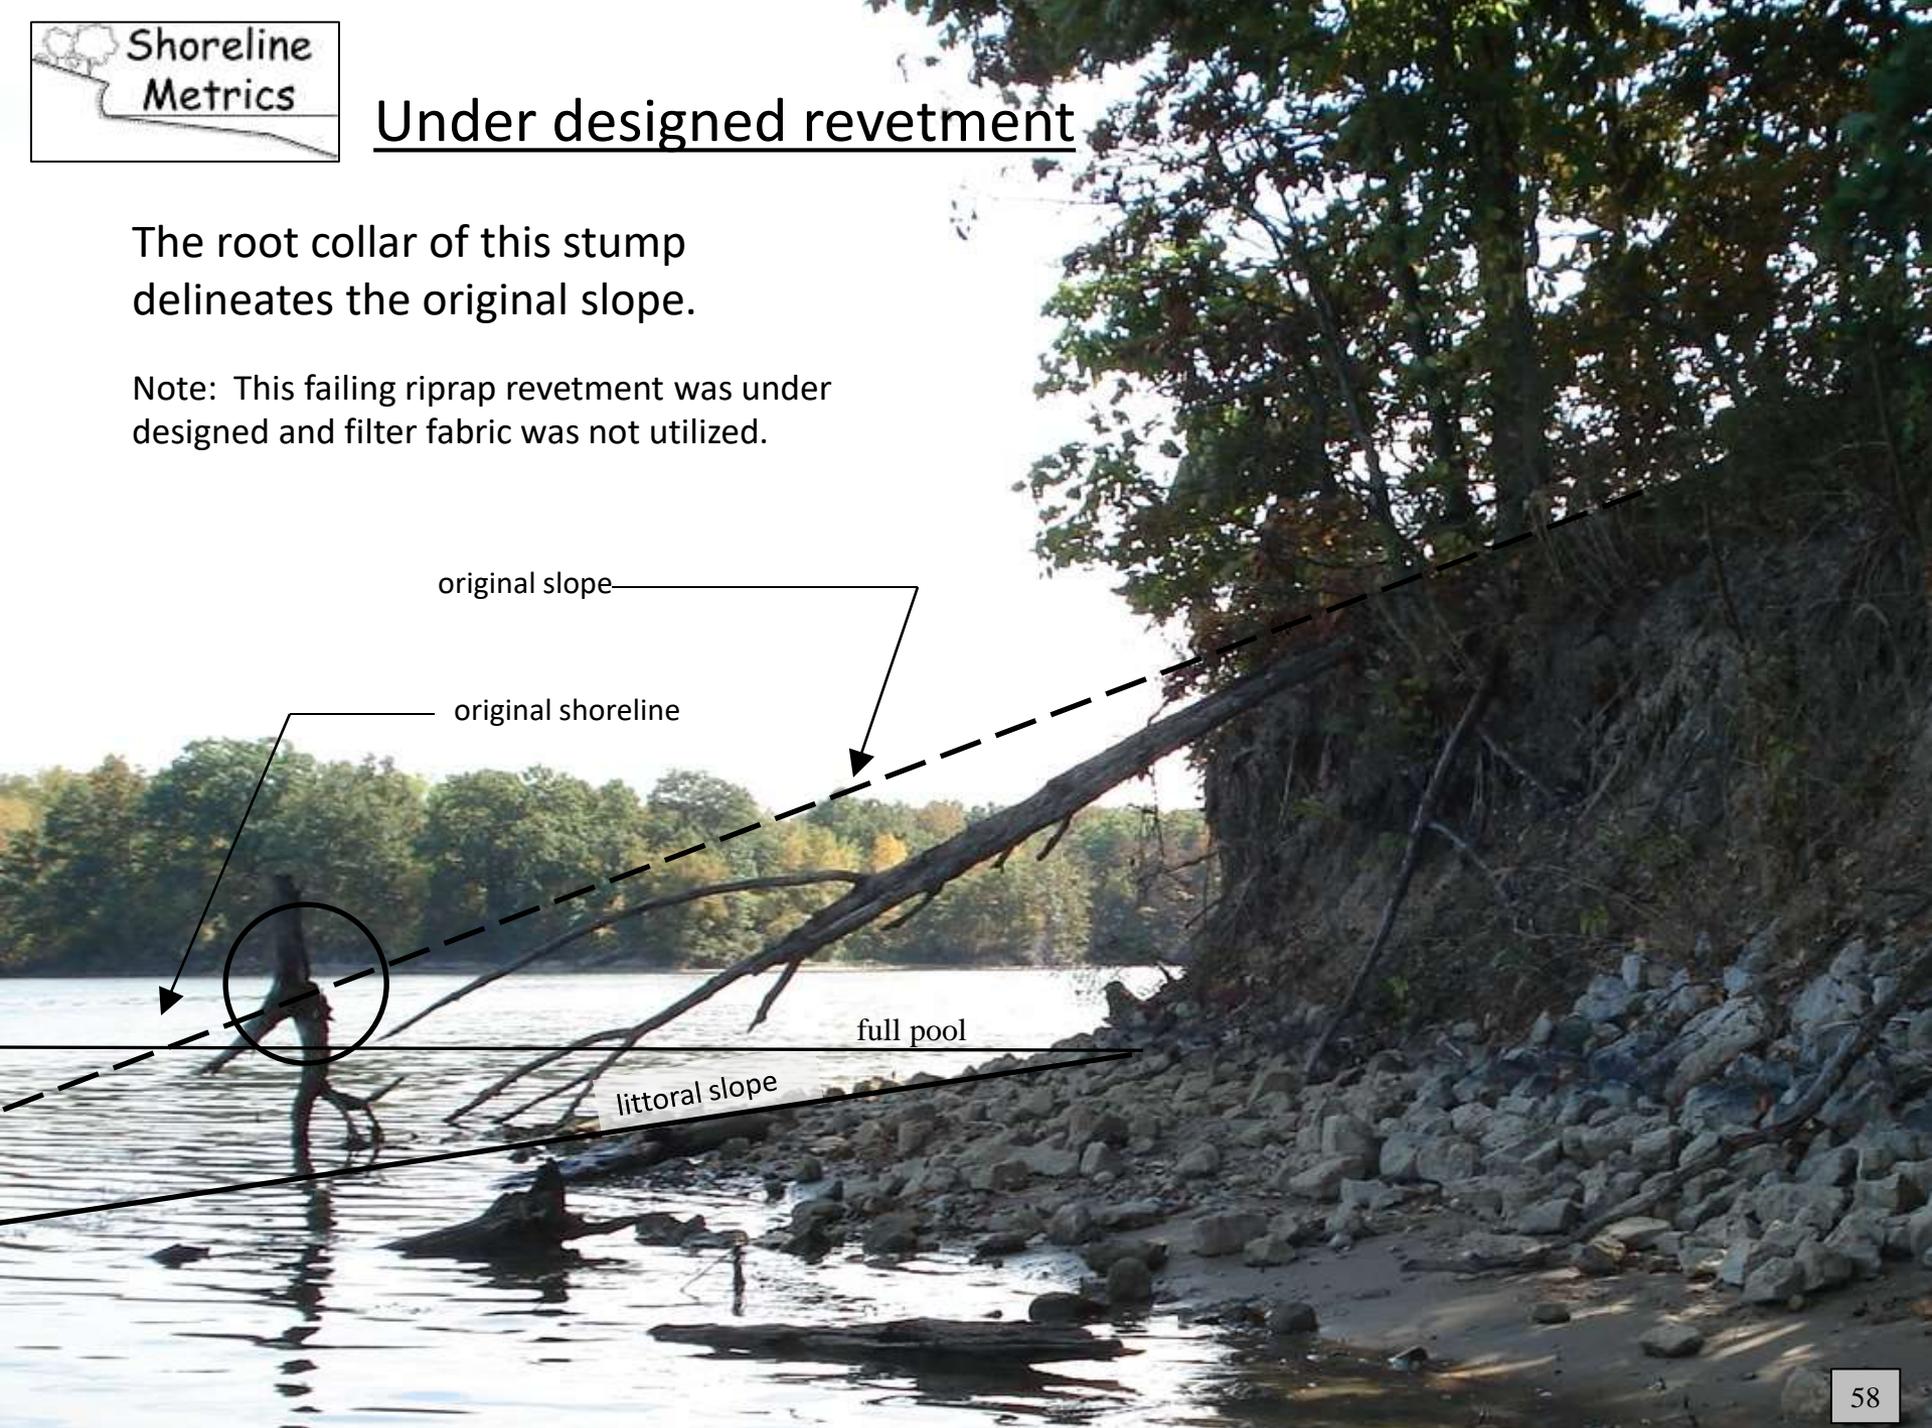
Note: This failing riprap revetment was under designed and filter fabric was not utilized.

original slope

littoral slope
