Understanding and Controlling Shoreline Erosion on Reservoirs with fine grain, cohesive shoreline soils

Presented by: Shoreline Metrics, LLC
Hank Sutton, Senior Engineering Technician

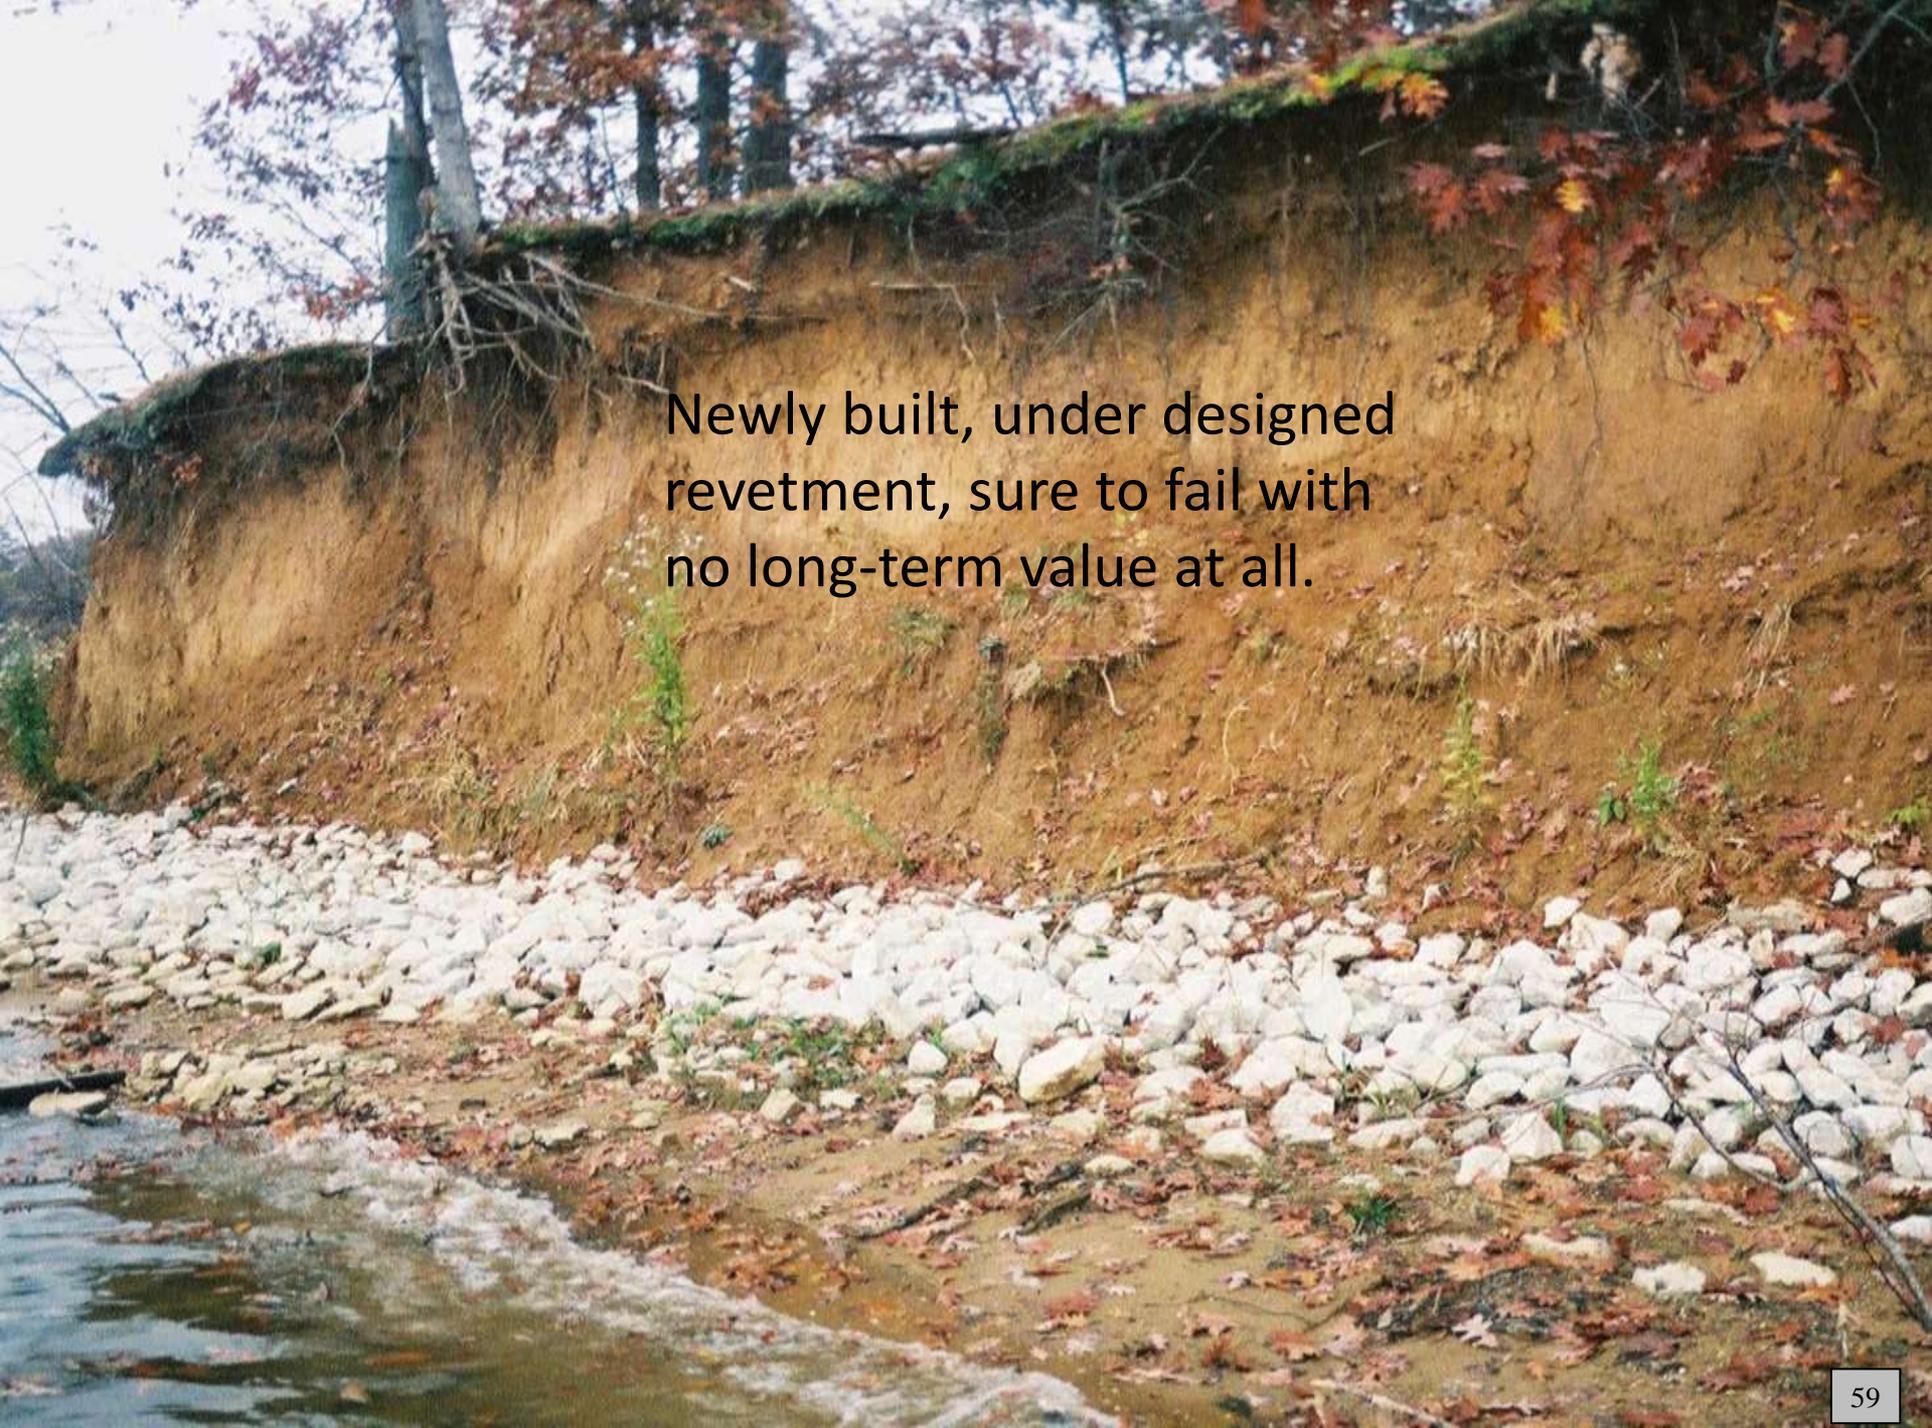
Newly built, under designed
revetment, sure to fail with
no long-term value at all.

Under designing is a failure, of course,
but over designing is also a failure,
not physically but financially.

This breakwater design, with excessive height
above full pool, required more riprap than the
Standard Breakwater, resulting in a failure of
cost-effectiveness.

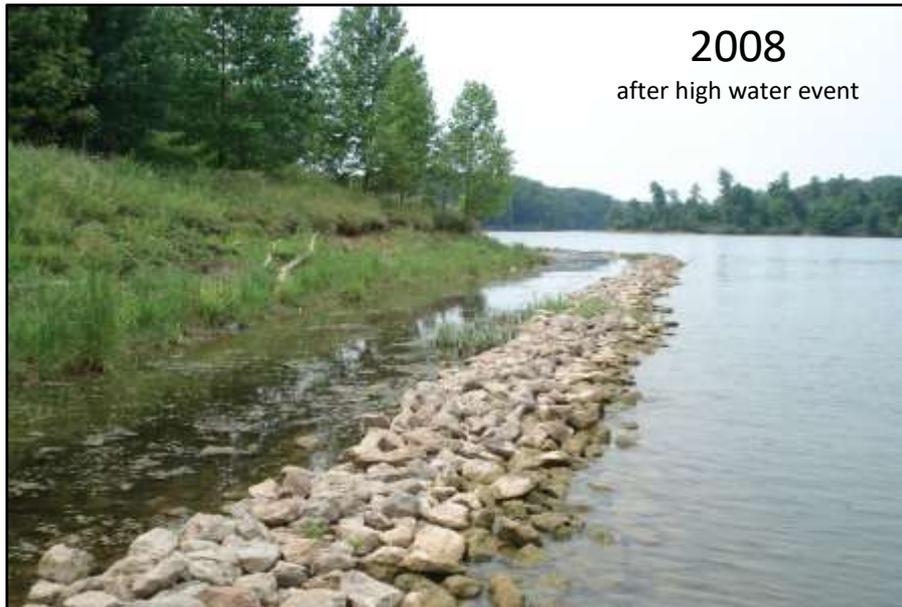
A turbid high water event occurred in 2008 and remained up to 6 feet above full pool for several weeks. The naturally colonized vegetation in the littoral zone was destroyed for lack of sunlight, but the breakwater remained intact and continued to isolate the bank from wave energy. By 2010 the littoral zone was starting to be naturally colonized again by aquatic vegetation with no repairs required.

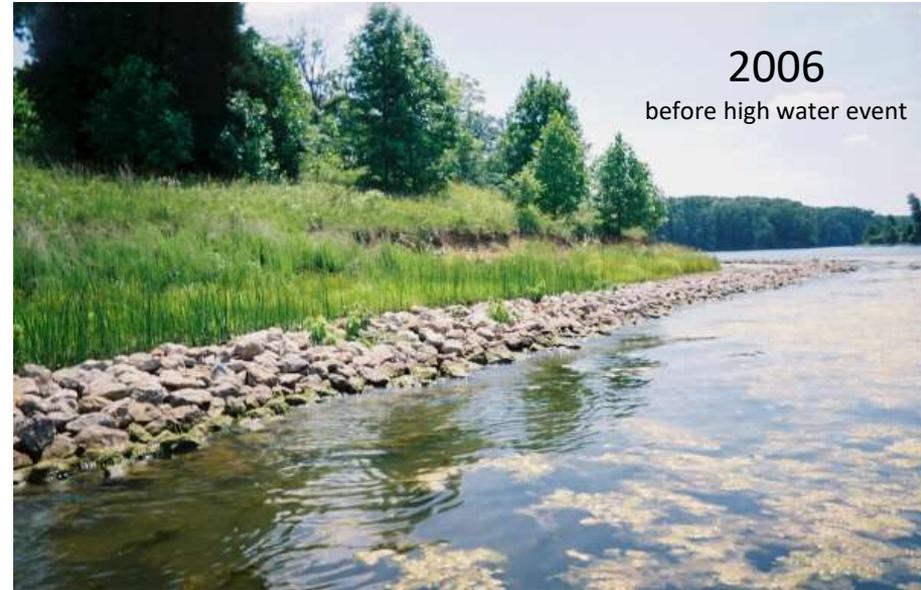
2006
before high water event

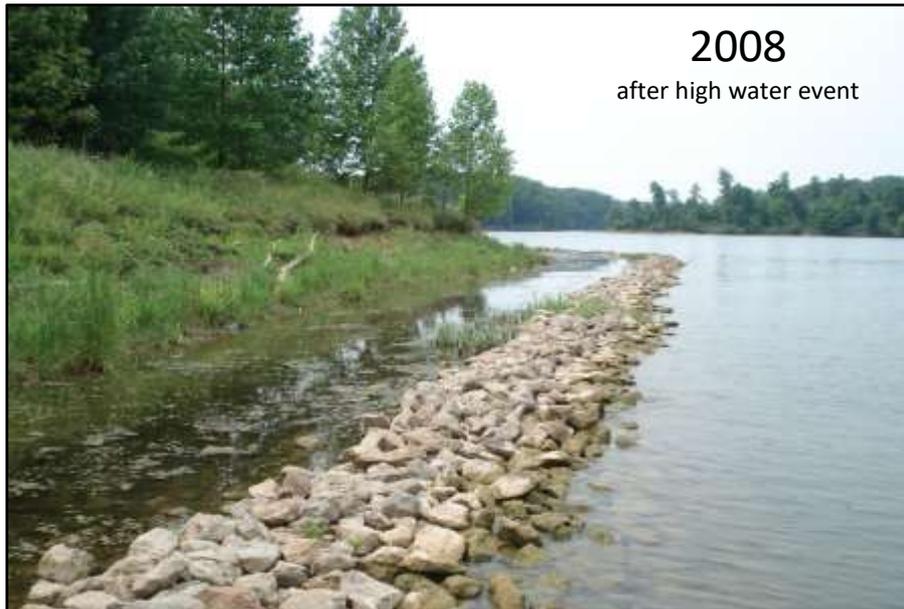
2008
after high water event

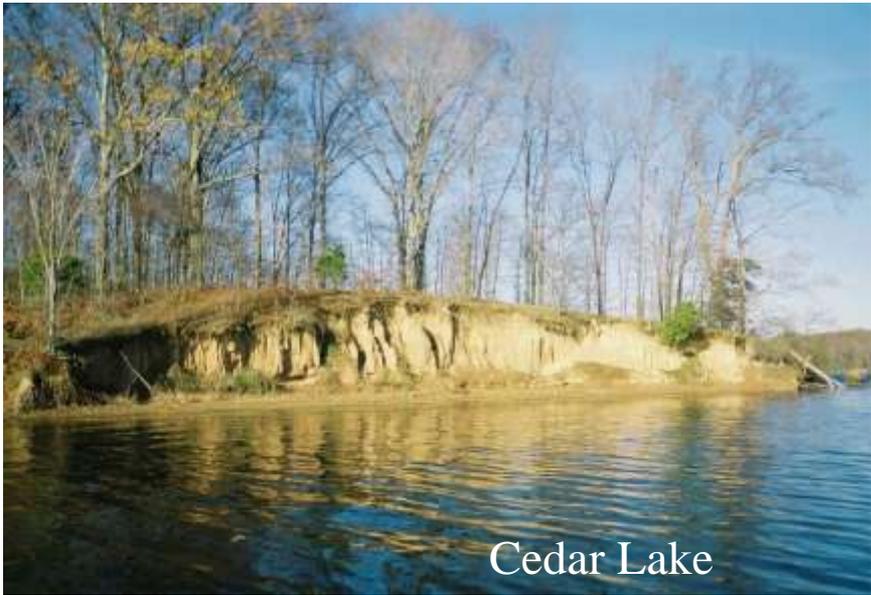
Cedar Lake
10 Horsepower Limit

A photograph showing a shoreline with a significant erosion. The top of the bank is covered with a dense line of tall, thin trees. Below the tree line, the soil has eroded away, exposing a light-colored, sandy or silty bank. The water of the lake is in the foreground, reflecting the sky and the trees.

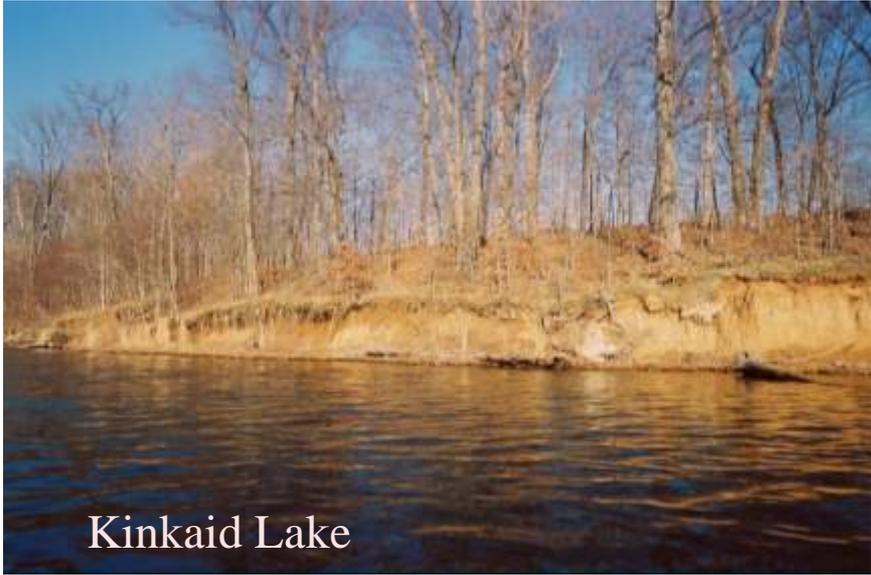
Kinkaid Lake
No limit of Horsepower

A photograph showing a shoreline with a significant erosion. The top of the bank is covered with a dense line of tall, thin trees. Below the tree line, the soil has eroded away, exposing a light-colored, sandy or silty bank. The water of the lake is in the foreground, reflecting the sky and the trees.

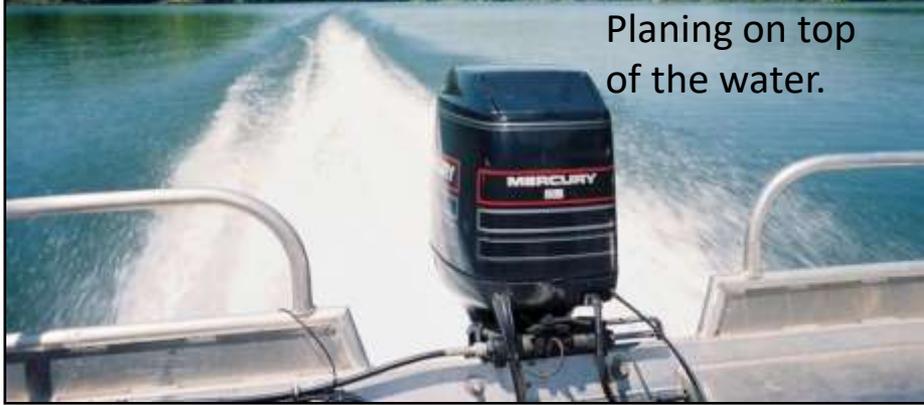
115 hp
45 mph

Planing on top
of the water.

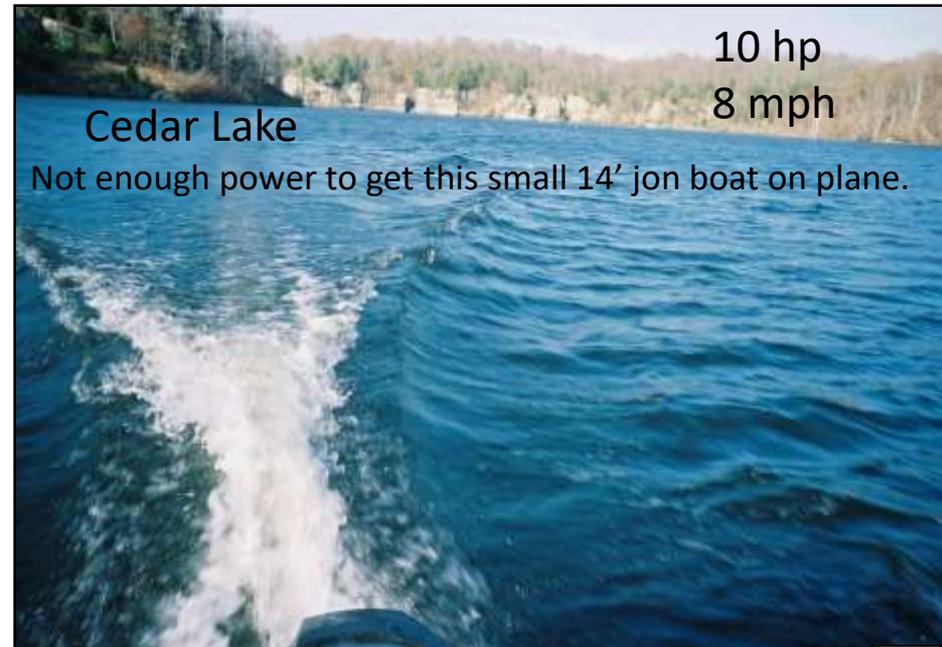
Cedar Lake

Not enough power to get this small 14' jon boat on plane.

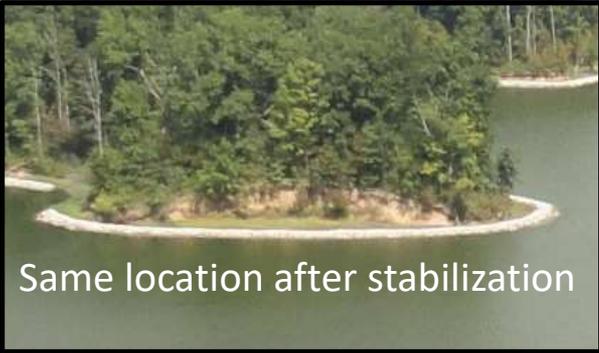
Cedar Lake, Carbondale, Illinois
10 hp limit

Shoreline Erosion on Reservoirs with Restricted Horse Power

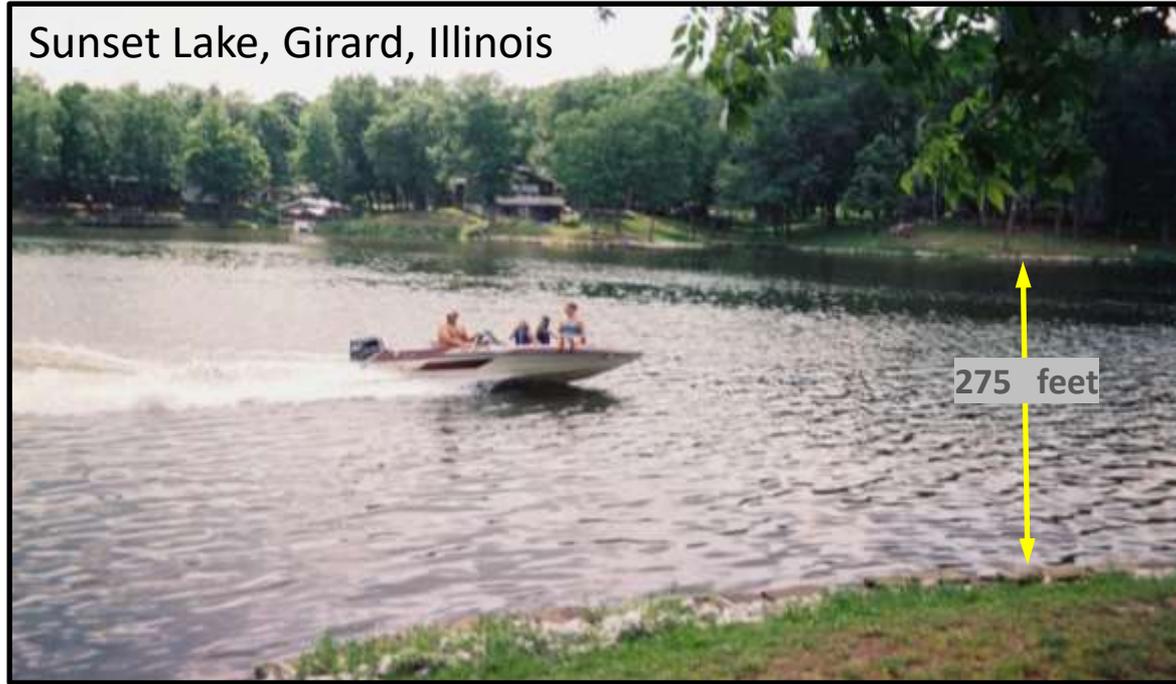
This small 173 acre residential lake has the entire shoreline stabilized with well maintained riprap revetments and has no significant shoreline erosion after 65 years.

Sunset Lake has a 50 hp limit to control speed for safety with “No Wake” before noon to accommodate fishermen and kayaks.

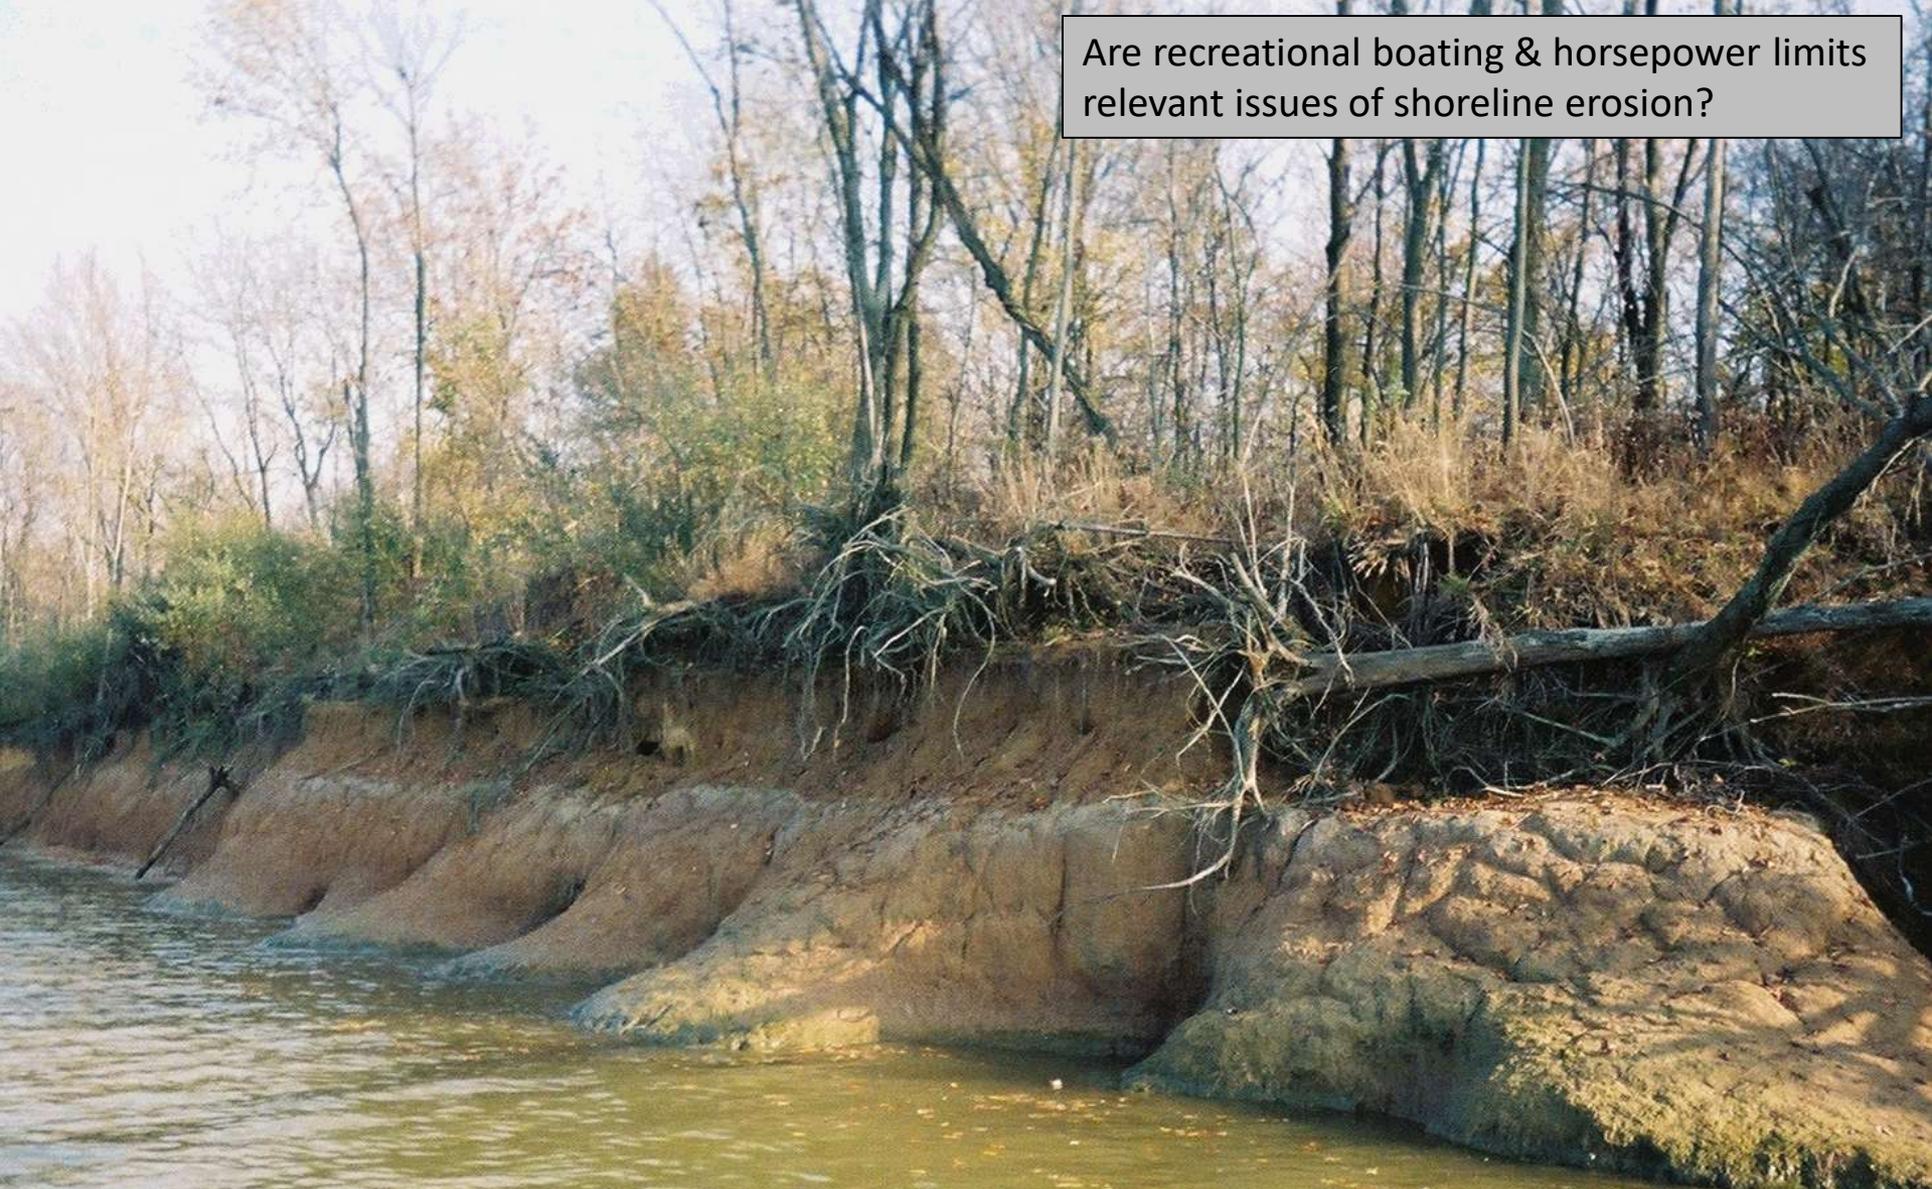
Carlyle Lake in early April. The frost weakened soil has been transported to deeper water. Boat generated waves and wind driven waves together are not likely to overcome the cohesive strength of this newly exposed tight clay soil.... but frost will, again next Winter.

Small wind driven waves have sufficient energy to easily remove frost weakened soil.
(pictured here: 15 mph wind with 1/2 mi. fetch - wave period ~ 1 second)
Over 30,000 wind driven waves per windy day (10 hours).

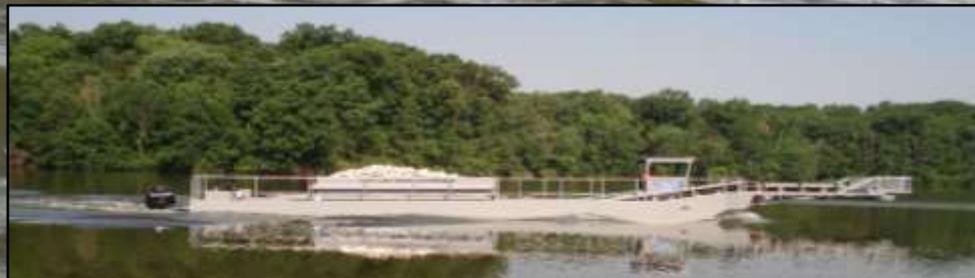
Illinois reservoirs experience hundreds of thousands of wind driven waves every year.

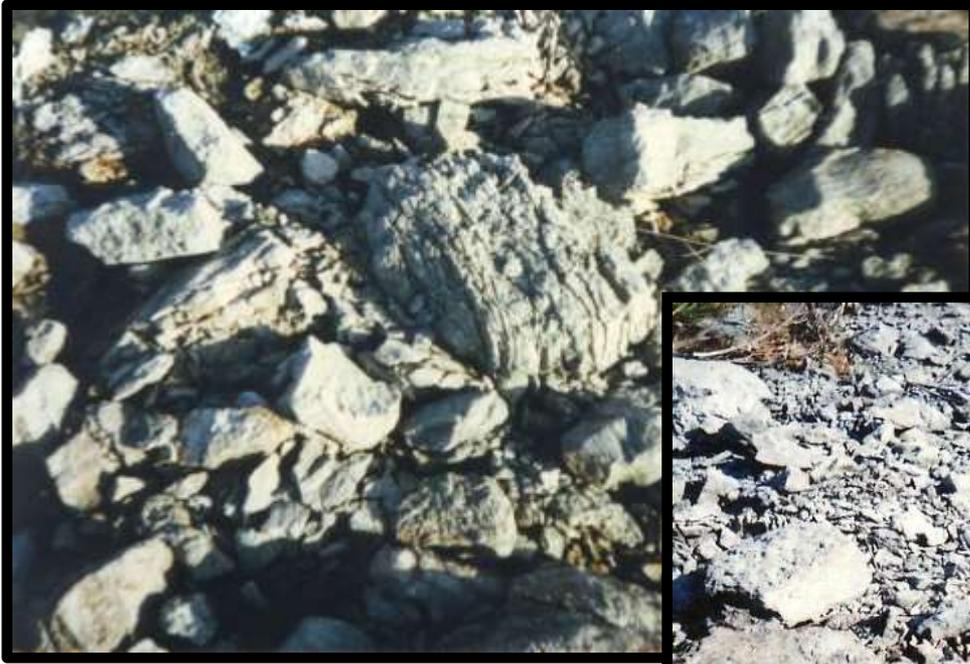
Low quality riprap is broken down by the stresses of freezing & thawing.

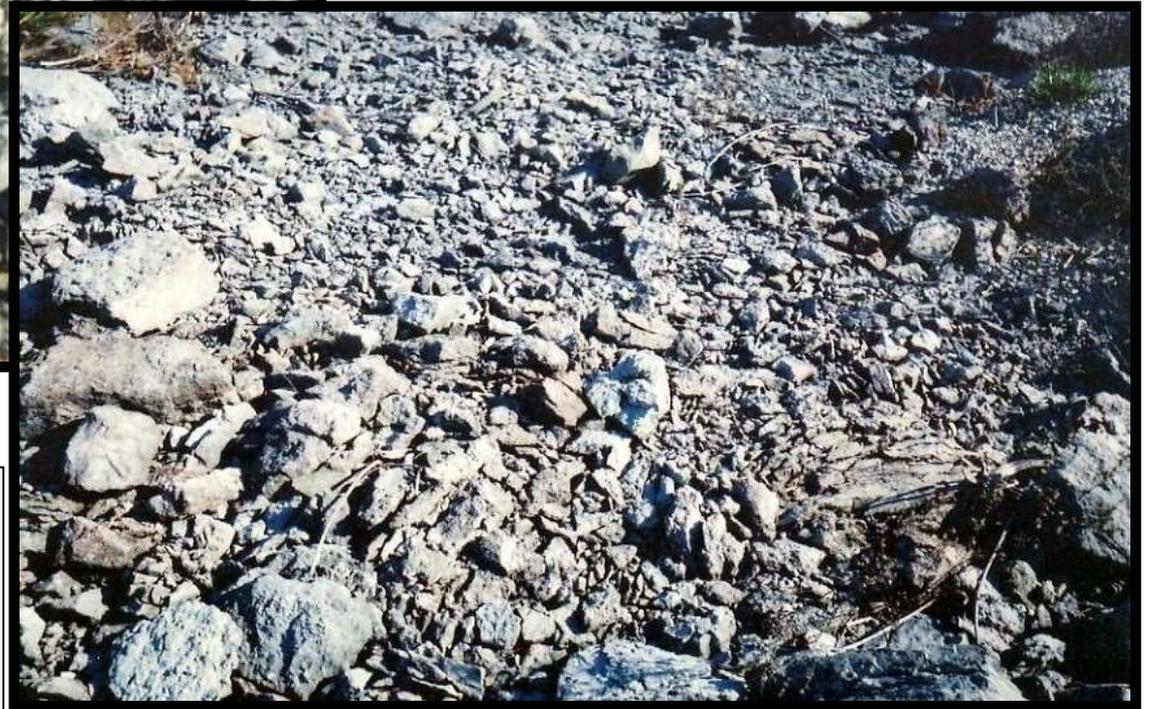
IDOT Spec. for riprap quality,
Sodium Sulfate Soundness Loss
after 5 cycles:
15% loss maximum

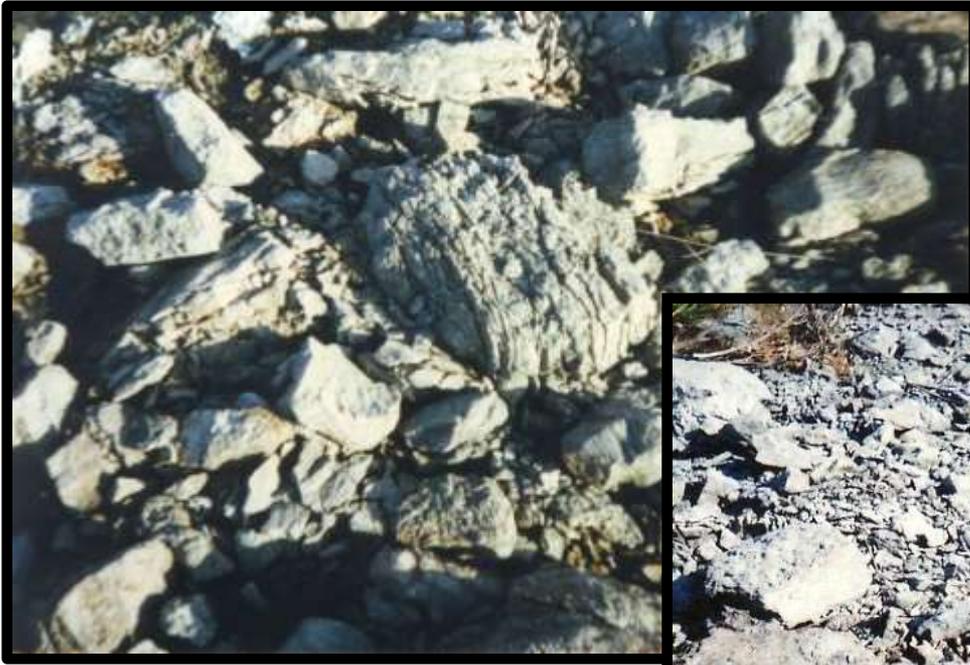
Low quality riprap is broken down by the stresses of freezing & thawing.

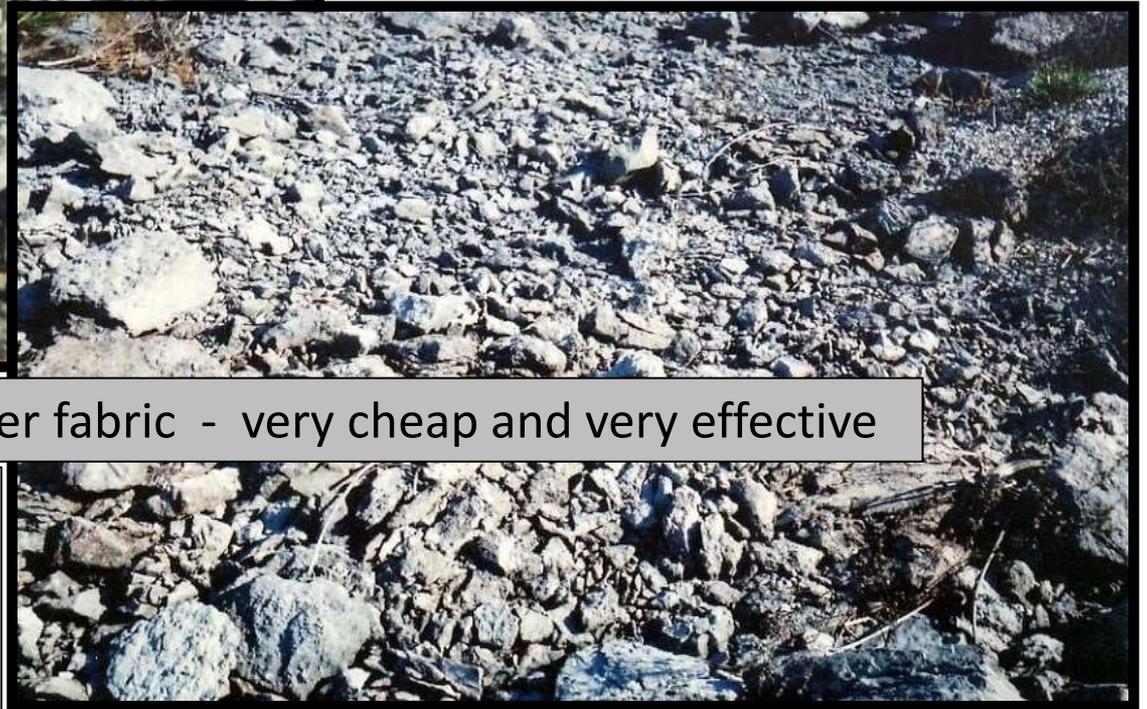
Don't forget the filter fabric - very cheap and very effective

IDOT Spec. for riprap quality,
Sodium Sulfate Soundness Loss
after 5 cycles:
15% loss maximum

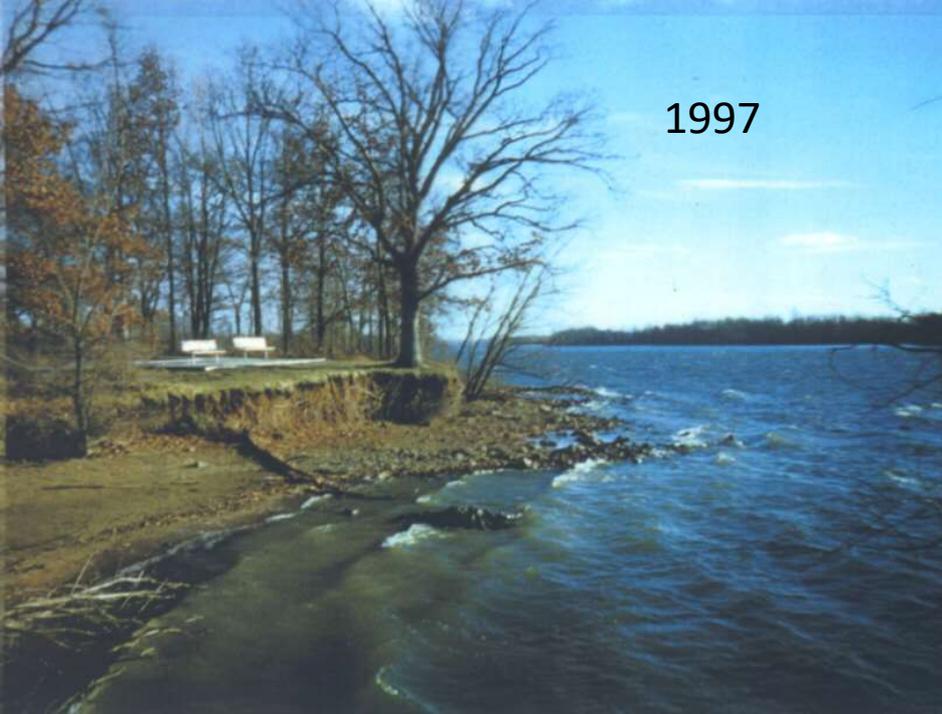
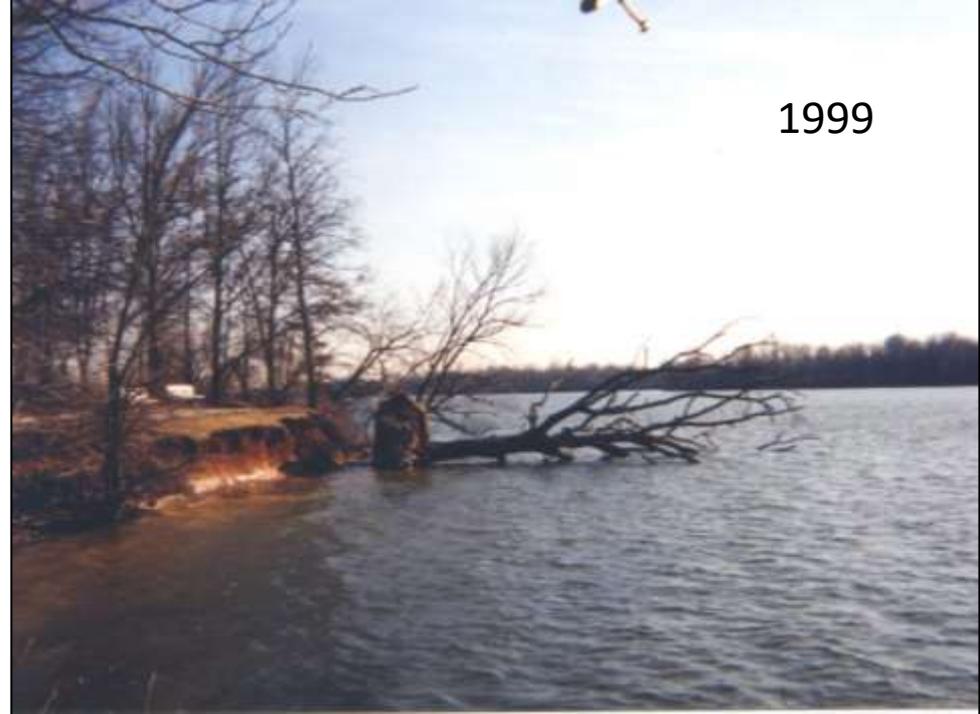
In the 1990's -
Local teenagers were hired to hand place riprap without adequate supervision.
At this location, the roll of fabric was buried under the riprap instead of being installed.

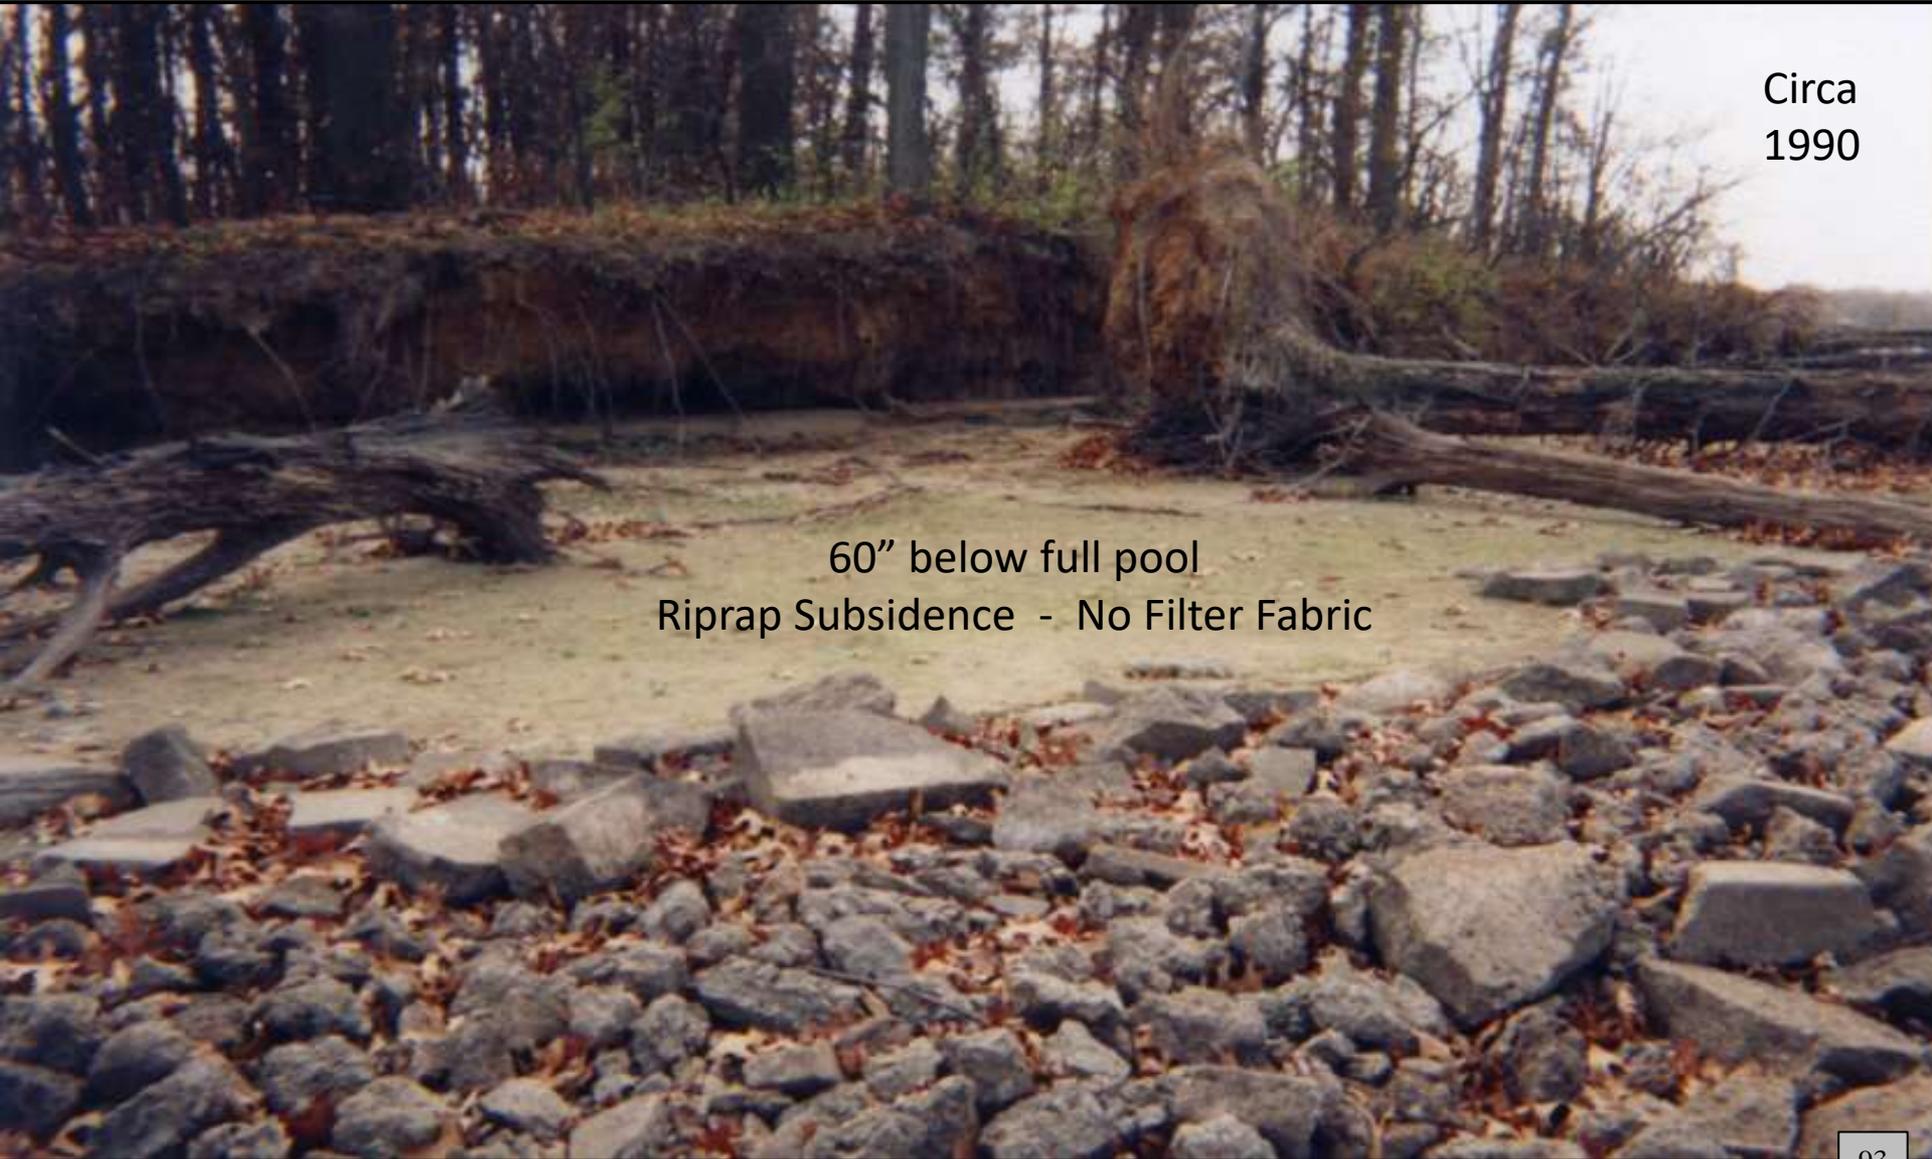
Lake Springfield
Revetment Failure & Repair
39.6908333N 89.6448611W

This revetment was built in the late 1950's
before filter fabric was available.
(Next slide shows the repair)

60" below full pool
Riprap Subsidence - No Filter Fabric

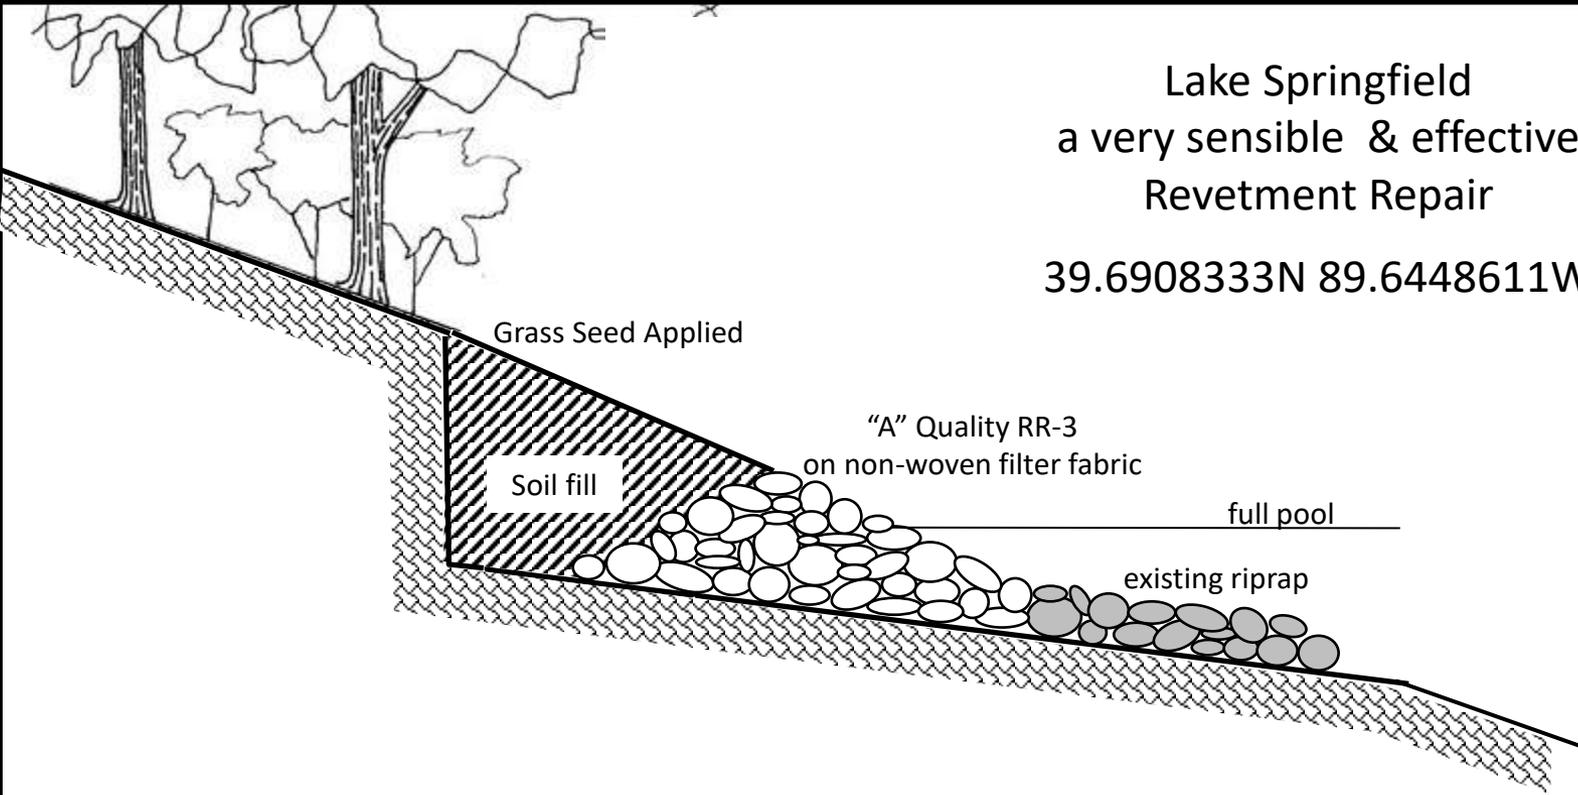
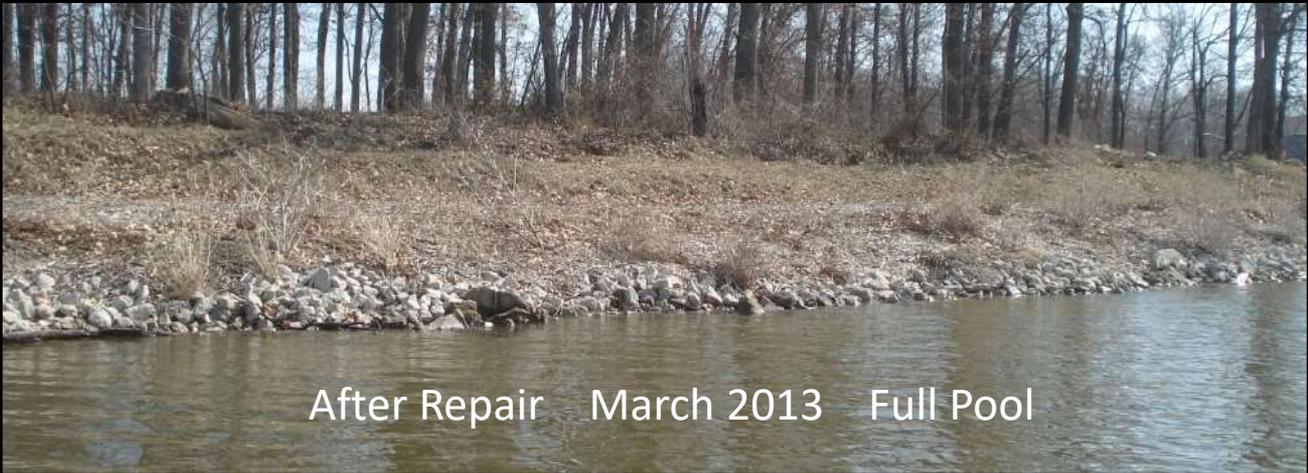
Lake Springfield
a very sensible & effective
Revetment Repair

After Repair March 2013 Full Pool

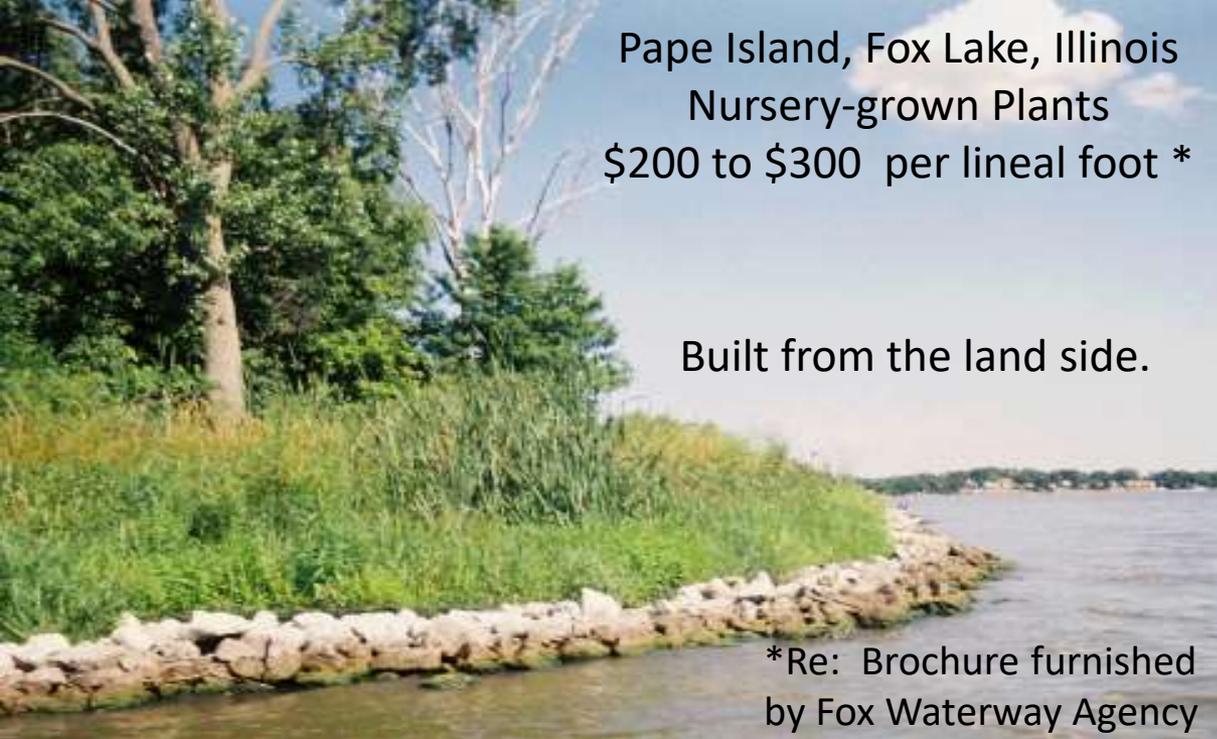
Pape Island, Fox Lake, Illinois
Nursery-grown Plants
\$200 to \$300 per lineal foot *

Built from the land side.

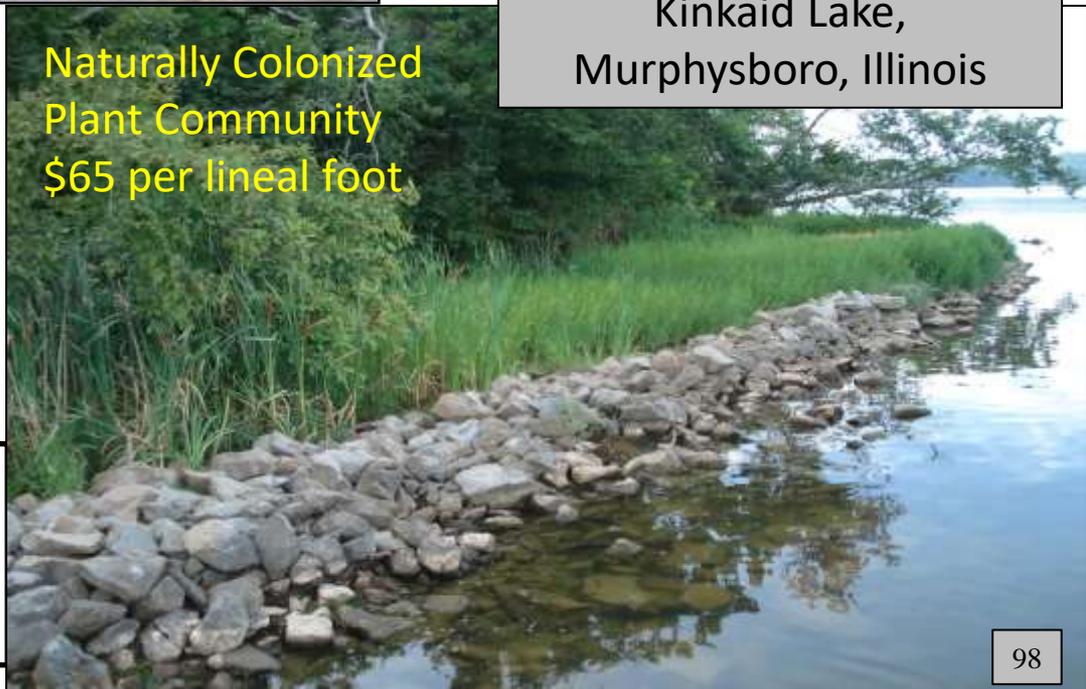
**Naturally Colonized
Plant Community
\$65 per lineal foot**

A natural plant community takes a few years to develop, but it is worth the wait and at less than one third the cost, this living shoreline is feasible for large remote projects.

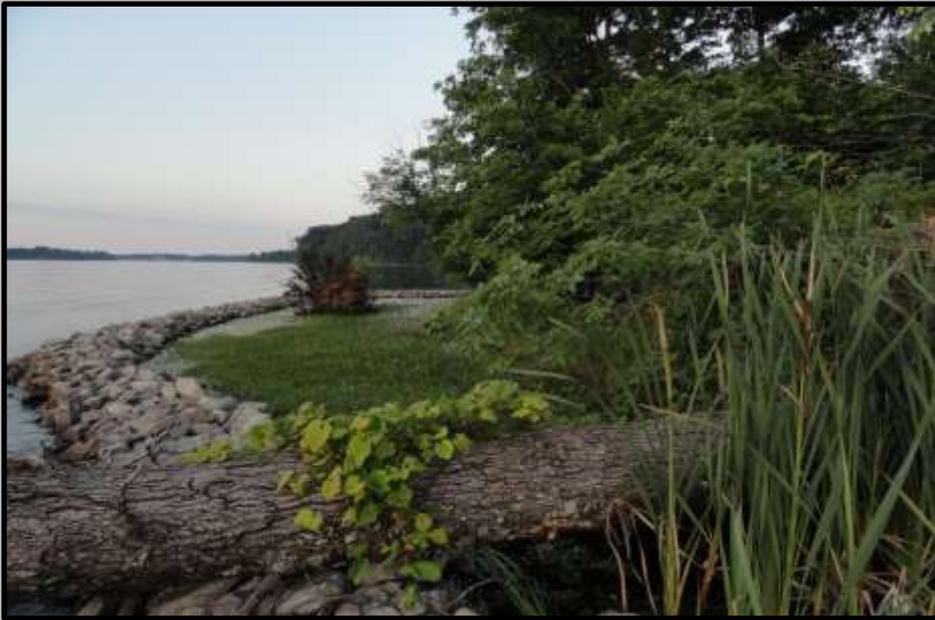
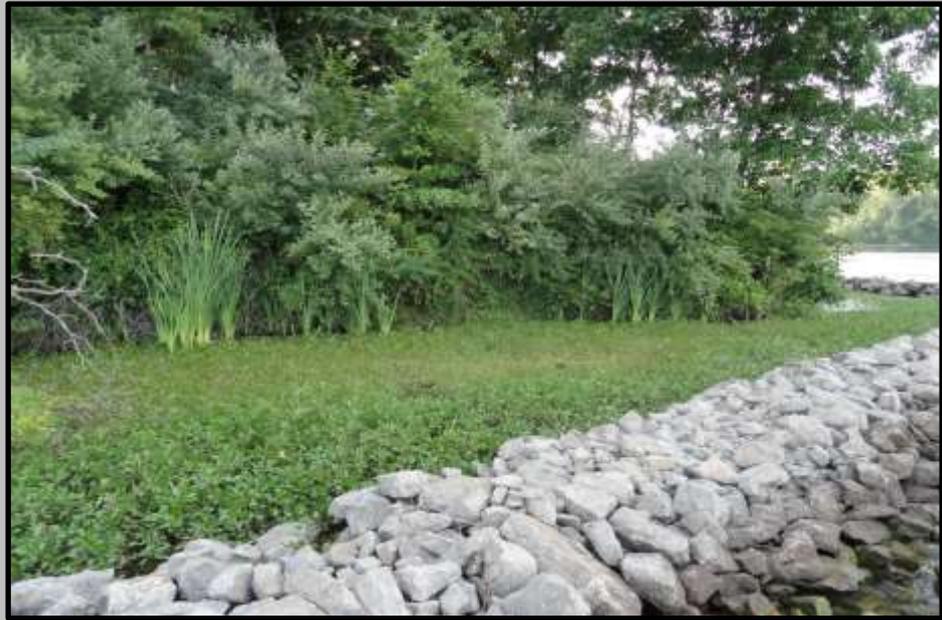
Standard offshore breakwater with naturally colonized littoral habitat “Affordable Lean Bioengineering”

This method does not offer great plant diversity, but is very affordable on a large scale and is extremely effective in wave energy dissipation. Even a monoculture is better than no vegetation at all. (well over 150,000 feet installed on Illinois Reservoirs)

Initially there were only 12 shoreline plant species identified on this reservoir, 6 years after the breakwater was installed, there were 121 shoreline plant species identified plus numerous fauna species.
