Understanding and Controlling Shoreline Erosion on Reservoirs with fine grain, cohesive shoreline soils

Presented by: Shoreline Metrics, LLC
Hank Sutton, Senior Engineering Technician

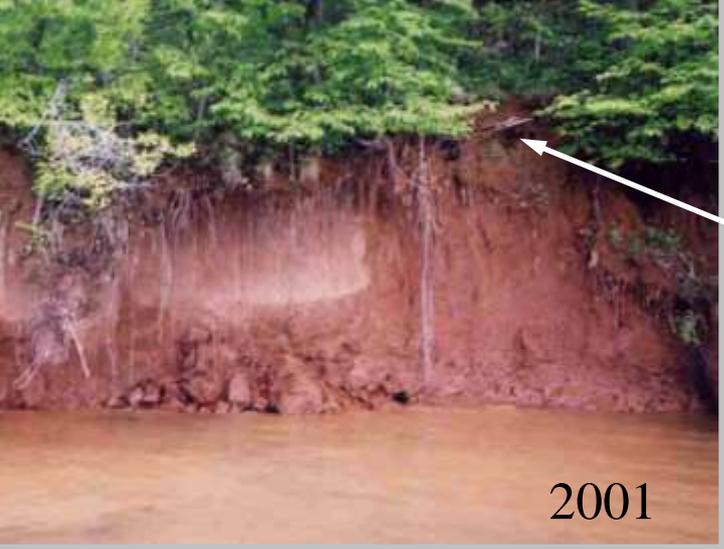
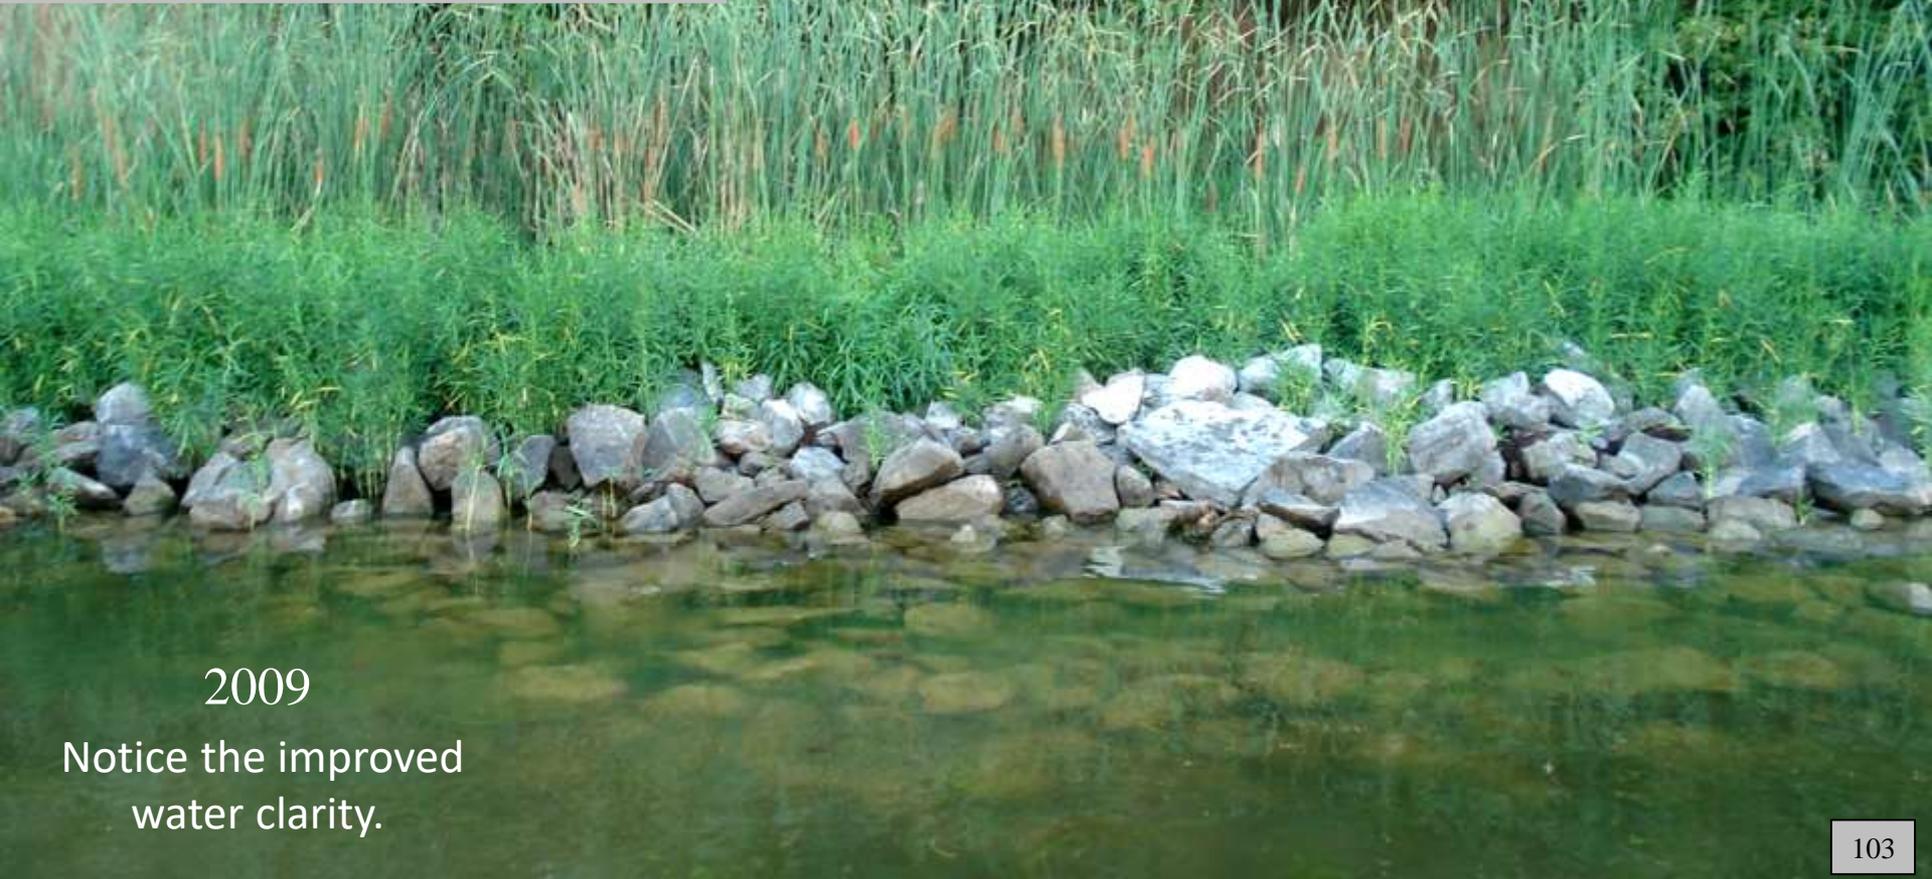
Lake Rip Rap, Inc.
Living Shoreline
(Standard Breakwater with natural plant colonization)
after 8 years

Notice the improved
water clarity.

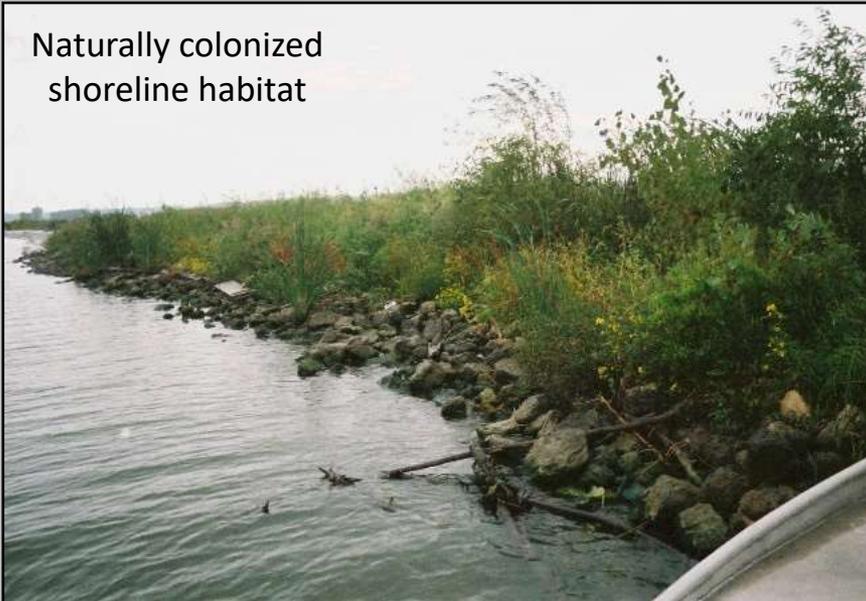
Grass Island, Fox Lake, Illinois

An emergency repair of the Grass Lake Geo-tube Island sets the stage for a lush shoreline habitat by natural propagation.

Two years later, Lake Rip Rap, Inc. was contracted to make similar repairs on an additional 2000 feet of the Geo-Tubes.

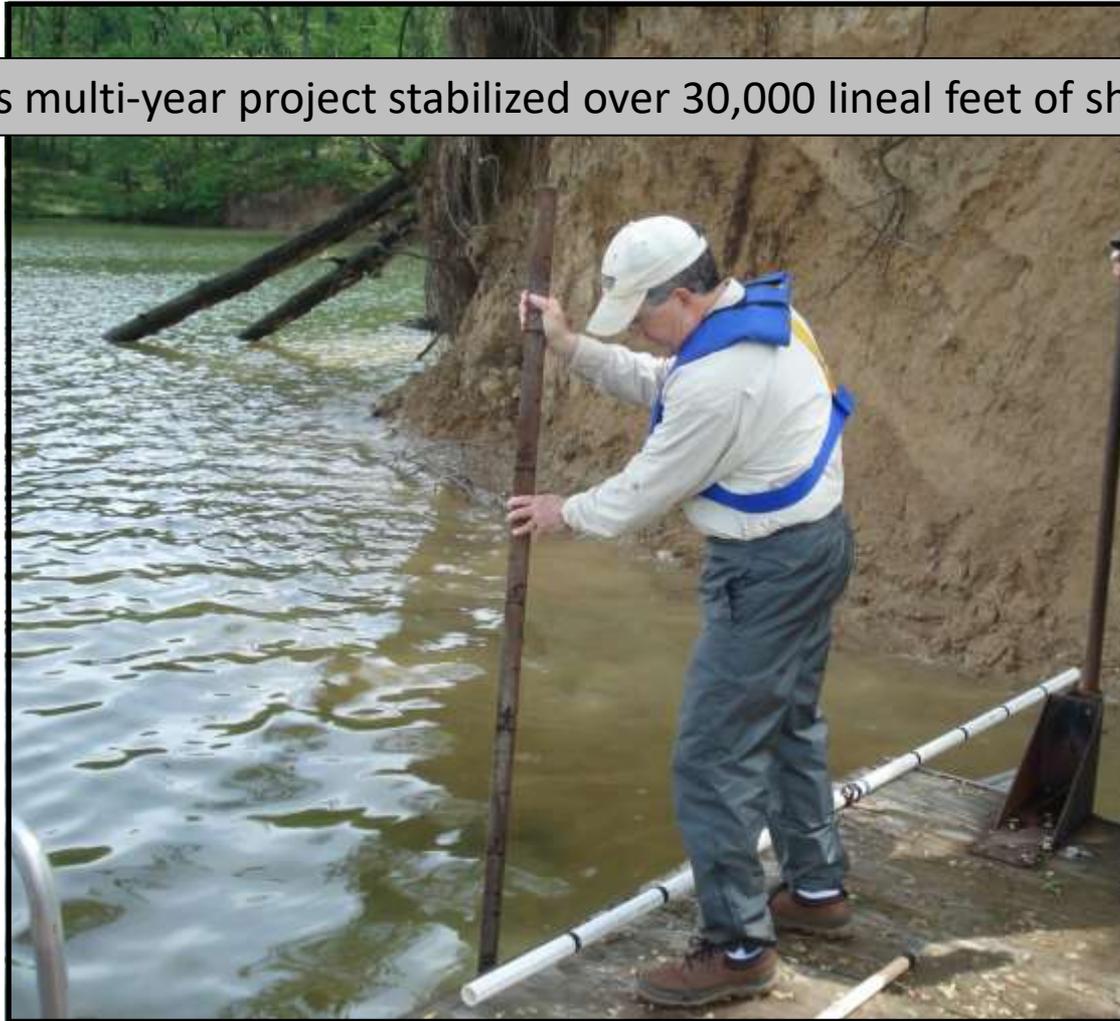
Lake Sara, Effingham, Illinois - Project Manager: Tom Ryan

Determine the littoral slope gradient - 1.5 feet of water at 10 feet from the bank
and 3.0 feet of water at 20 feet from the bank = 15% littoral slope

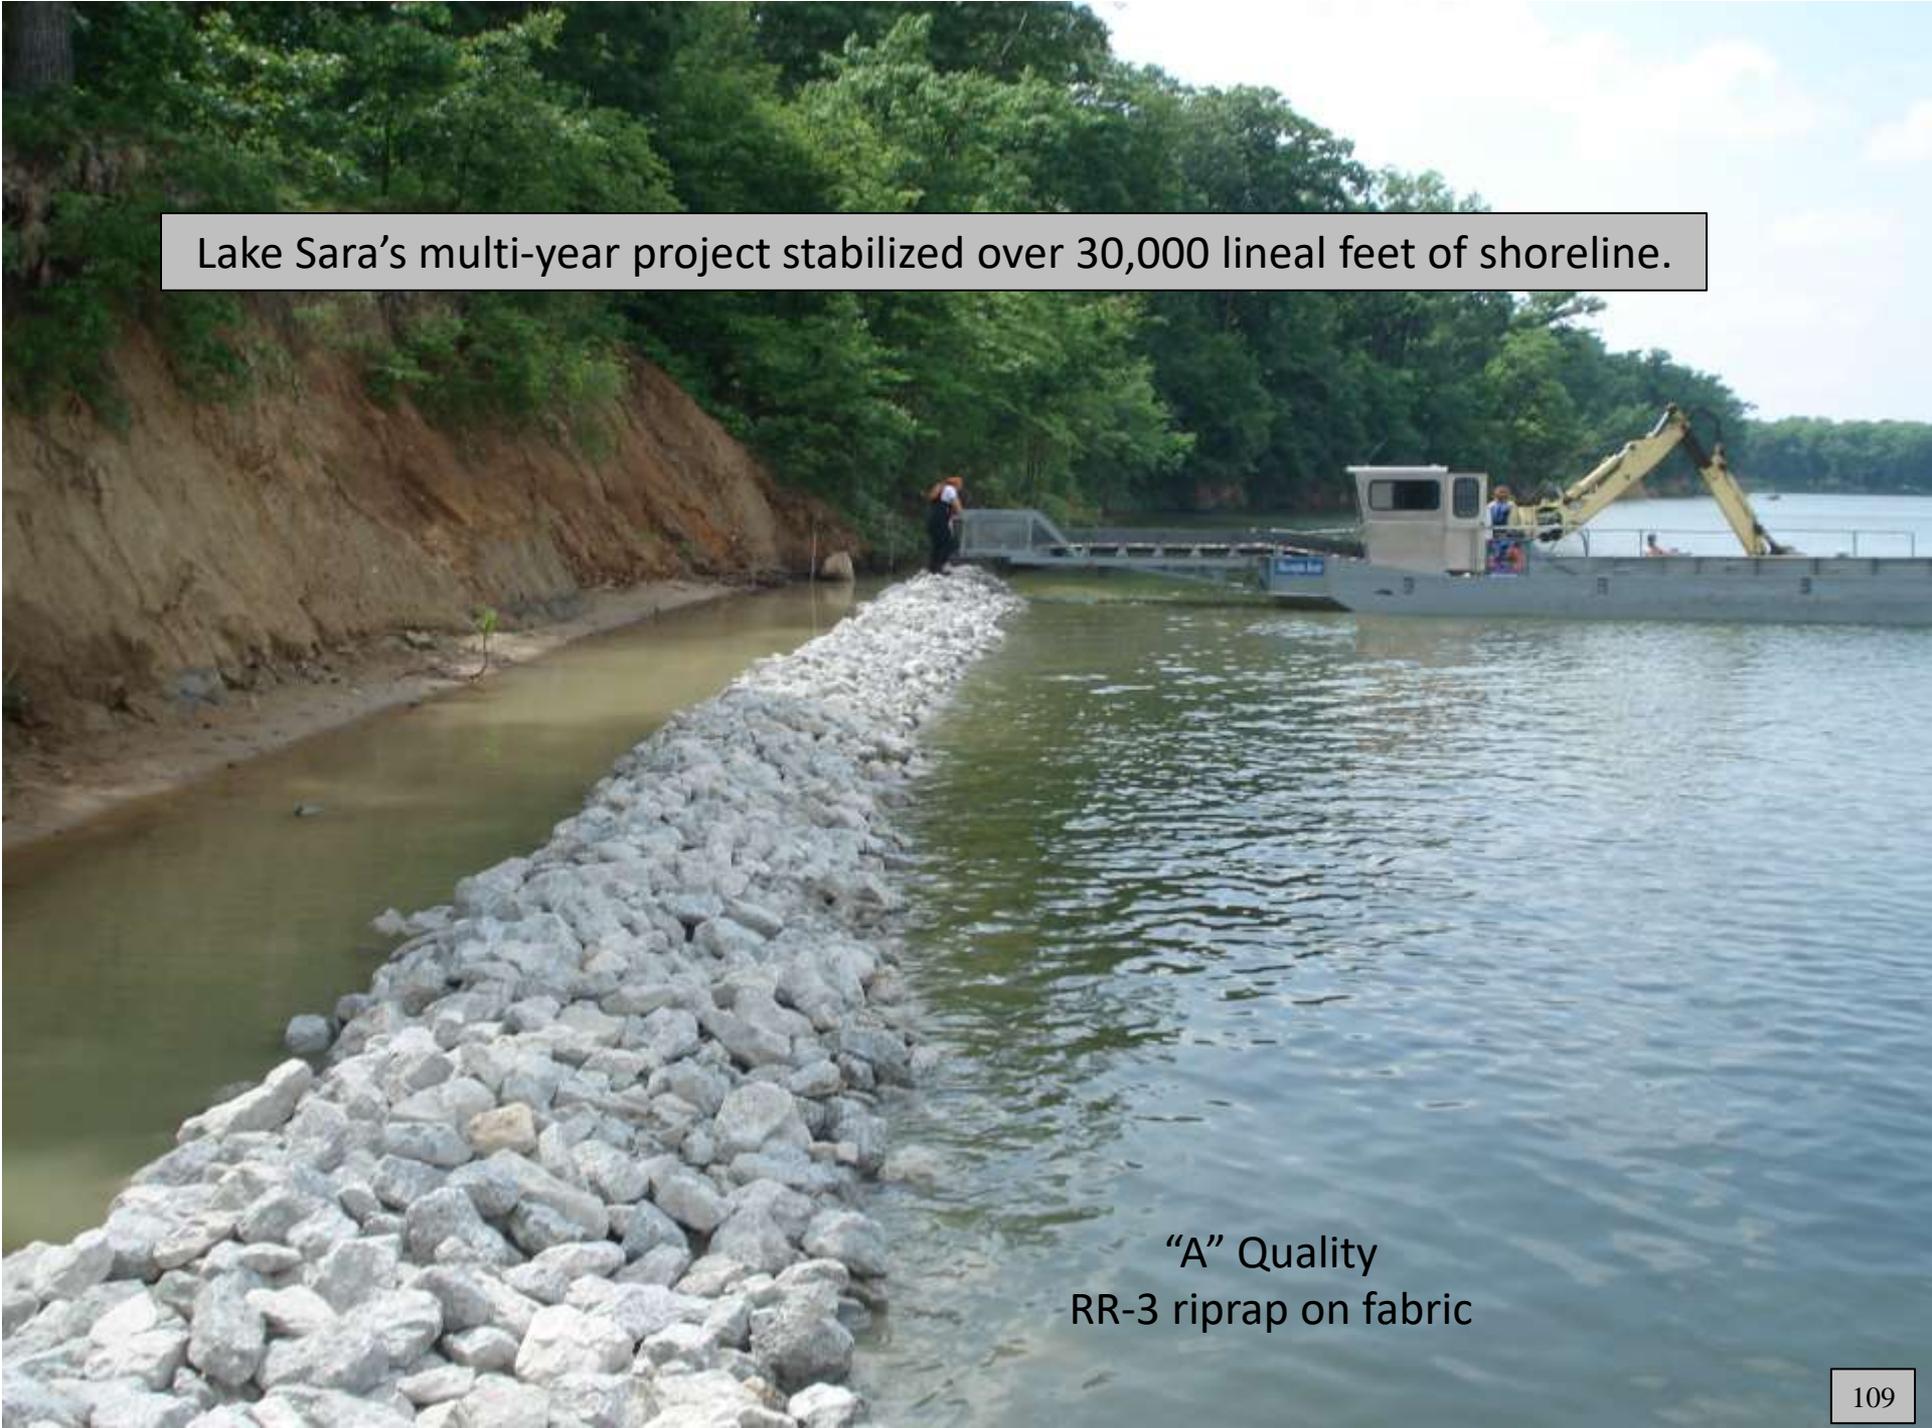
"A" Quality
RR-3 riprap on fabric

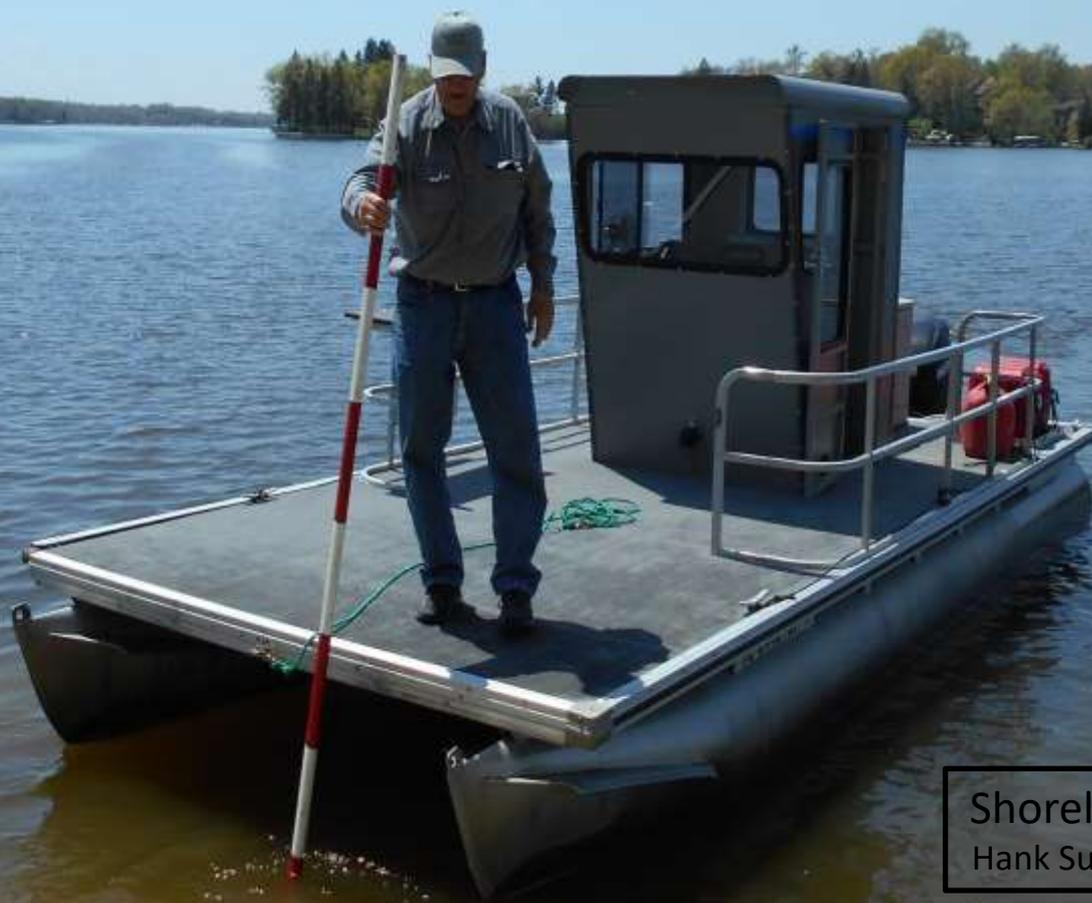
An example of Assumed Topography

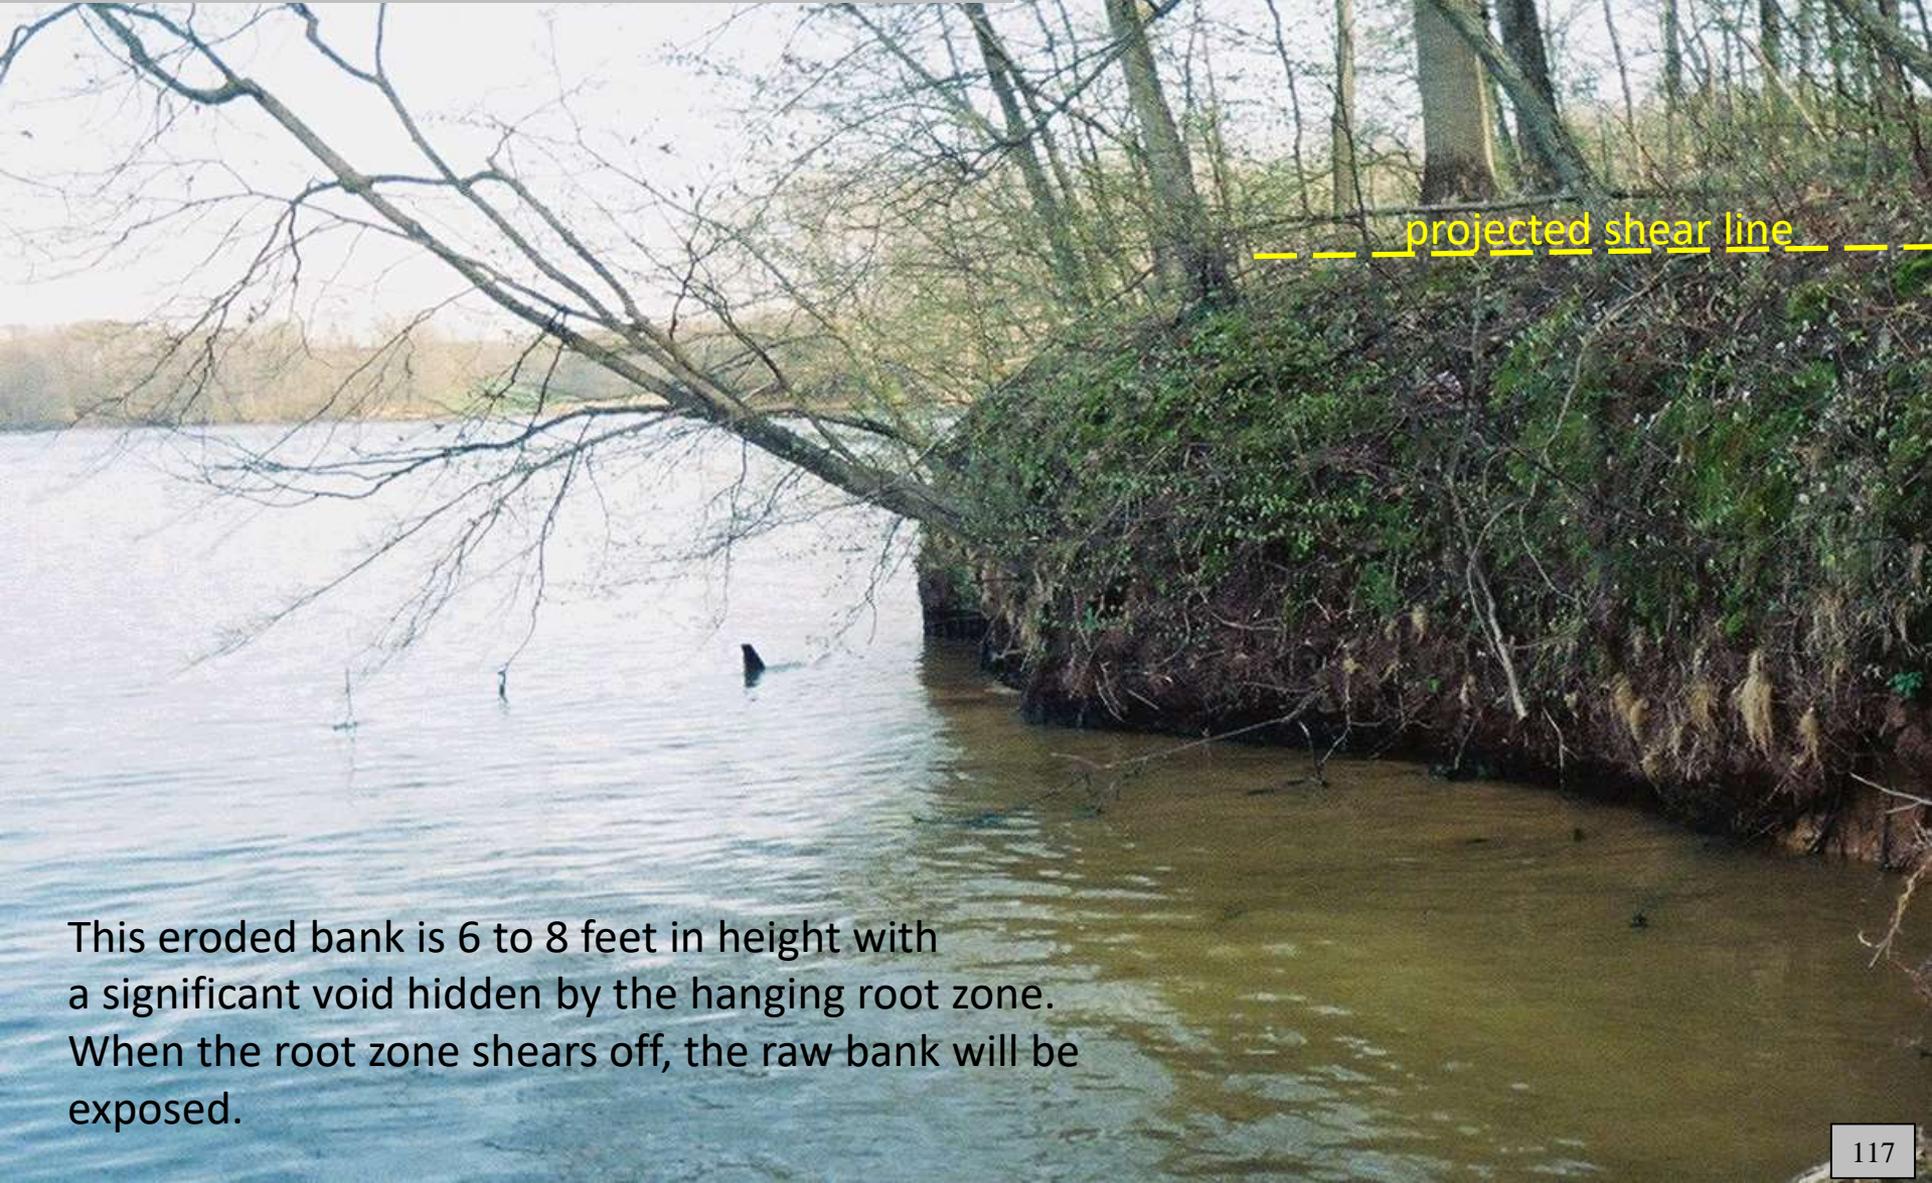
A hanging root zone is simply an earthen flap, reinforced by roots, that will collapse sooner or later.

This eroded bank is 6 to 8 feet in height with a significant void hidden by the hanging root zone. When the root zone shears off, the raw bank will be exposed.

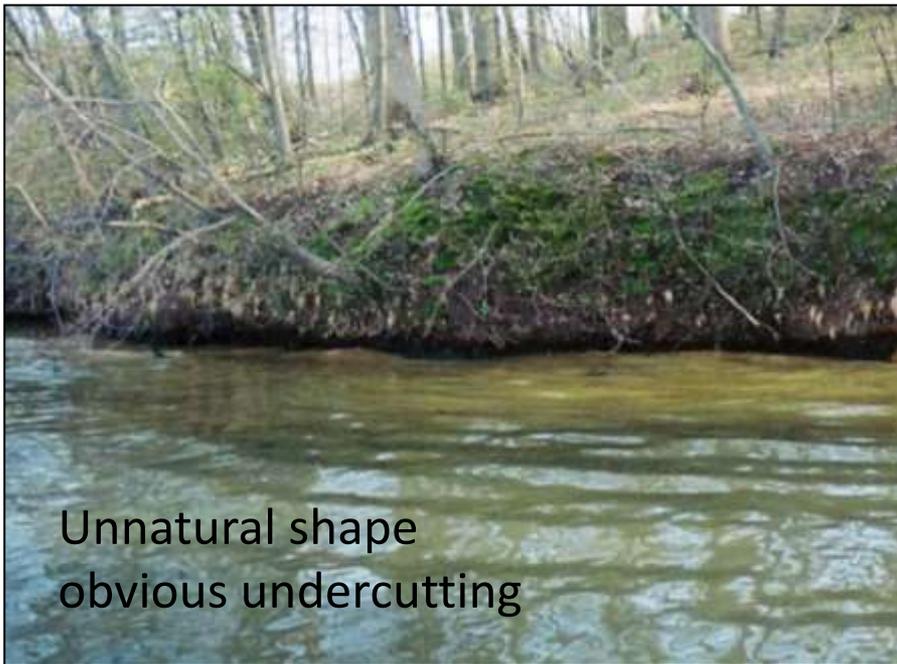
hanging root zone in the process of collapsing

Looks may be deceiving: This shoreline is rapidly receding and rated severe shoreline erosion based on bank height and littoral slope gradient.

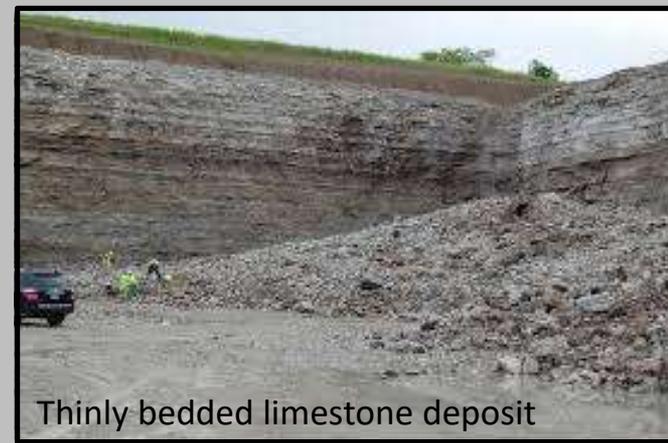
Thinly bedded limestone deposit

Quarries with thick bedding layers can be used for production of all riprap sizes, but a thinly bedded deposit may be limited to the production of RR-3 only. Some quarries with high quality stone are so thinly bedded that they cannot produce riprap at all. Heavy duty riprap screening equipment “Grizzly Bar Screens” are very expensive and some quarries do not produce riprap because it may not be profitable in their market area.

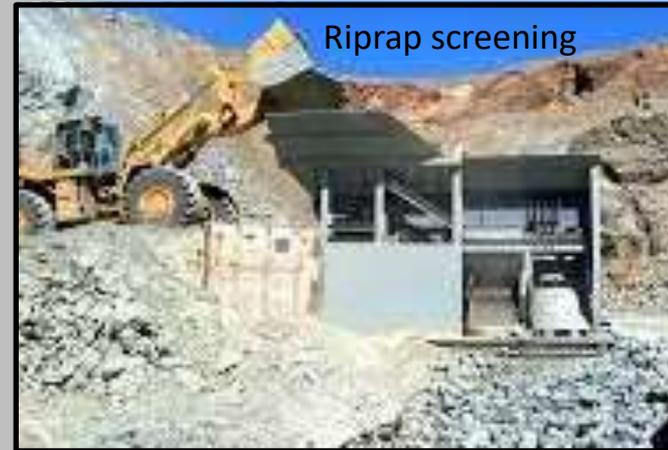
Riprap screening

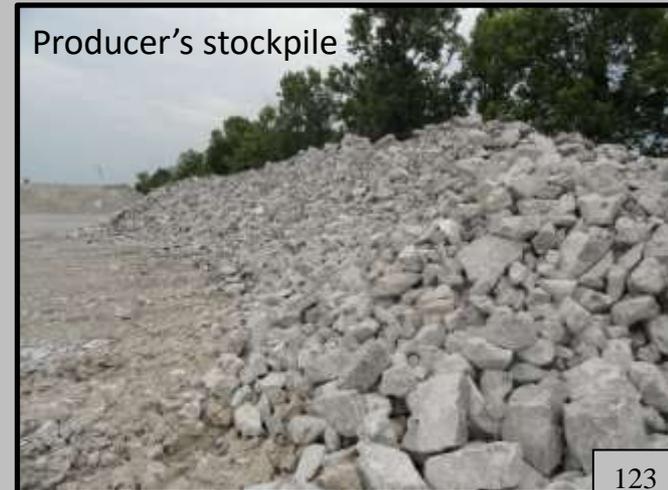
Producer's stockpile

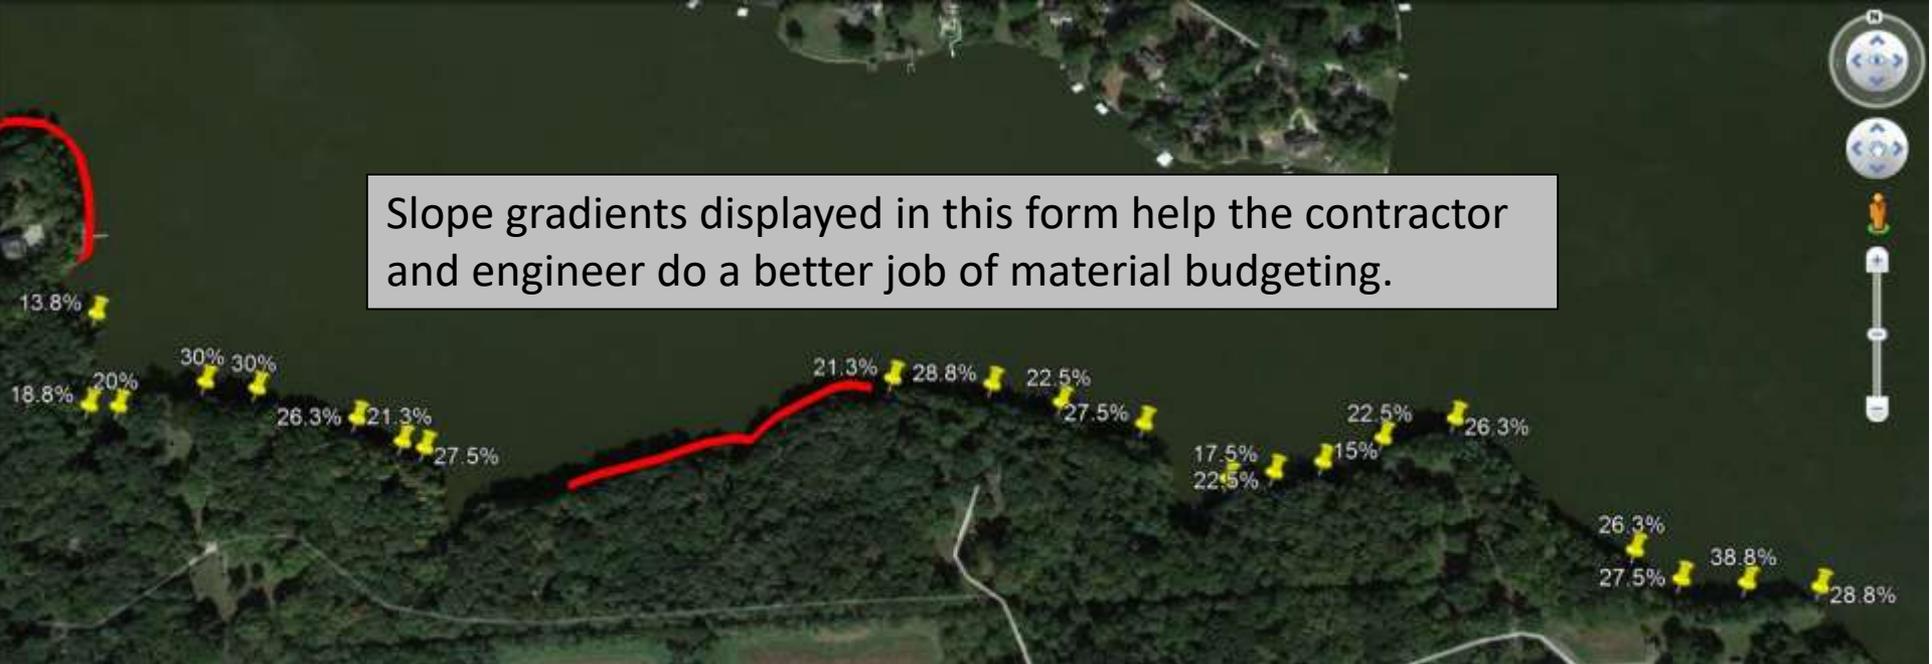
2018 Shoreline Stabilization Project

Slope gradients displayed in this form help the contractor and engineer do a better job of material budgeting.

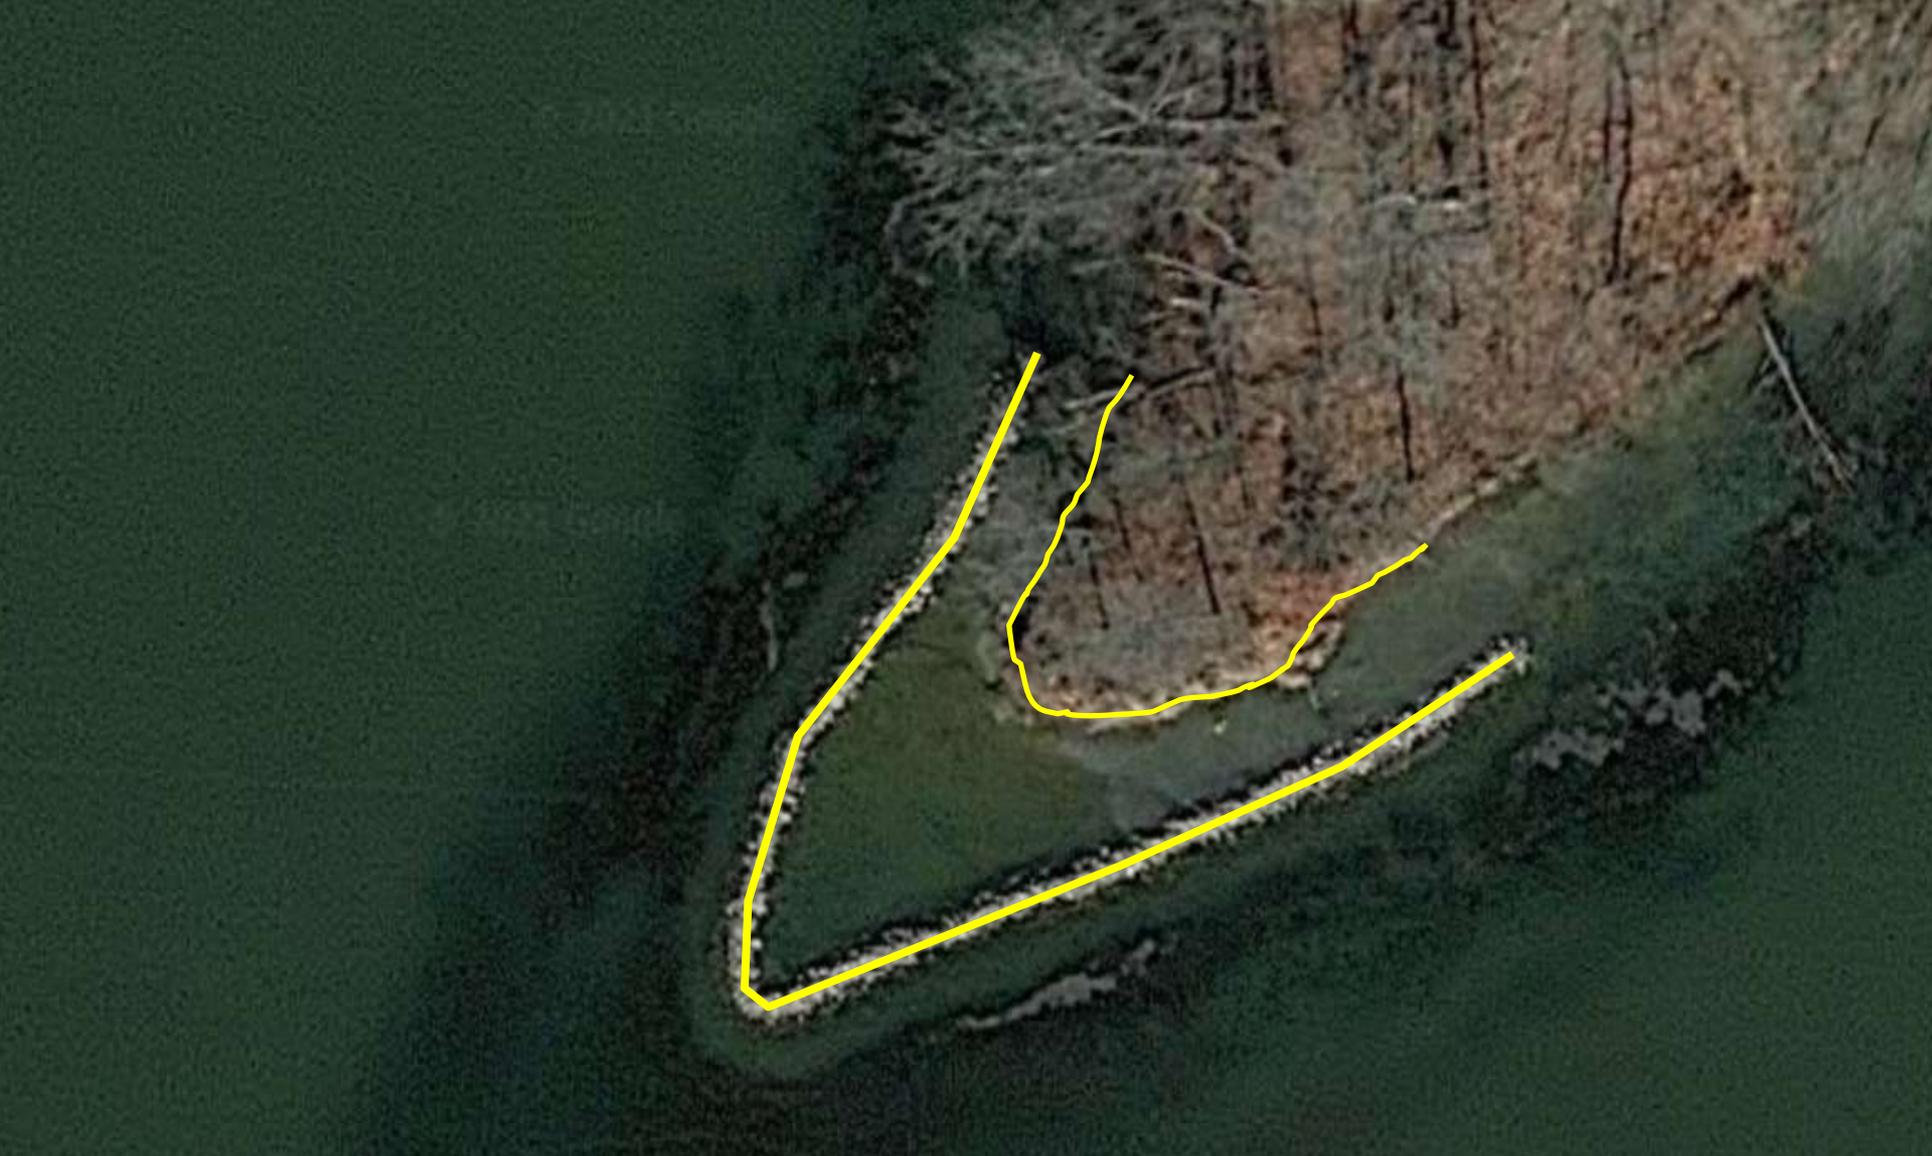
<p>Job site inspection regardless of littoral slope gradient</p>	<p><i>Shoreline Metrics, LLC</i> Hank Sutton, Senior Engineering Technician</p>
<p>Spot check total breakwater width (15 ft.) and above water dimensions as shown here</p>		
<p>Illinois Standard Breakwater</p>		
<p>NOTE: If the 15 ft. dimension, the 6.5 ft. dimension, the top elevation are all correct and the yield in tons / foot is correct, the breakwater would appear to be acceptable.</p>

A littoral zone survey will determine the true length of the riprap structure and not just the length of shoreline to be protected.

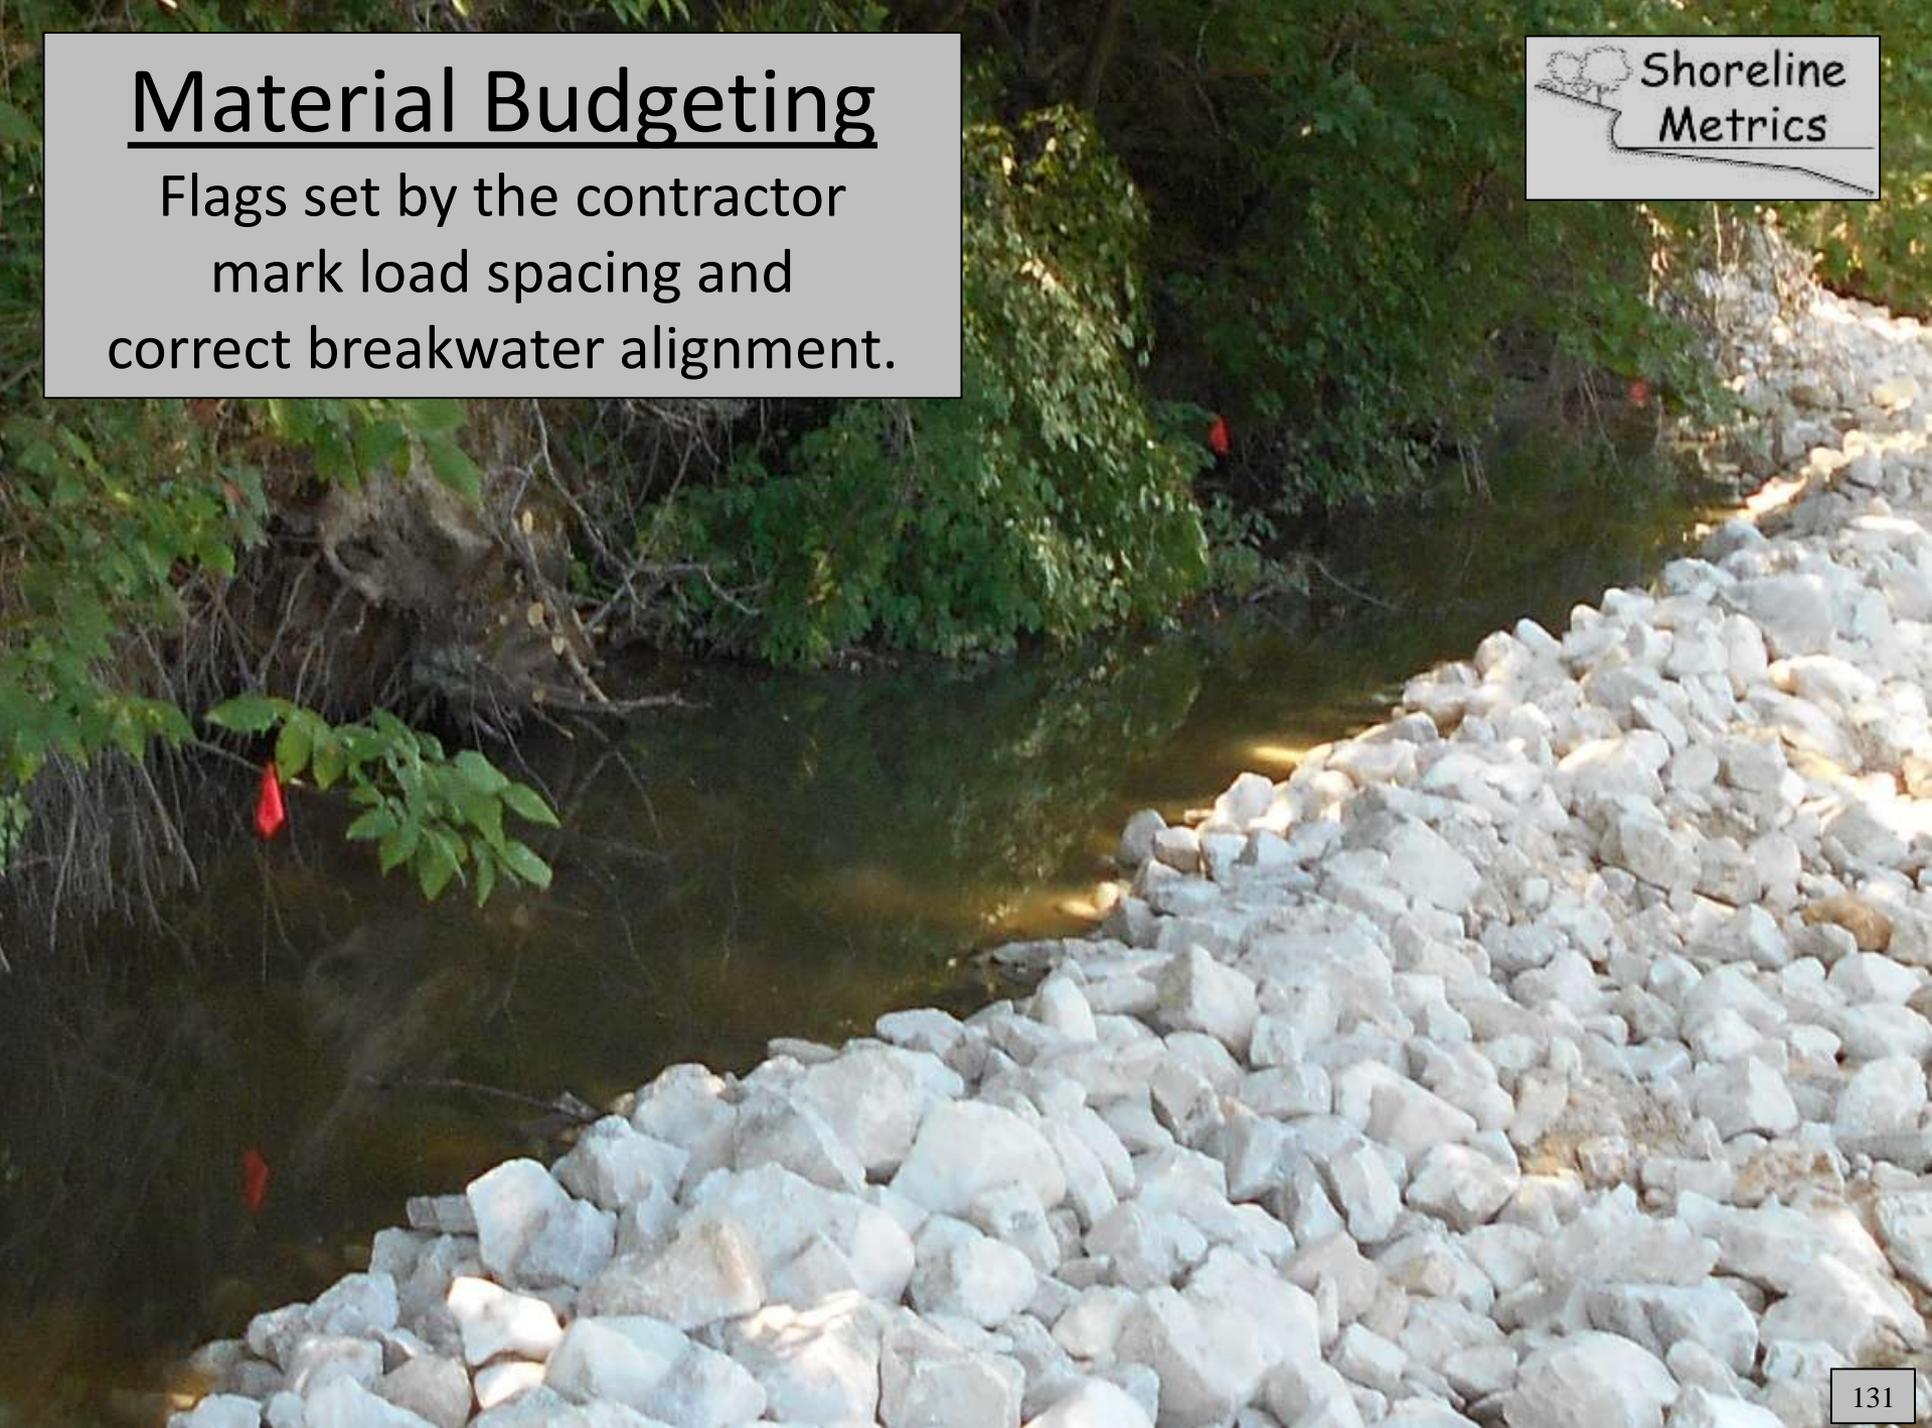
Flags set by the contractor
mark load spacing and
correct breakwater alignment.
